# 3D 'O' Ring Vacuum Tests – PART II

Updated 21<sup>st</sup> July 2011

by Ian Clark, Trevor Savidge & Peter Savage

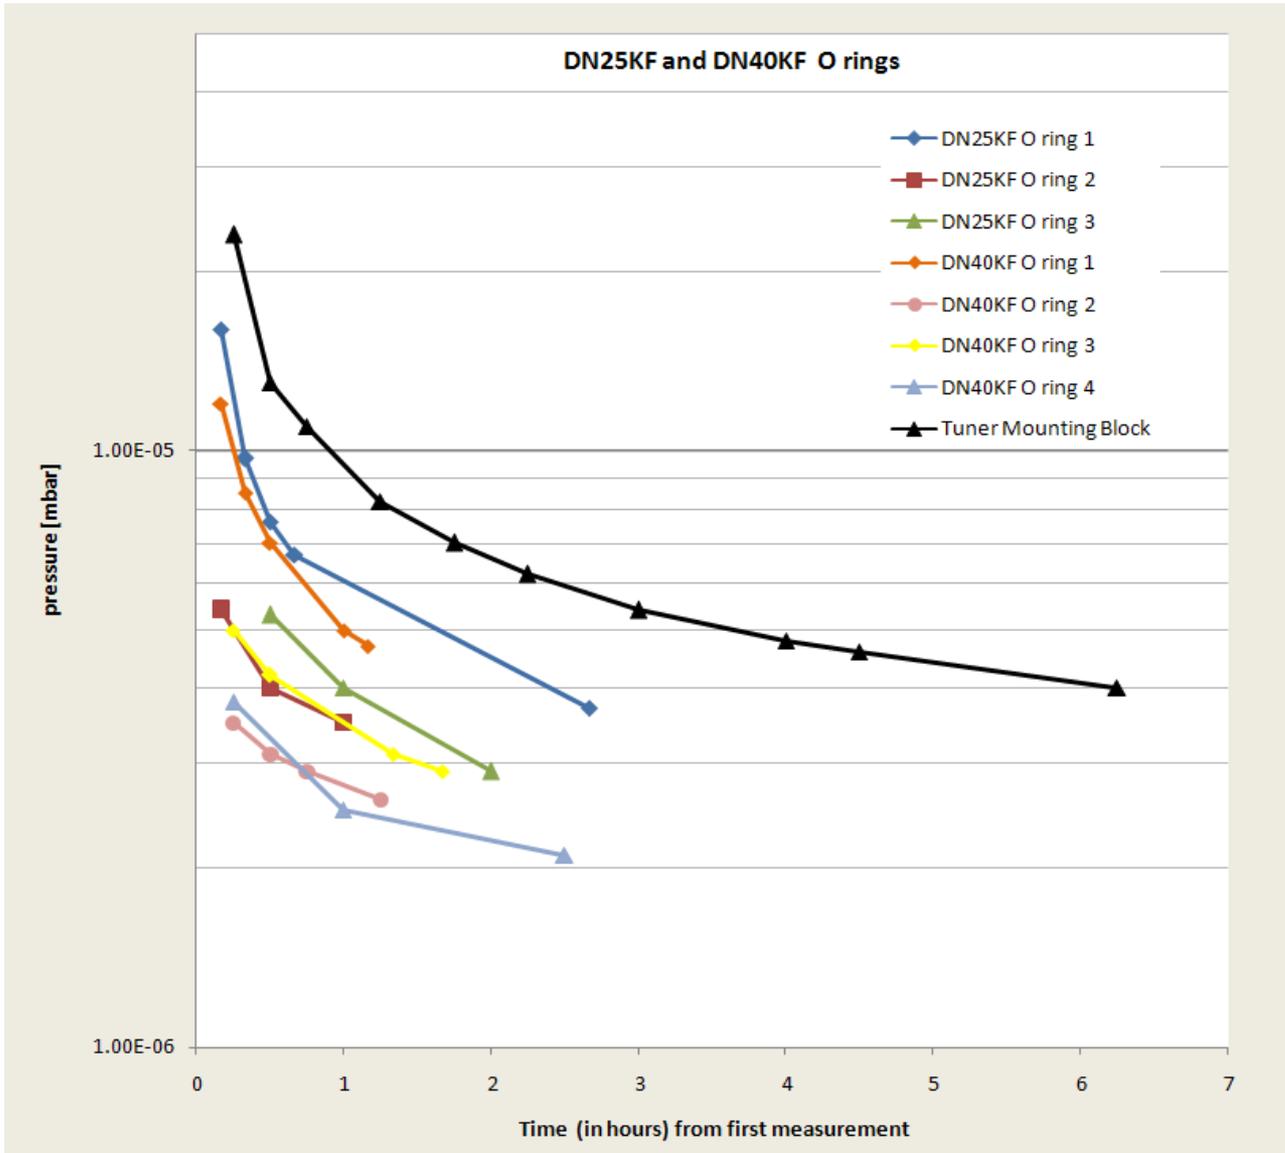
At a recorded temperature of 85°C the pressure suddenly increased and did not recover.

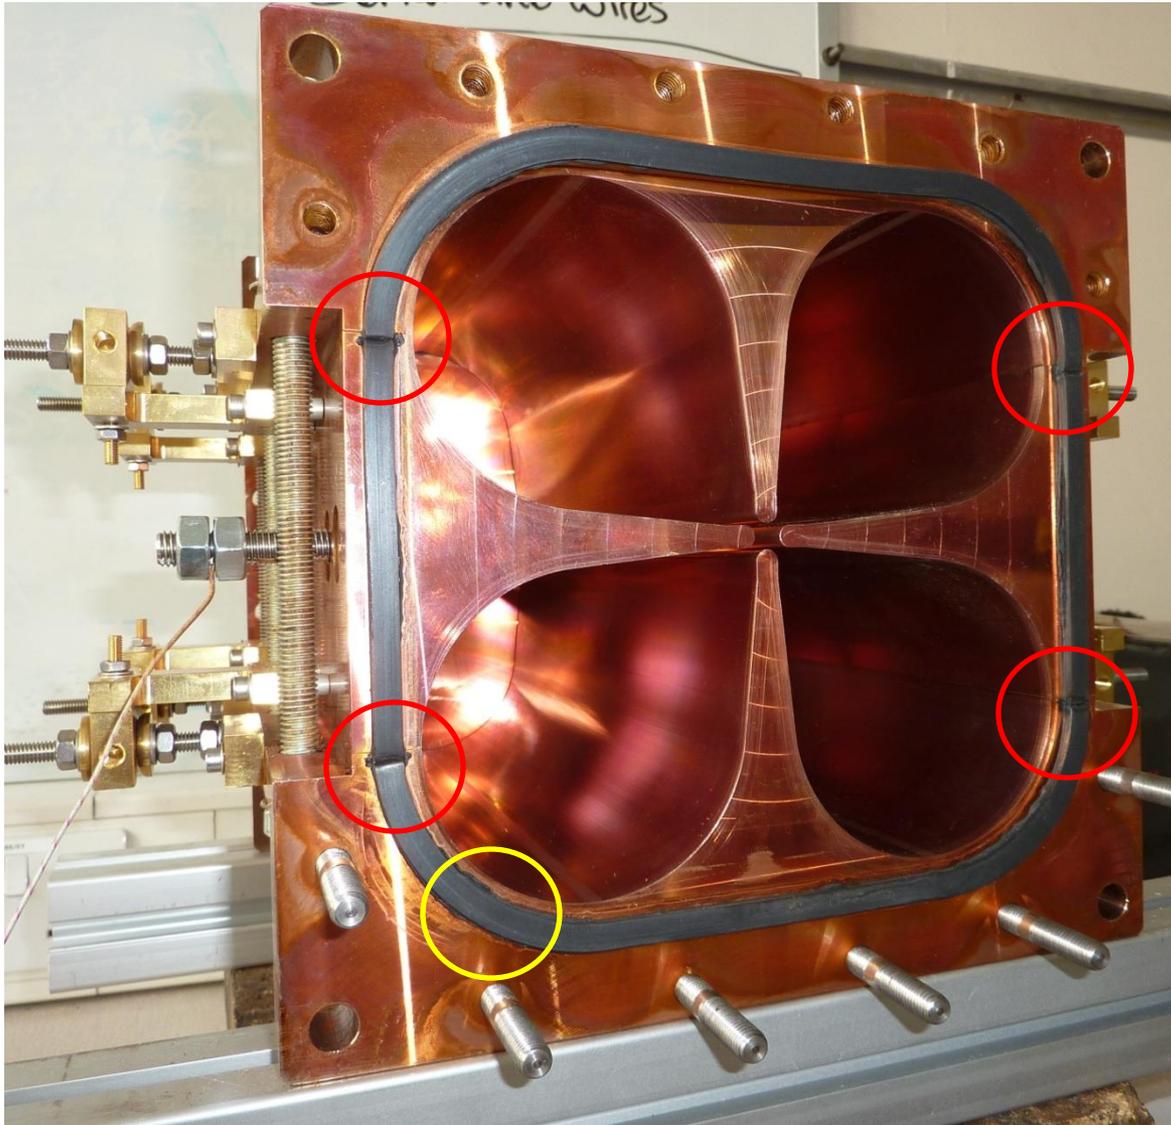
The O ring had visibly changed in 2 ways:

- 1) There were slots or dents at the positions where the longitudinal 'O' ring is bonded to the transverse ring. The slots were present at all 4 locations at both ends of the model.
- 2) Flash on the edges of the inner face (bulk copper side, not flange side) of the transverse ring. Present at both ends.

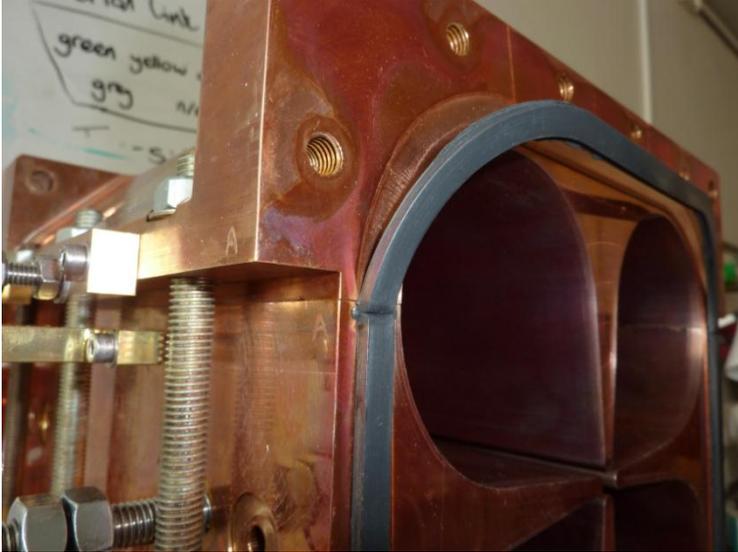
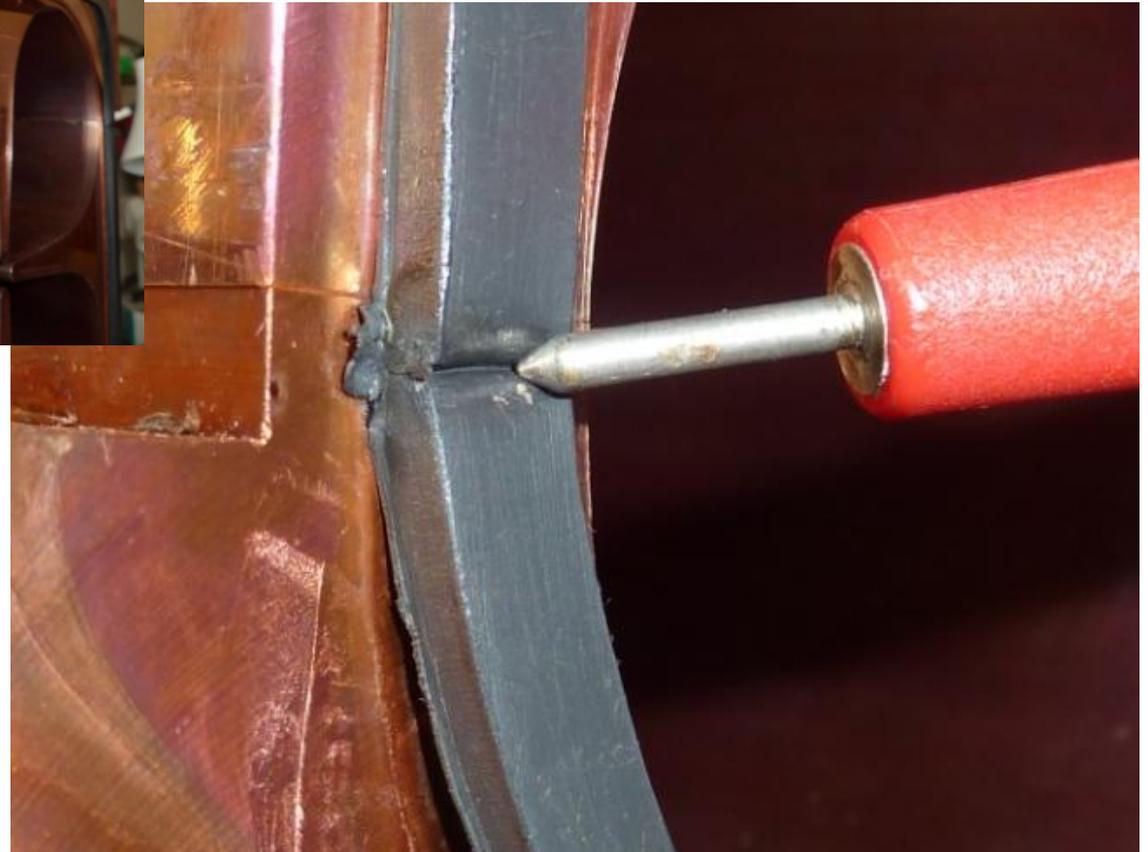
Centre line of dent does not coincide with joint interface because the longitudinal slot is only present in one vane.

It is imagined that due to the tension, heat and vacuum over time the 'O' ring is drawn down into the square slot for the longitudinal 'O' ring.

This will have caused the vacuum leak. This behaviour has not been seen before with the full length longitudinal 'O' rings.

- The dents must be prevented because they will cause a vacuum leak.
- This behaviour has not been seen before using the full length longitudinal 'O' rings and so should be easy to cure.

- Build a new 3D O ring using full length longitudinal 'O' rings and Permabond 920.
- Cure the adhesive to the manufacturers specification.
- Re-test vacuum performance with heat applied.

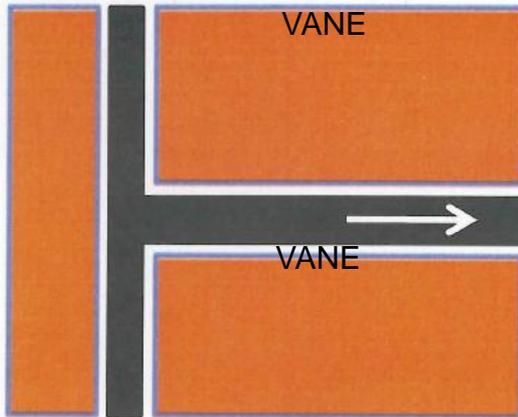
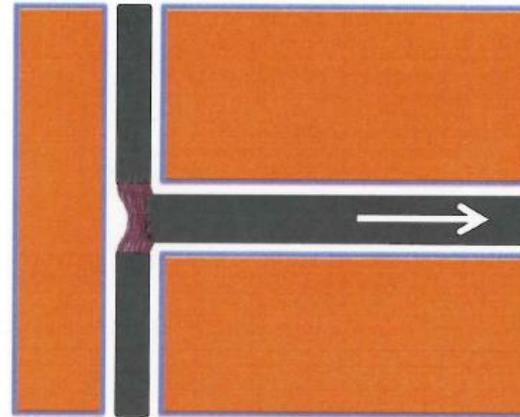
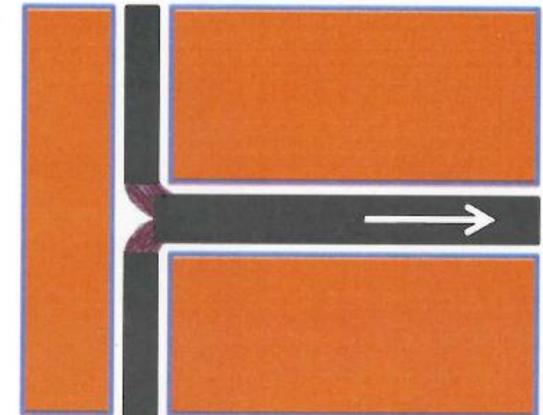
For this 3D 'O' ring build the longitudinal 'O' rings were cut short at 245mm instead of 250mm. The idea was to counter the length increase due to compression and to pull the transverse ring onto the end faces which assists the fitting of the end flanges. However this results in a tension at the adhesive joint region.

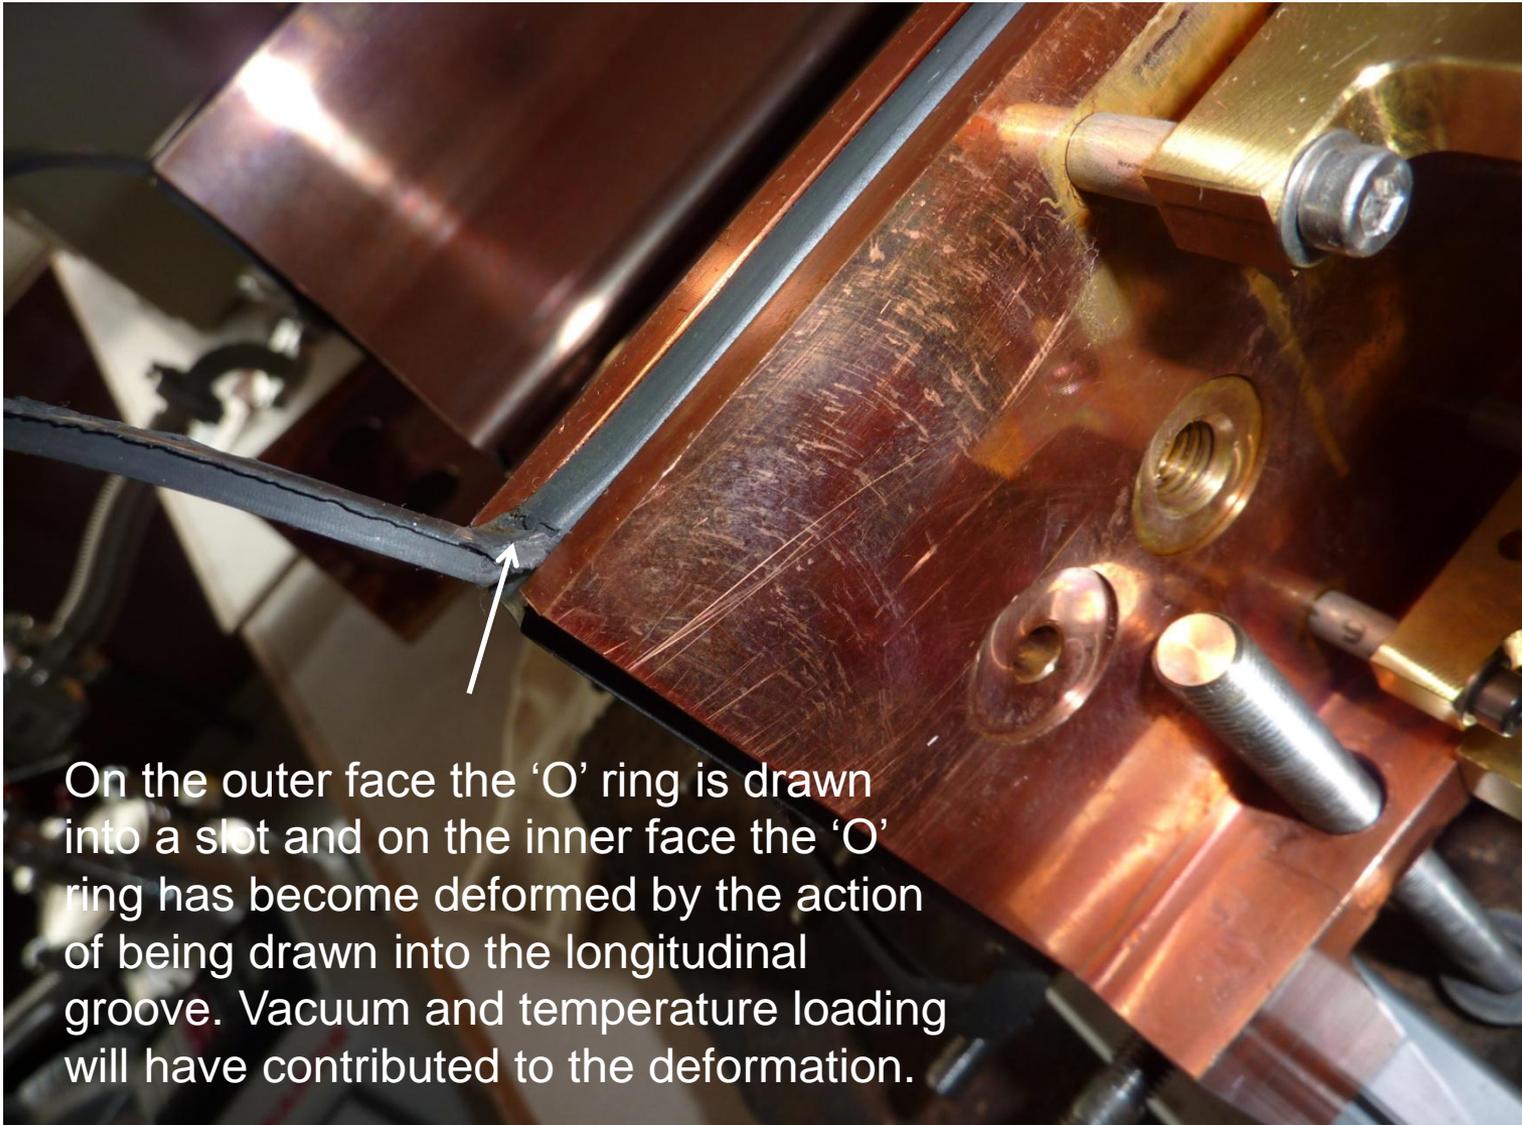
On the outer face the 'O' ring is drawn into a slot and on the inner face the 'O' ring has become deformed by the action of being drawn into the longitudinal groove. Vacuum and temperature loading will have contributed to the deformation.

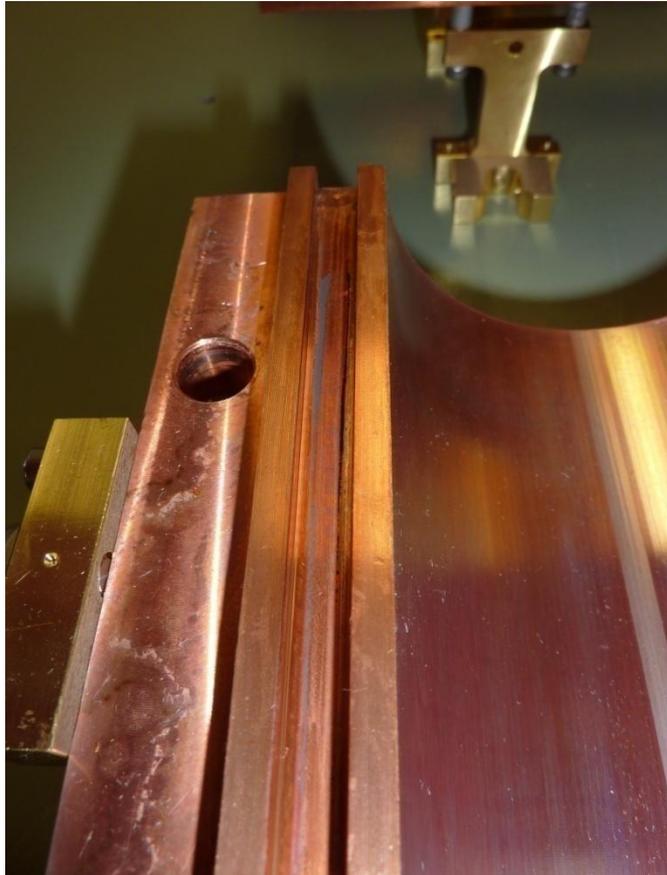
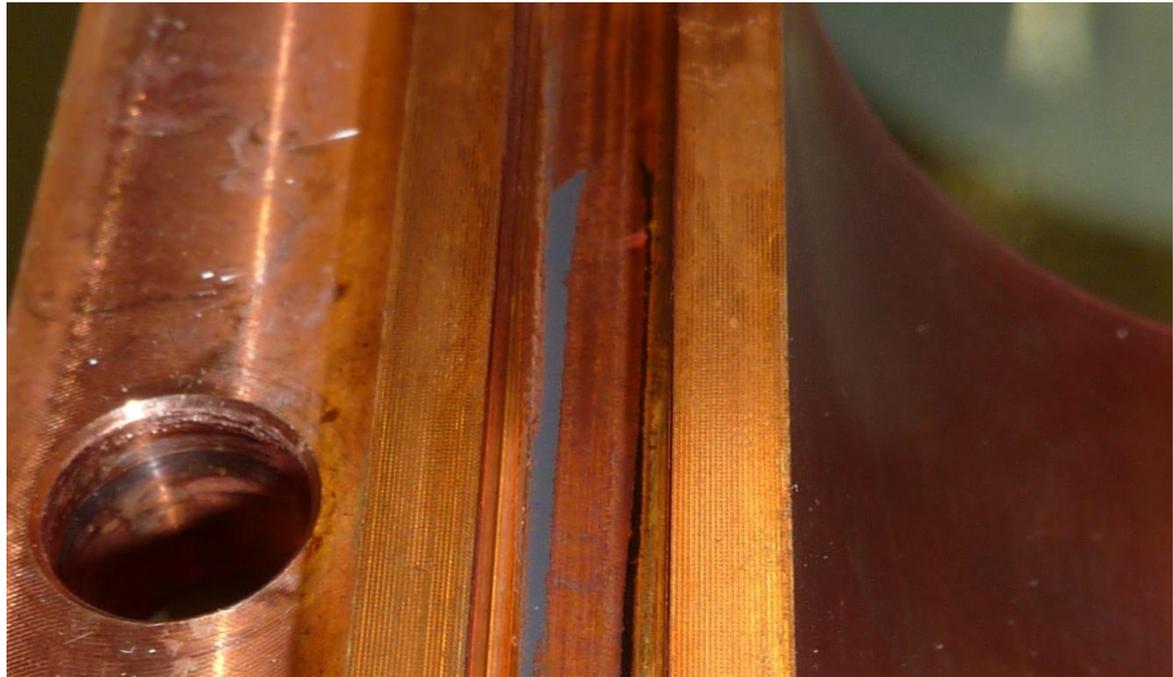
Observation - rubber has been deposited on the weld test model.

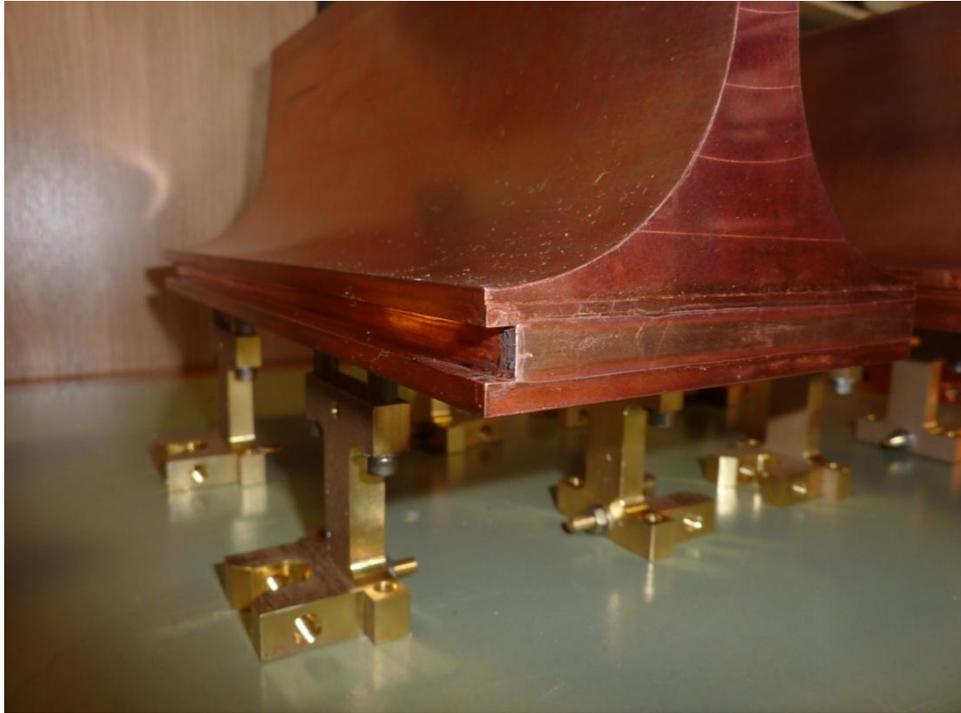
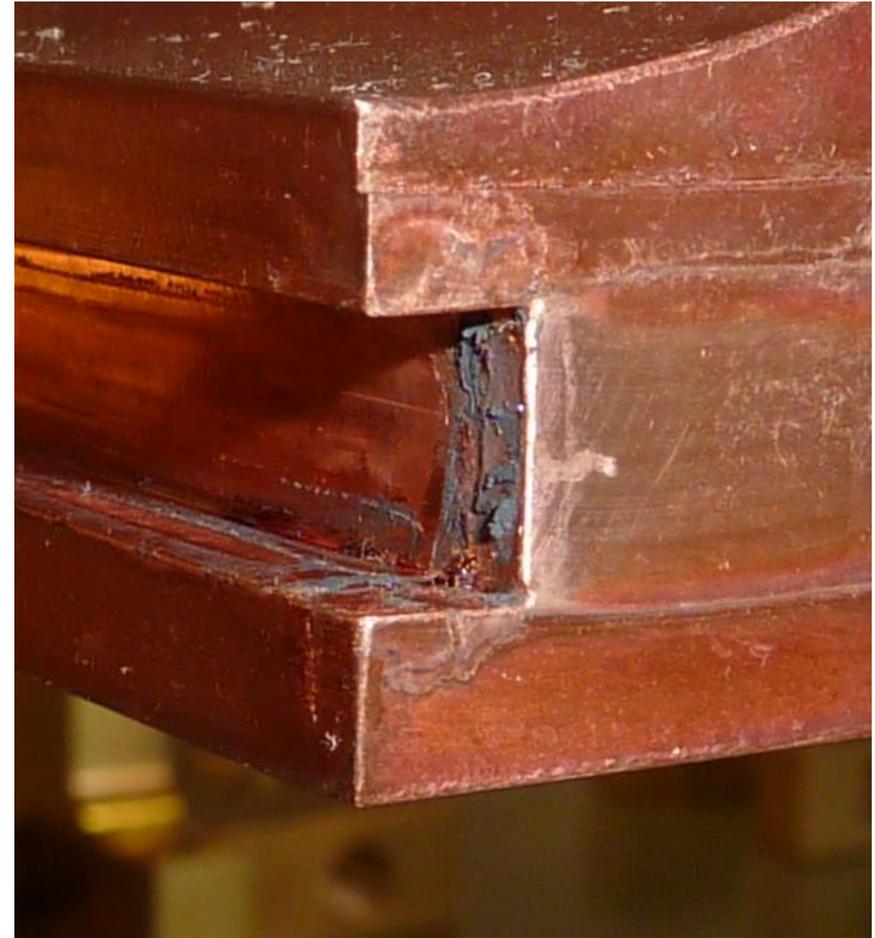
Observation - rubber has been deposited on the weld test model.

- Do not know the cause.
- Is the temperature measurement reliable?
- Is it a feature of square profile 'O' ring?
- Does it matter? – it would probably still have maintained a vacuum seal.

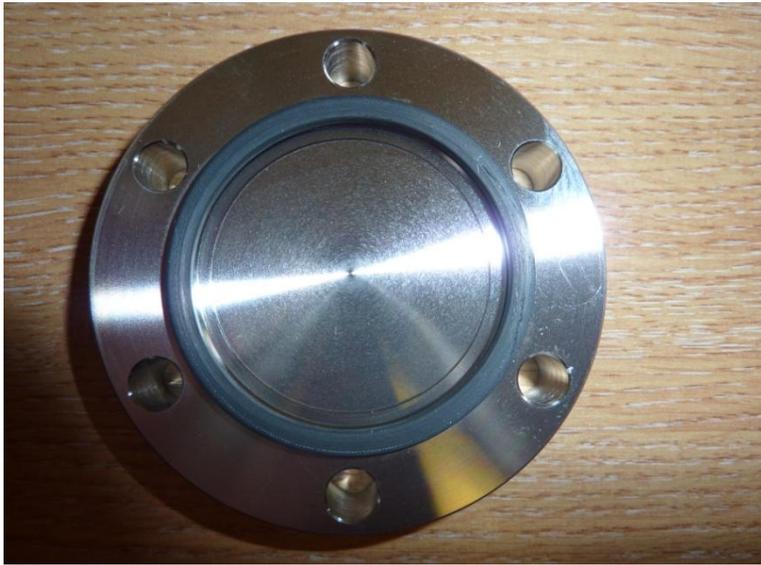
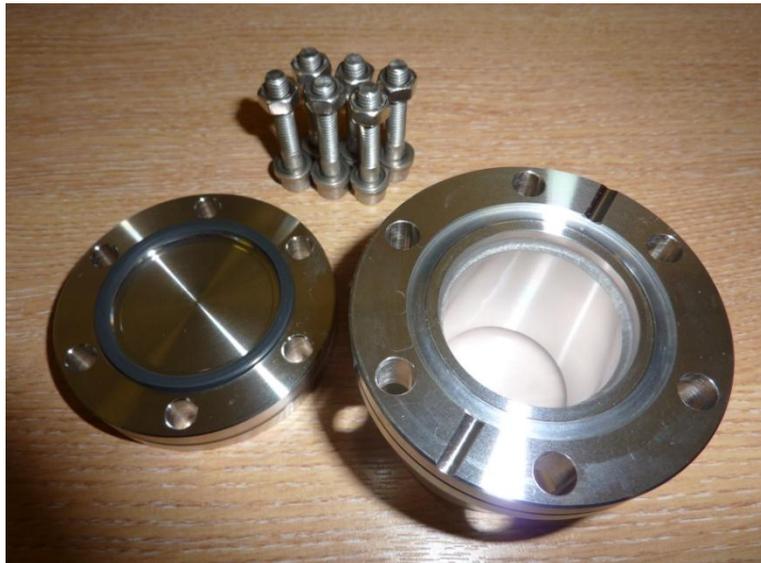
Test #26.....

Opening up the DN40CF flanges revealed that the square profile Viton ring showed no signs of 'flash'.

- The groove is present in both flanges and therefore the rubber ring square edges are constrained.
- The ring is smaller (there is less rubber).
- This system is stiffer with more clamping per unit area i.e. less chance for creep of rubber between mating faces.

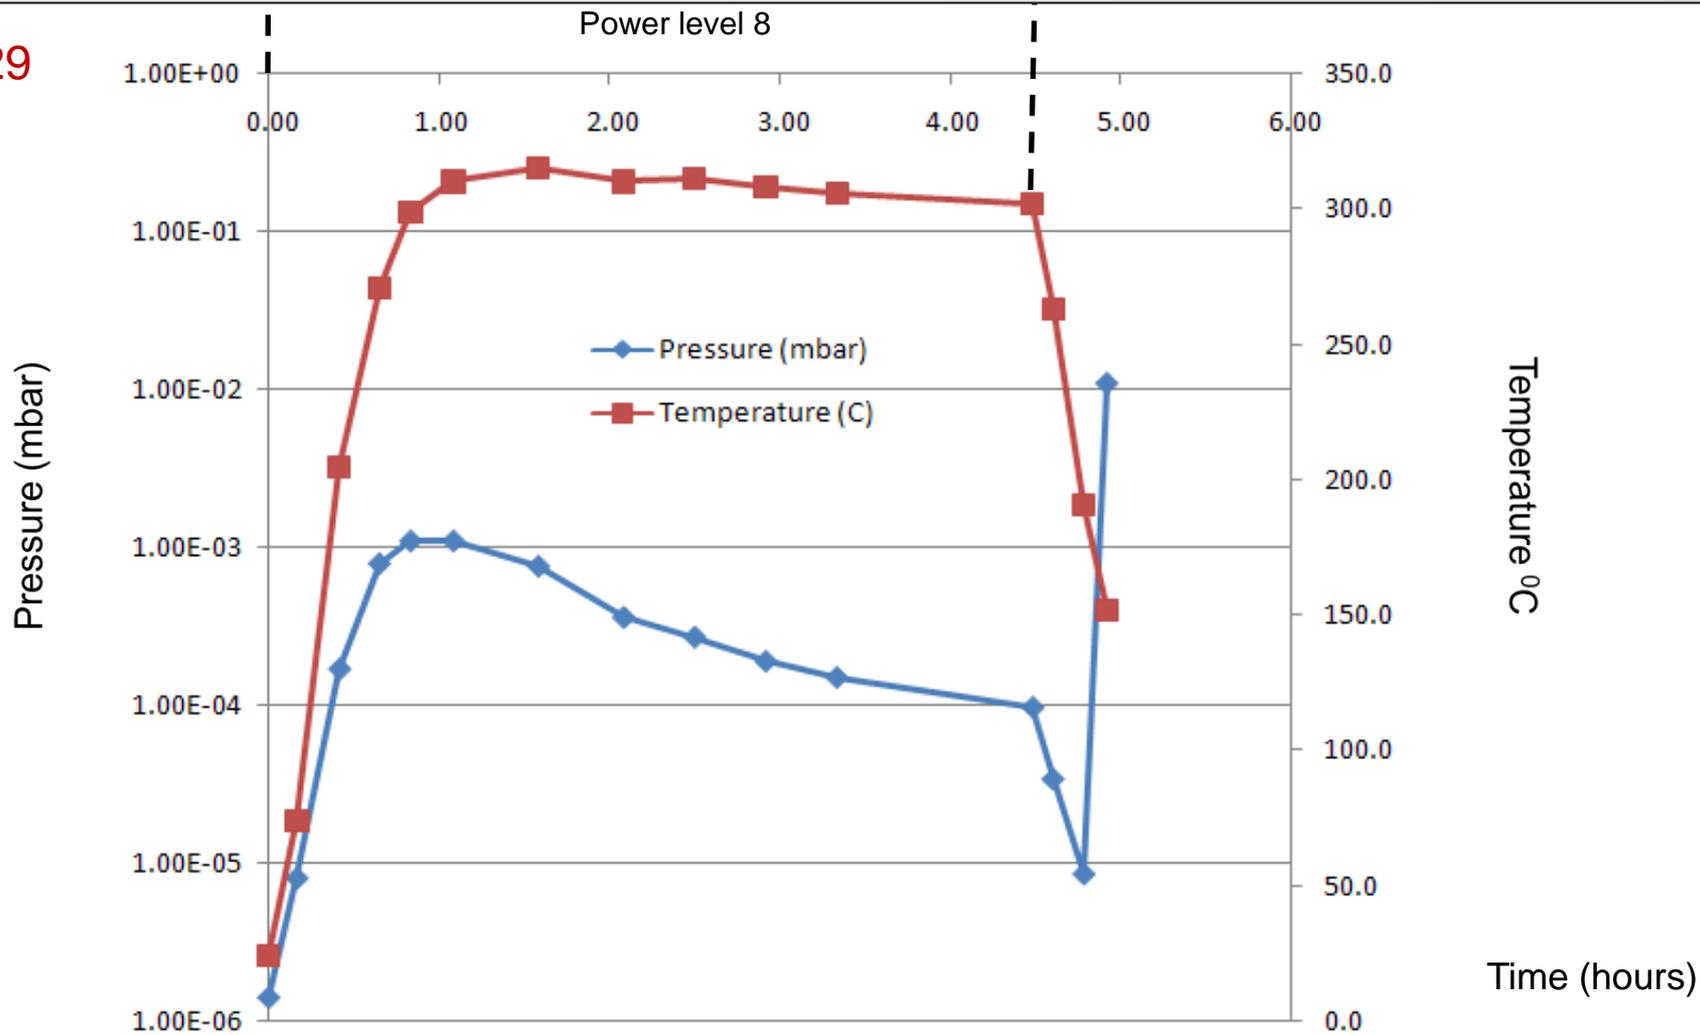
Test # 29

A repeat of test 26 but this time taking the system up to 300°C and holding.  
During the cool down the seal began to fail.

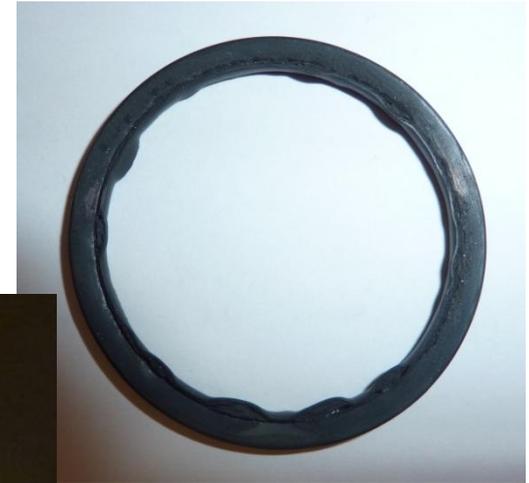
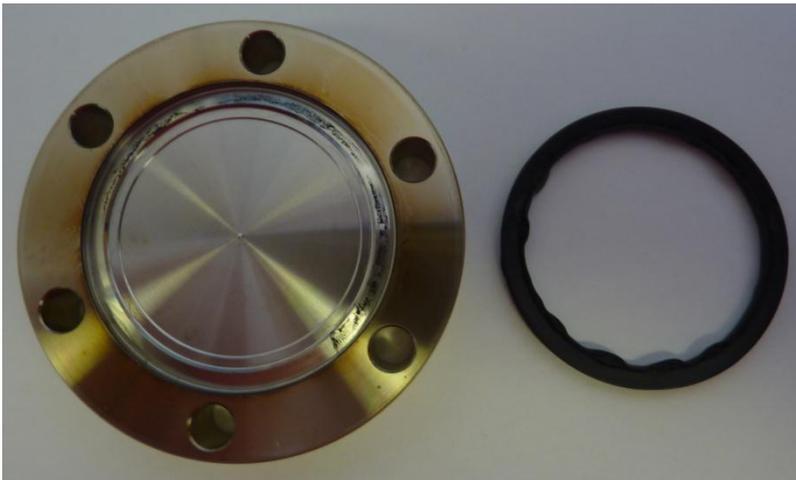
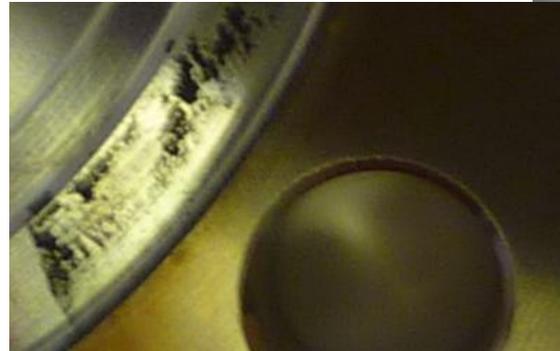
Test #29.....

Opening up the DN40CF flanges revealed that the stainless steel is discoloured and the 'O' ring has started to deteriorate. The 'O' ring was lightly stuck to the stainless steel and after peeling it off some rubber was left behind.
