## Problem Report

Report Number: 1

Project Name: TeraPixel APS for CALICE

Item: ASIC1 Sensor design: Monostable biases

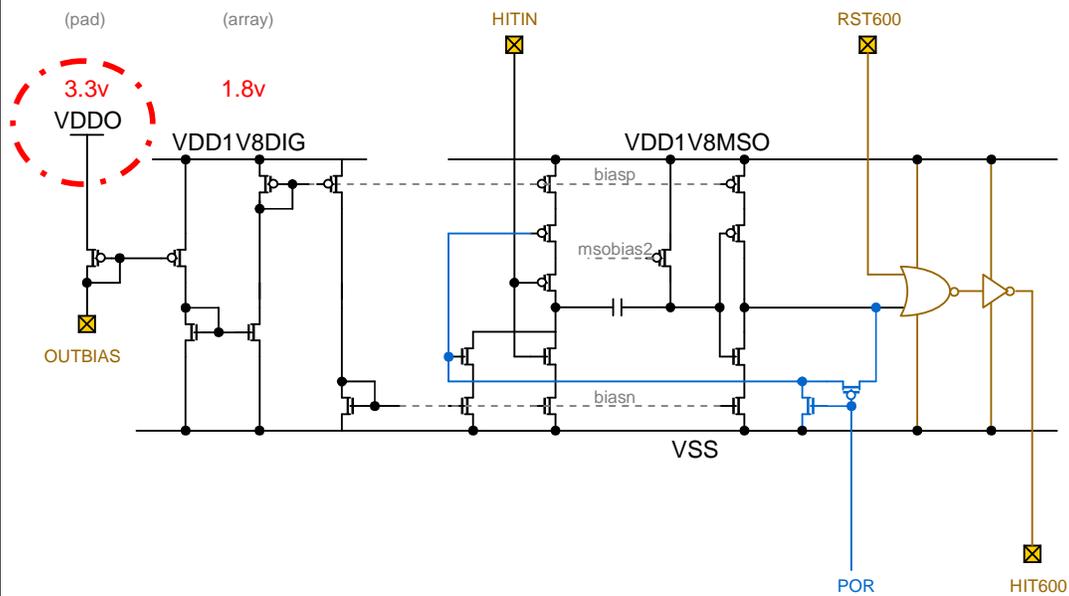
The monostable circuits were found to be non-operational on all three chips in first round of testing. The problem was finally diagnosed in the bias chain for the current-limited inverter. The general purpose bias pad cell was incorrectly connected such that "Vref" was tied to VDDO. This was proved by connecting VDDO to 2v and VDD1V8DIG to 2v. With the power rails the same the monostable circuit were seen to operate correctly, although this is not a practical long-term solution since the LVDS transceivers on the PCB run on a 3.3v supply.

A simple alternative was suggested, simulated and shown to work: Placing a low value resistor (100 ohms) from the bias pad to ground pulls enough current through the incorrectly connected PMOS transistor to develop around 3 volts drop from the power rail. This sets the gate of the linked bias transistor to approx 350mV which turns it on enough to activate the monostable circuits. There is very limited control of the current, but this is deemed sufficient to save the expense of FIB modification to a small selection of chips.

*UPDATE (29/11/07): Noise effects in the bulk pixels were diagnosed to be due to excessive current flow in adjacent monostables drooping the power local supply and triggering other local pixels. On further investigation it was discovered that there is reasonable control of monostable current with this solution – therefore the recommended fix is now a 2k2 resistor to ground, which still ensures monostables operate correctly but with limited power.*

**DESIGN FIX:** Change OUTBIAS reference transistor to connect to 1.8v instead of 3.3v
