Electrical Tapes & Optical Links

- **Electrical tapes**
 - Al/kapton tapes for SCT
 - Wiggly tapes for SCT EC
 - Lessons learned.
- **Optical Links**
 - Survey reliability in ATLAS
 - Focus on problematic systems
 - Lessons learned and being learnt.

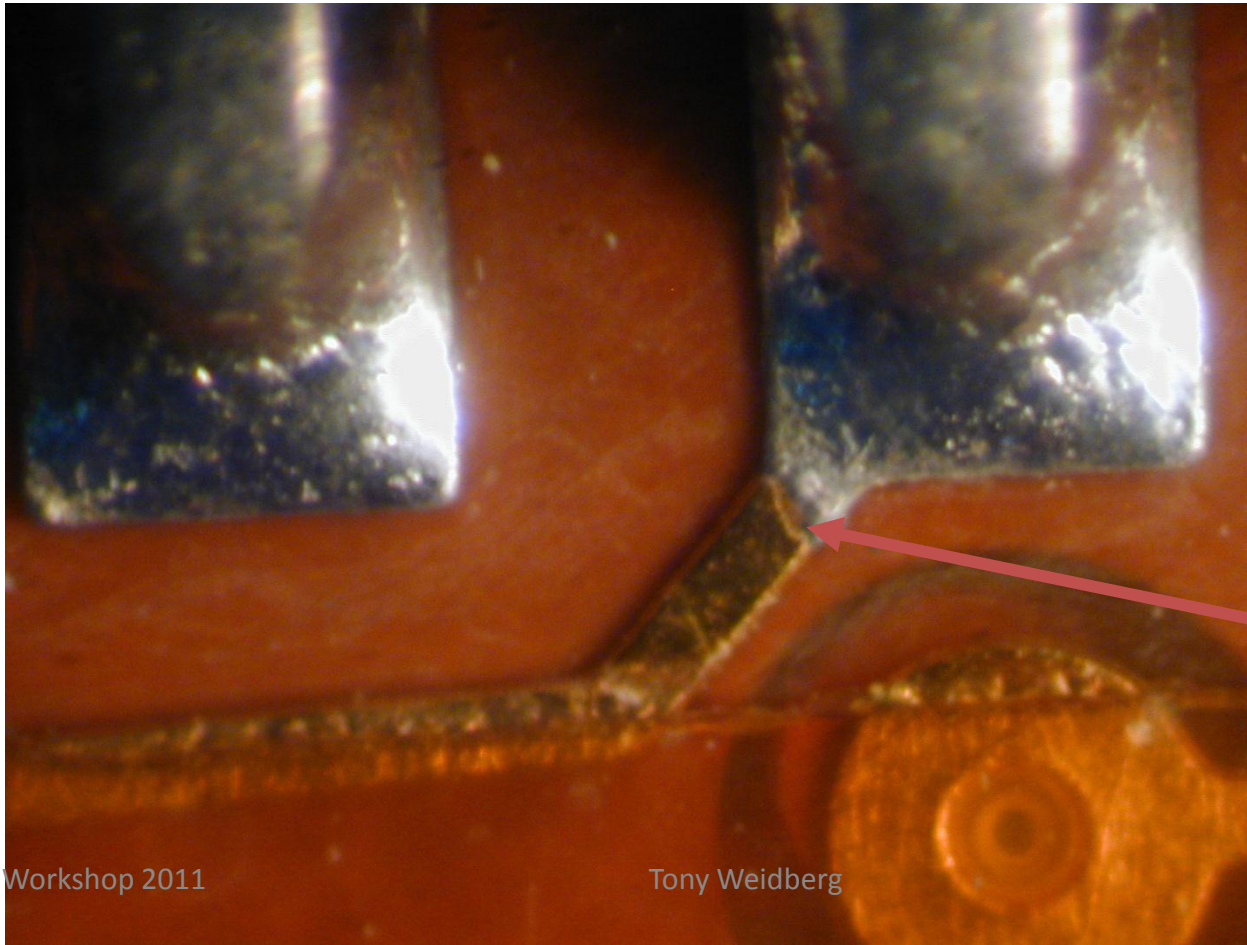
- 50 um Al/50 um kapton
- 500 um wide tracks for HV & control signals (wider tracks for LV).
- Al/kapton tape was quite robust but ...
- After Ni/Sn plating for soldering to PCBs tapes were extremely fragile → photo next slide.
- We believe this is due to hydrogen embrittlement.
- Managed to do repairs(bodge) for barrel LMTs
- Changed to Cu/kapton for EC because number of breaks unmanageable.

500 μm

Cracks appear to form on grain boundaries

Cracks Barrel kapton flexes

Crack!

- Layout of opto-flexes not optimised because there were too many flavours to design!
- Added ceramic stiffeners behind connectors.

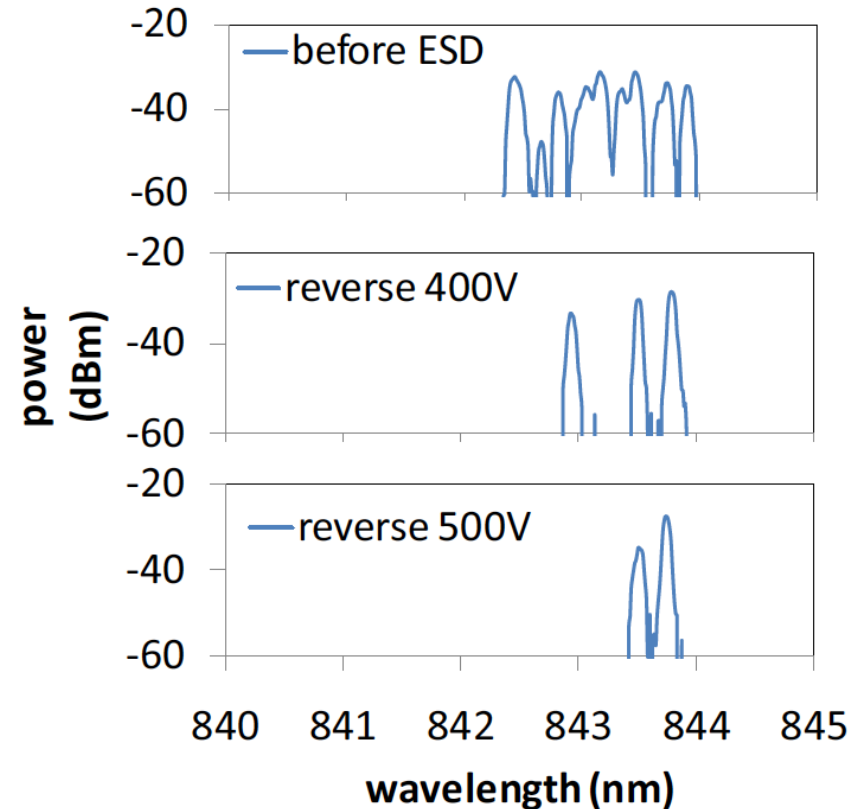
- **ESD**
 - VCSELs known to have very low ESD thresholds
 - ESD most common cause of field failures for VCSELs
 - Controlled low level ESD pulses can cause a decrease in spectral widths

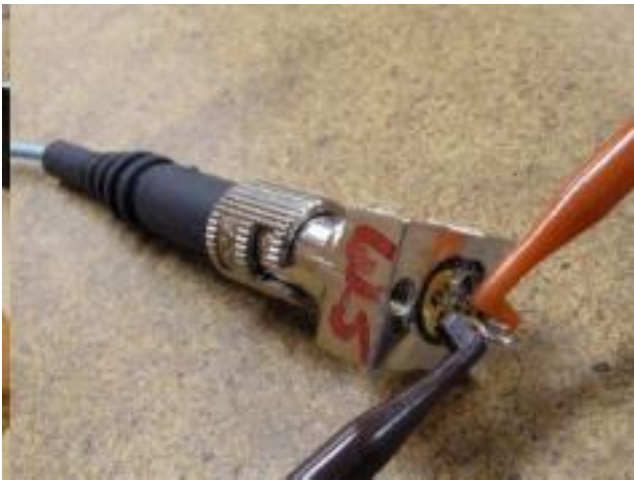
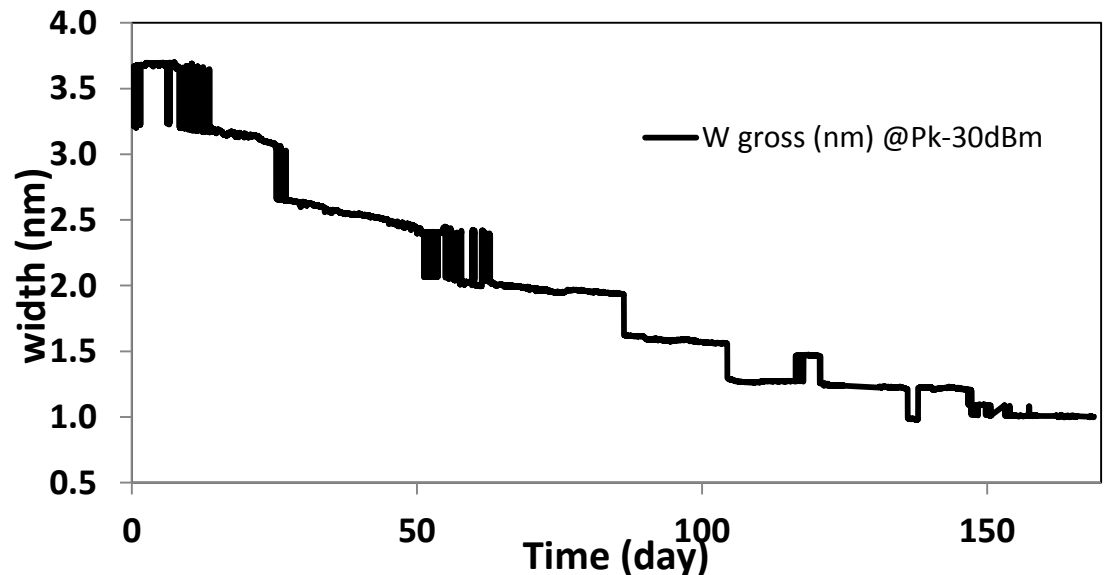
- Humidity (TO can should be hermetic but suspect some damage during assembly)
- Deliberately opened TO can
 - Operation of VCSEL in lab environment with RH ~ 55% shows decrease in spectral width

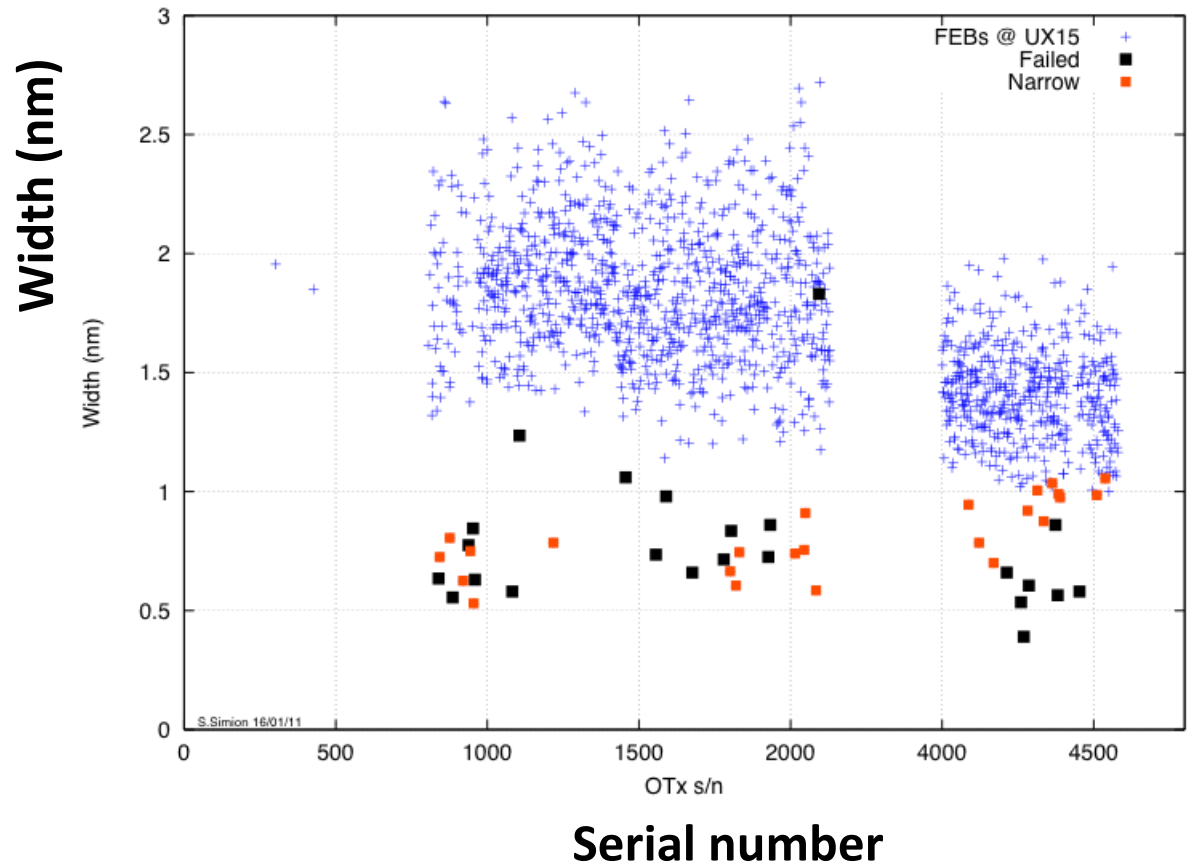
ATLAS LAr

- OSA revealed two populations

Failed devices nearly all show narrow spectral widths

Remaining devices with narrow widths removed during 2011 shutdown

No failures seen since

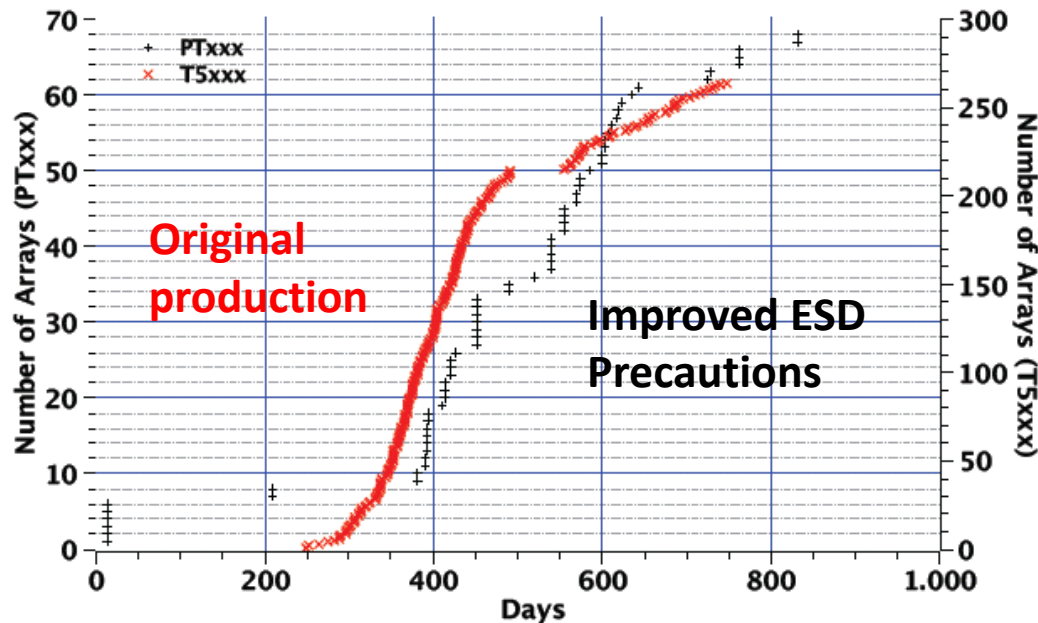
Pixel & SCT TXs

- End of life failures experienced after ~ 6 months
- ESD suspected during assembly → all devices replaced with greatly improved ESD precautions
- Lifetimes improved but still \ll 10 years required for ATLAS operation

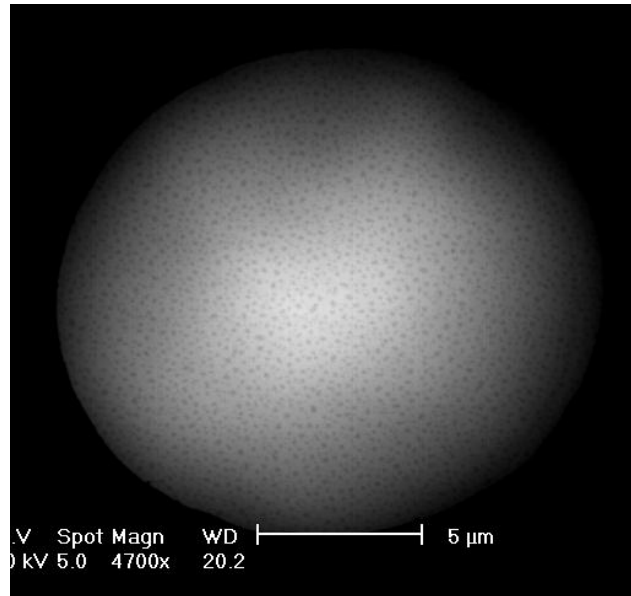
Working

EBIC comparison working & Failed channels TL VCSEL array

- All taken with same SEM settings: 10KV spot 5 (roughly same mag 4700X and 5000x)
- Original Image LUTs stretched to accentuate EBIC changes across VCSELS
- Only Ch 10 shows distinct EBIC minima (dark spots) within the emission region
- Ch 06 & 08 show some inhomogeneity but no distinct minima
- Small dark speckles are surface topography

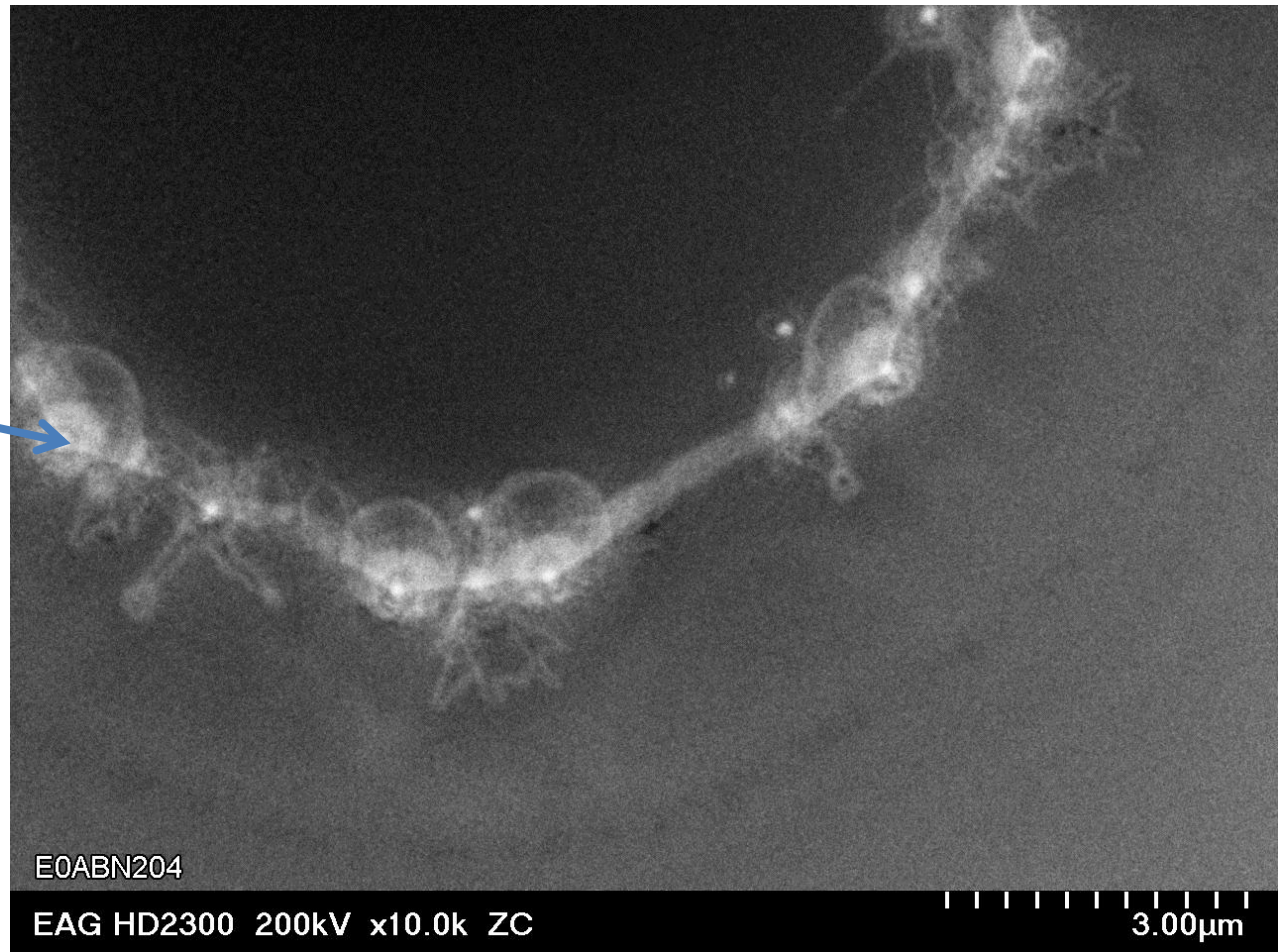
Used Working Channel Plan View SEM

Dislocations
starting to
form on edge
of aperture

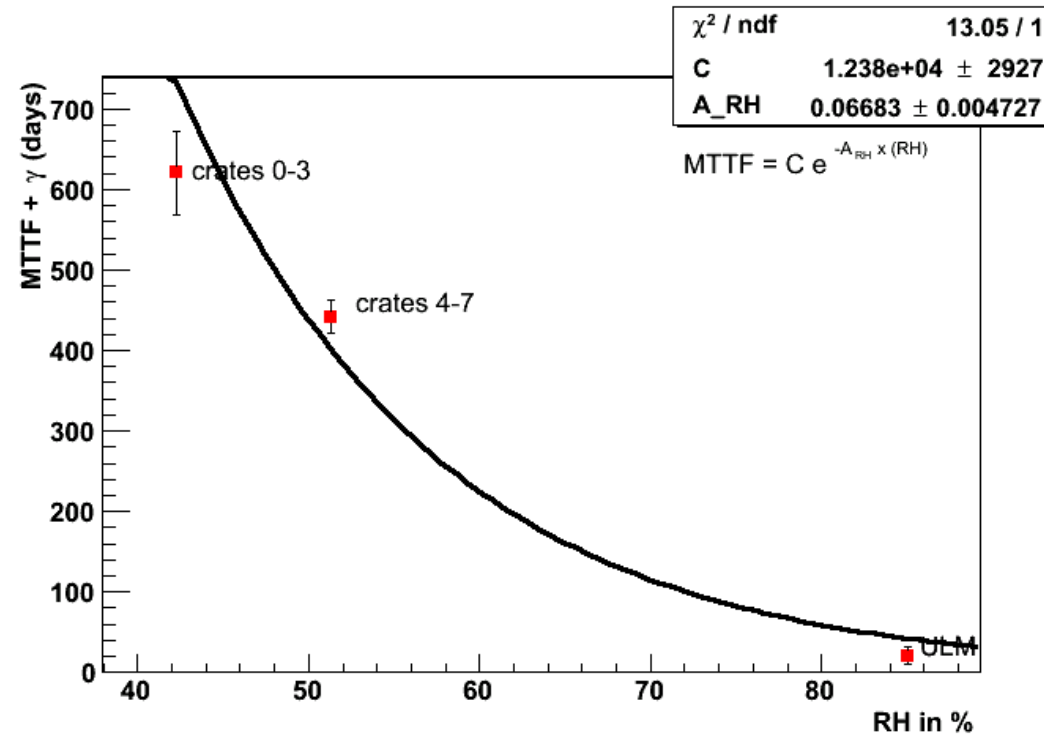
RH and Lifetime Correlation

- Use (accidental) fact that RH was different for some SCT crates
- Weibull fits to failures
Mean Time To Failure
- Correlation with RH similar to that reported in literature

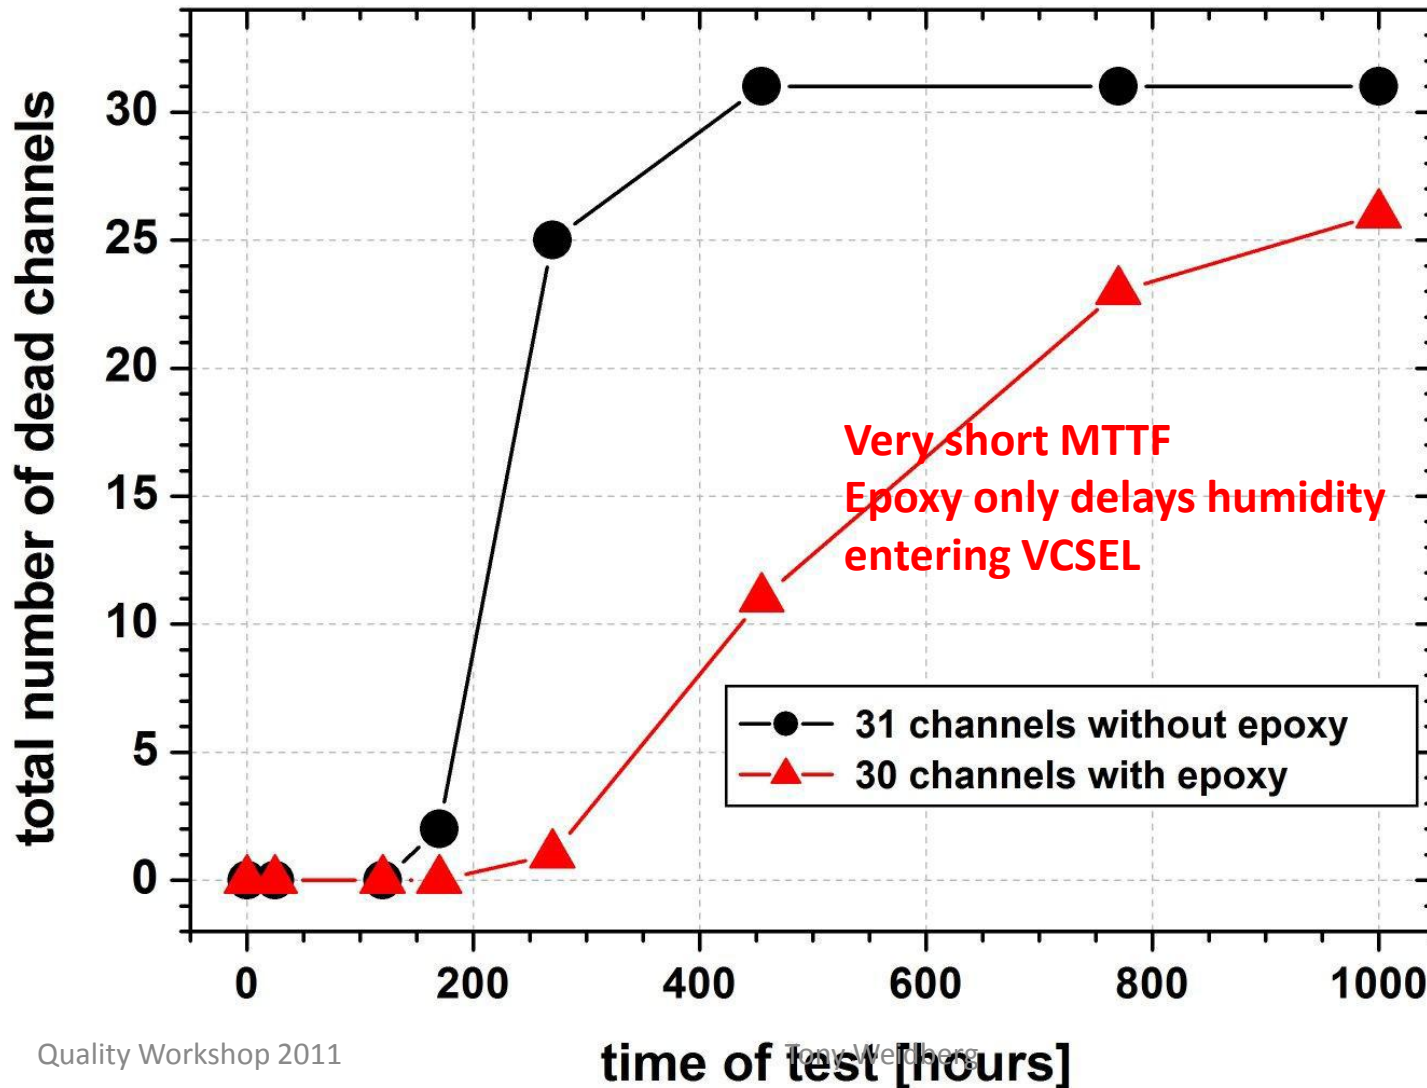
THB test of True Light VCSEL at 85°C / 85% R.H.

- Single channel VCSELs usually packaged in hermetic TO cans
- Very difficult to package arrays in hermetic packages
- Reliability of first arrays in damp environments was poor (lifetimes ~ 100 hours at 85C/85% RH)
- Electrolytic corrosion hypothesis:
 - Moisture depletes As in oxide layer → excess Ga → point defects which grow toward active area

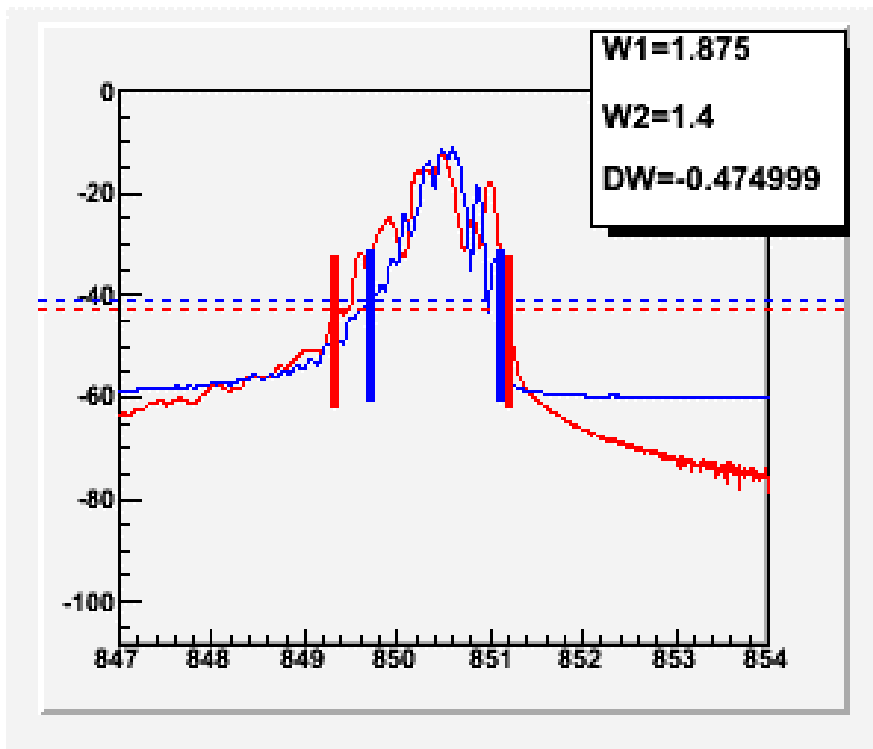
- Air ~ 50% RH
 - Loss of higher order modes visible

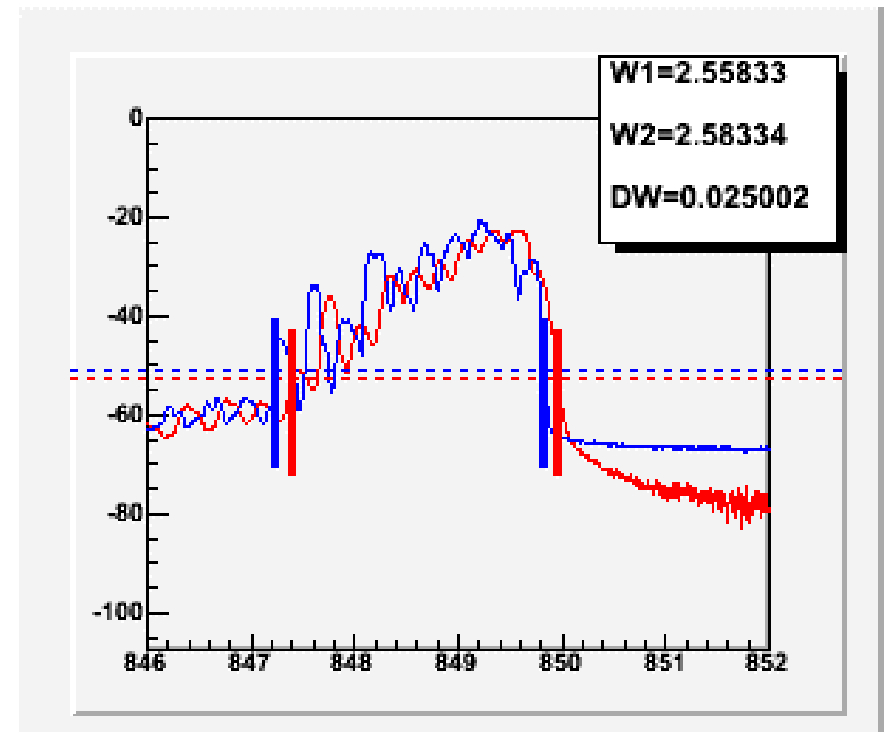
- Dry N₂
 - Higher order modes very similar
