# APV25 Production Testing Status

Mark Raymond, Imperial College

April, 2003

CMS tracker electronics

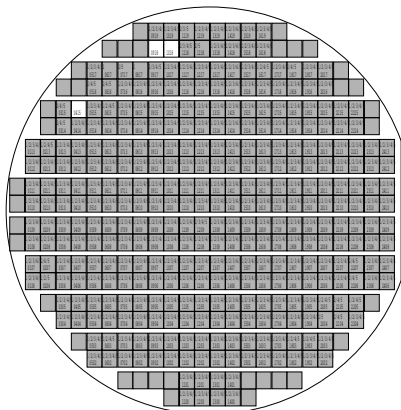
Wafer Map: WG8P4CT

lot 4 – ave. yld. 33%

Date probed: Wed 26 Feb 2003  
 Chips passed: 3/360  
 Yield: 1%  
 Digital failures: 351  
 Power supply failures: 1  
 Channel defects (Peds & Cal): 4  
 Pipeline defects: 1

Lot 4 wafer extreme example but hopefully indicative of failure mode of other wafers in same lot  
 other wafers from this lot already with hybrid company

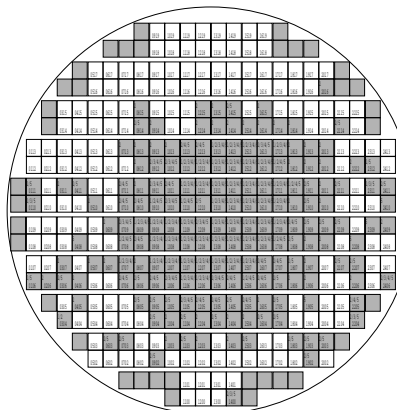
Wafer Map: W28P77T

lot 5 – ave. yld. 44%

Date probed: Thu 27 Feb 2003  
 Chips passed: 170/360  
 Yield: 47%  
 Digital failures: 111  
 Power supply failures: 1  
 Channel defects (Peds & Cal): 77  
 Pipeline defects: 1

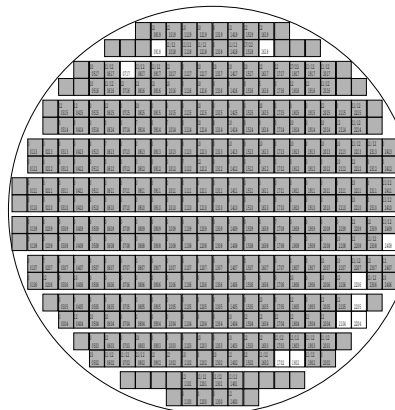
Wafer Map: A7BCG1T

lot 6 – ave. yld. ~ 0%

Date probed: Wed 29 Jan 2003  
 Chips passed: 10/360  
 Yield: 3%  
 Digital failures: 220  
 Power supply failures: 7  
 Channel defects (Peds & Cal): 123  
 Pipeline defects: 0

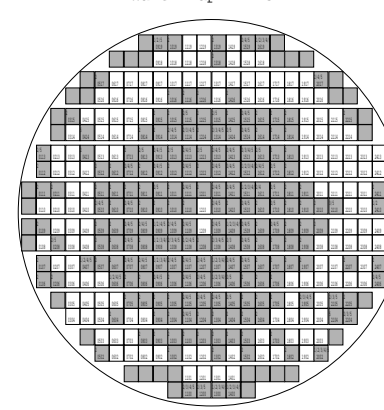
Wafer Map: KKM3K2T

lot 7 – ave. yld. 52%

Date probed: Tue 18 Feb 2003  
 Chips passed: 150/360  
 Yield: 42%  
 Digital failures: 77  
 Power supply failures: 2  
 Channel defects (Peds & Cal): 127  
 Pipeline defects: 4

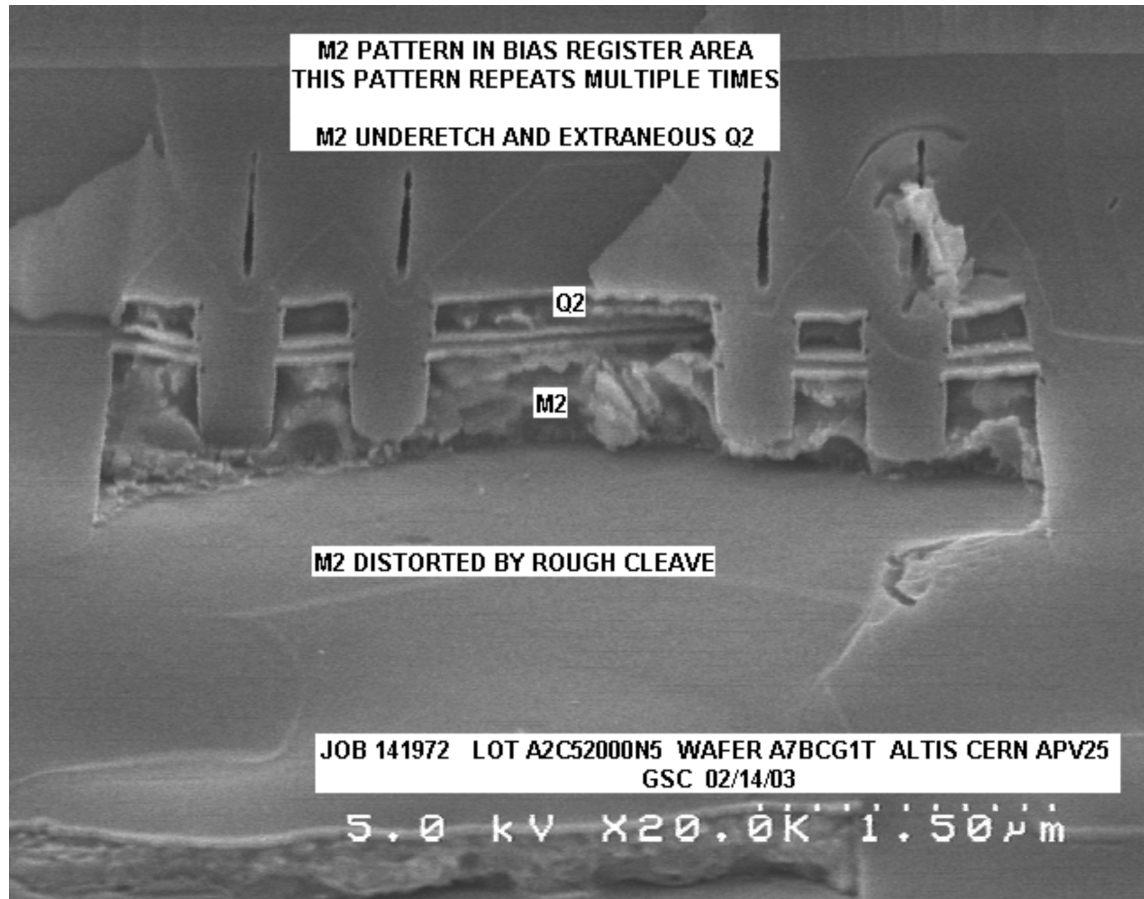
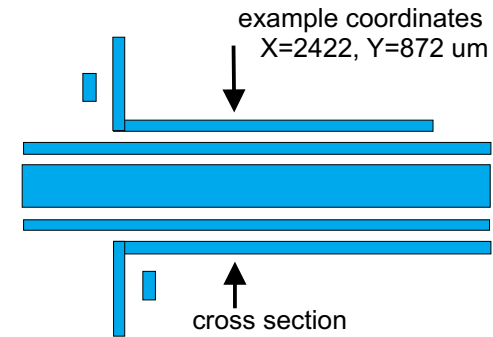
# Fault Diagnosis – Lot 6

severity of problem with this lot  
allowed fairly rapid diagnosis

X-section through metal tracking  
shows shorts between tracks, and  
Q2 (capacitor top-plate metal) where  
it shouldn't be

Q2 should have been stripped off (in  
areas where it is not supposed to be)  
prior to patterning of underlying M2

- problem thought to be incomplete removal of photo-resist layer used to pattern Q2
- => Q2 layer not removed properly (in areas where it should be)
- => subsequent M2 etch had to go through Q2 first and so didn't get all the way through

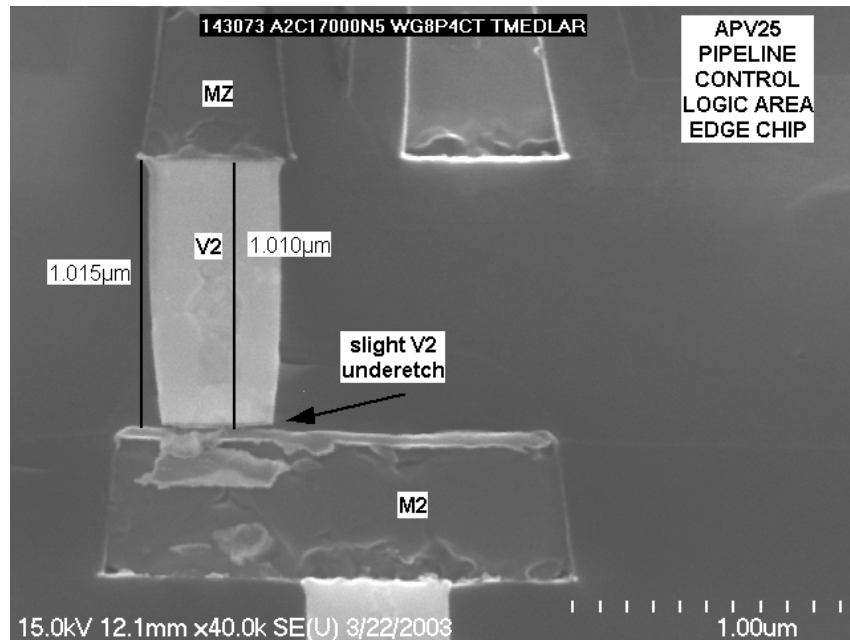
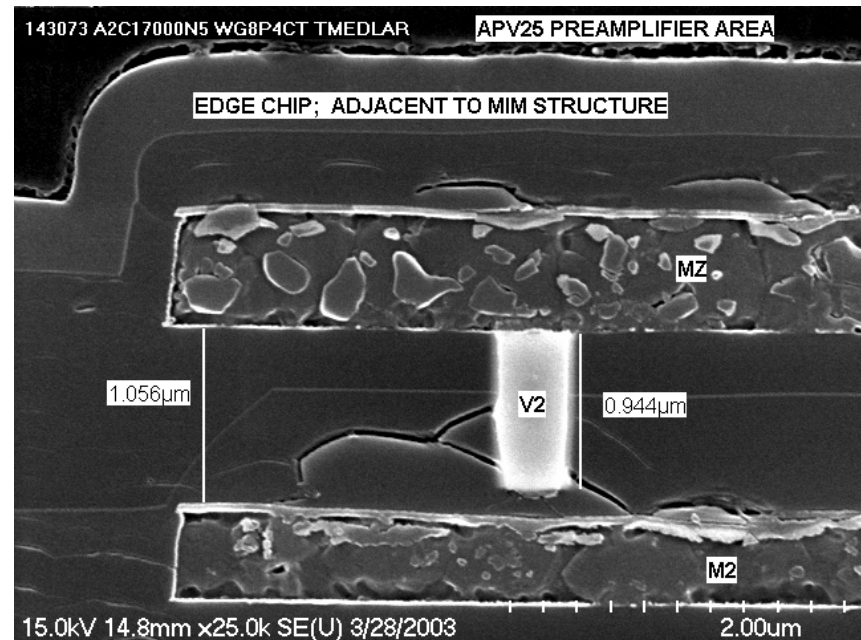
# Fault Diagnosis – lot 4

this wafer showed high power consumption failures – liquid crystal technique showed hotspots in pipeline control logic area

non-contacting vias => transistors which should be **off** can float to **on** condition => high power consumption

reasons for via underetch not clear, but separation between metal layers close to maximum allowed

=> points to possible problem with Inter-Level Dielectric (ILD) layer thickness control (etch time is fixed)

this problem now confirmed on chips in centre and at edge of wafer

2 free production lots offered and now in fabrication (delivery in ~ few weeks time)  
foundry proposes to vary ILD thickness (5 steps between process extremes) on one lot with additional measurements after each ILD stage

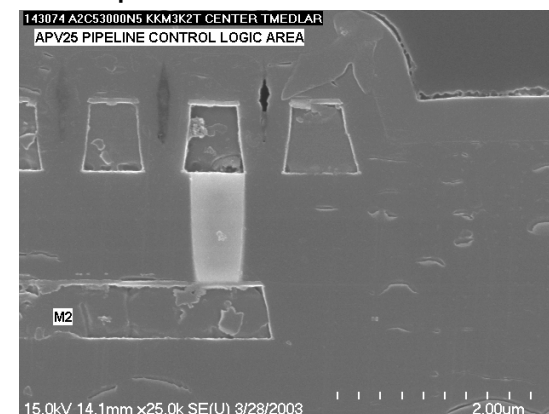
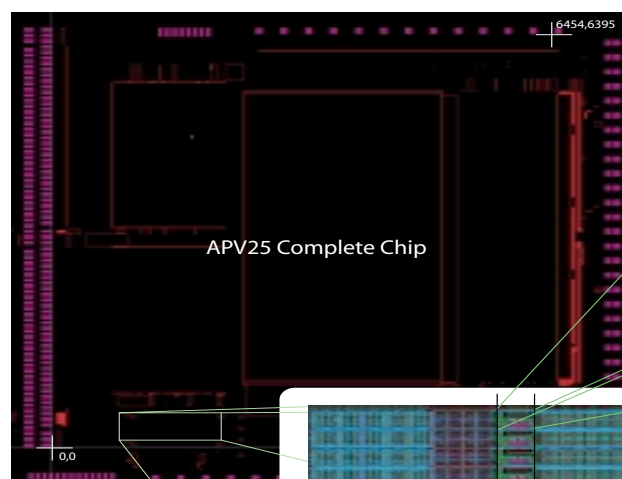
lot 7 wafer FA just started - this lot showed average 52% yield, so not such severe problem

no definite problem found so far (but ILD thickness also large)

physical coordinates of stuck bit locations in bias registers provided for both these lots – may be helpful
