# mini-module characterization

2 mini-pT modules exist

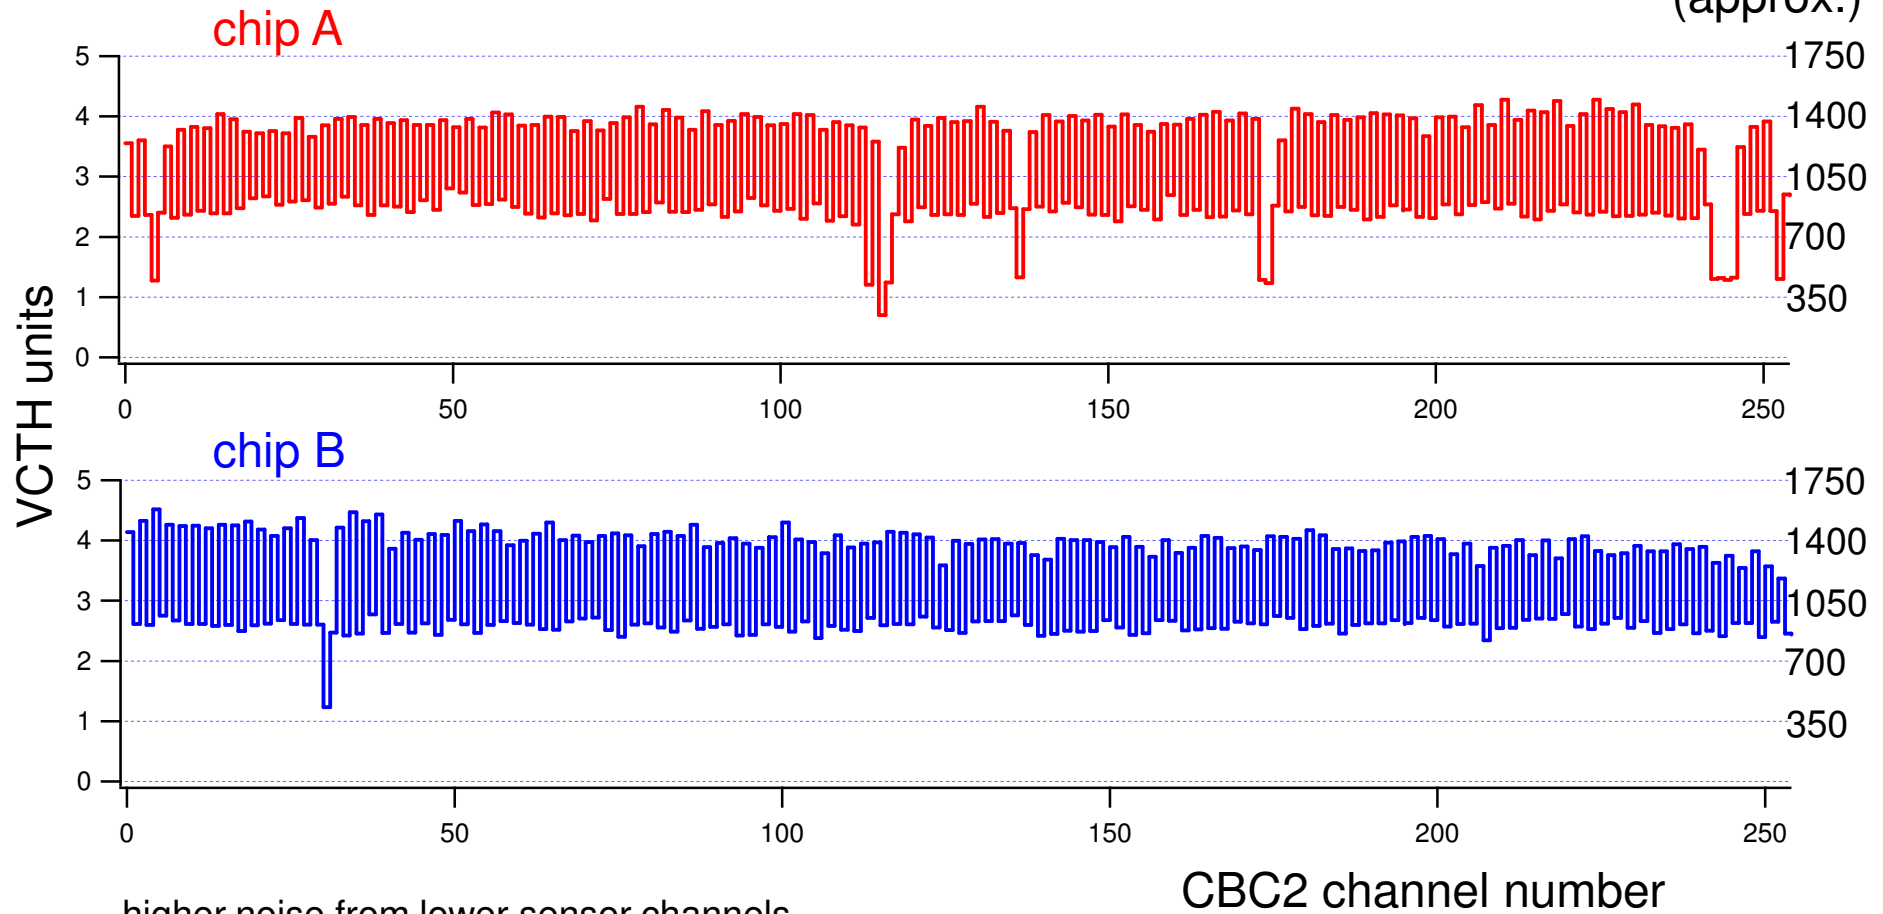
# noise measurements: module #2, 300V bias

higher noise from lower sensor channels  
not clear why

no explanation for anomalously low noise channels either  
would seem to indicate no sensor-to-hybrid contact

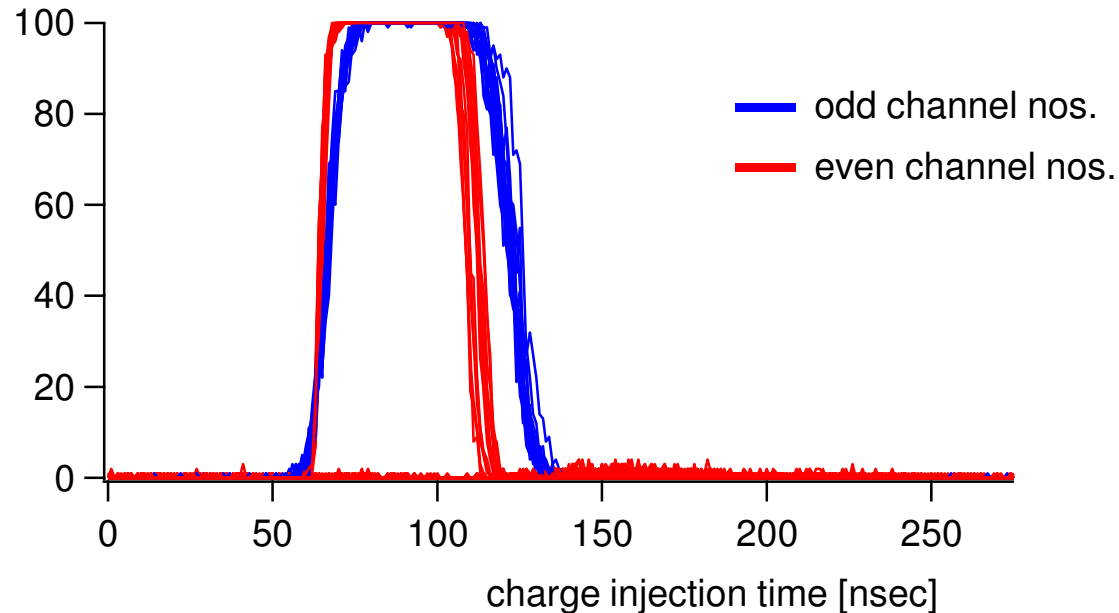
slower edge times for odd channels (lower sensor) => slower pulse shape => higher capacitance

consistent with higher noise

seems to indicate lower sensor not properly depleted? ← NO - see later

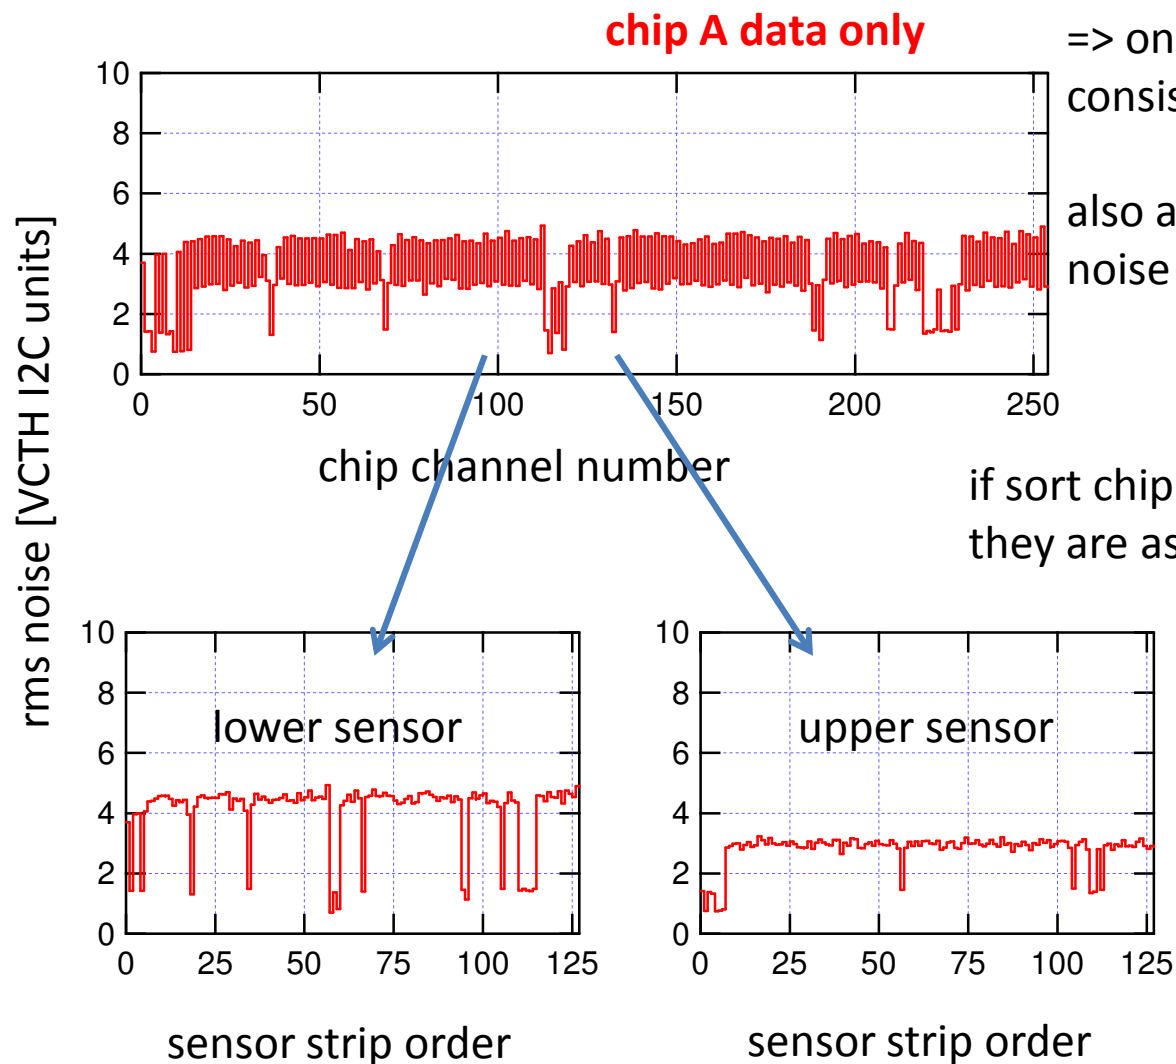
alternating high/low noise values  
=> one sensor (lower one) giving  
consistently higher noise than other

also a significant number of low  
noise channels

if sort chip channels by sensor with which  
they are associated, then systematic  
difference between each  
sensor becomes clearer

for this module (#1), at **50V**  
bias, the lower sensor  
channels show higher noise

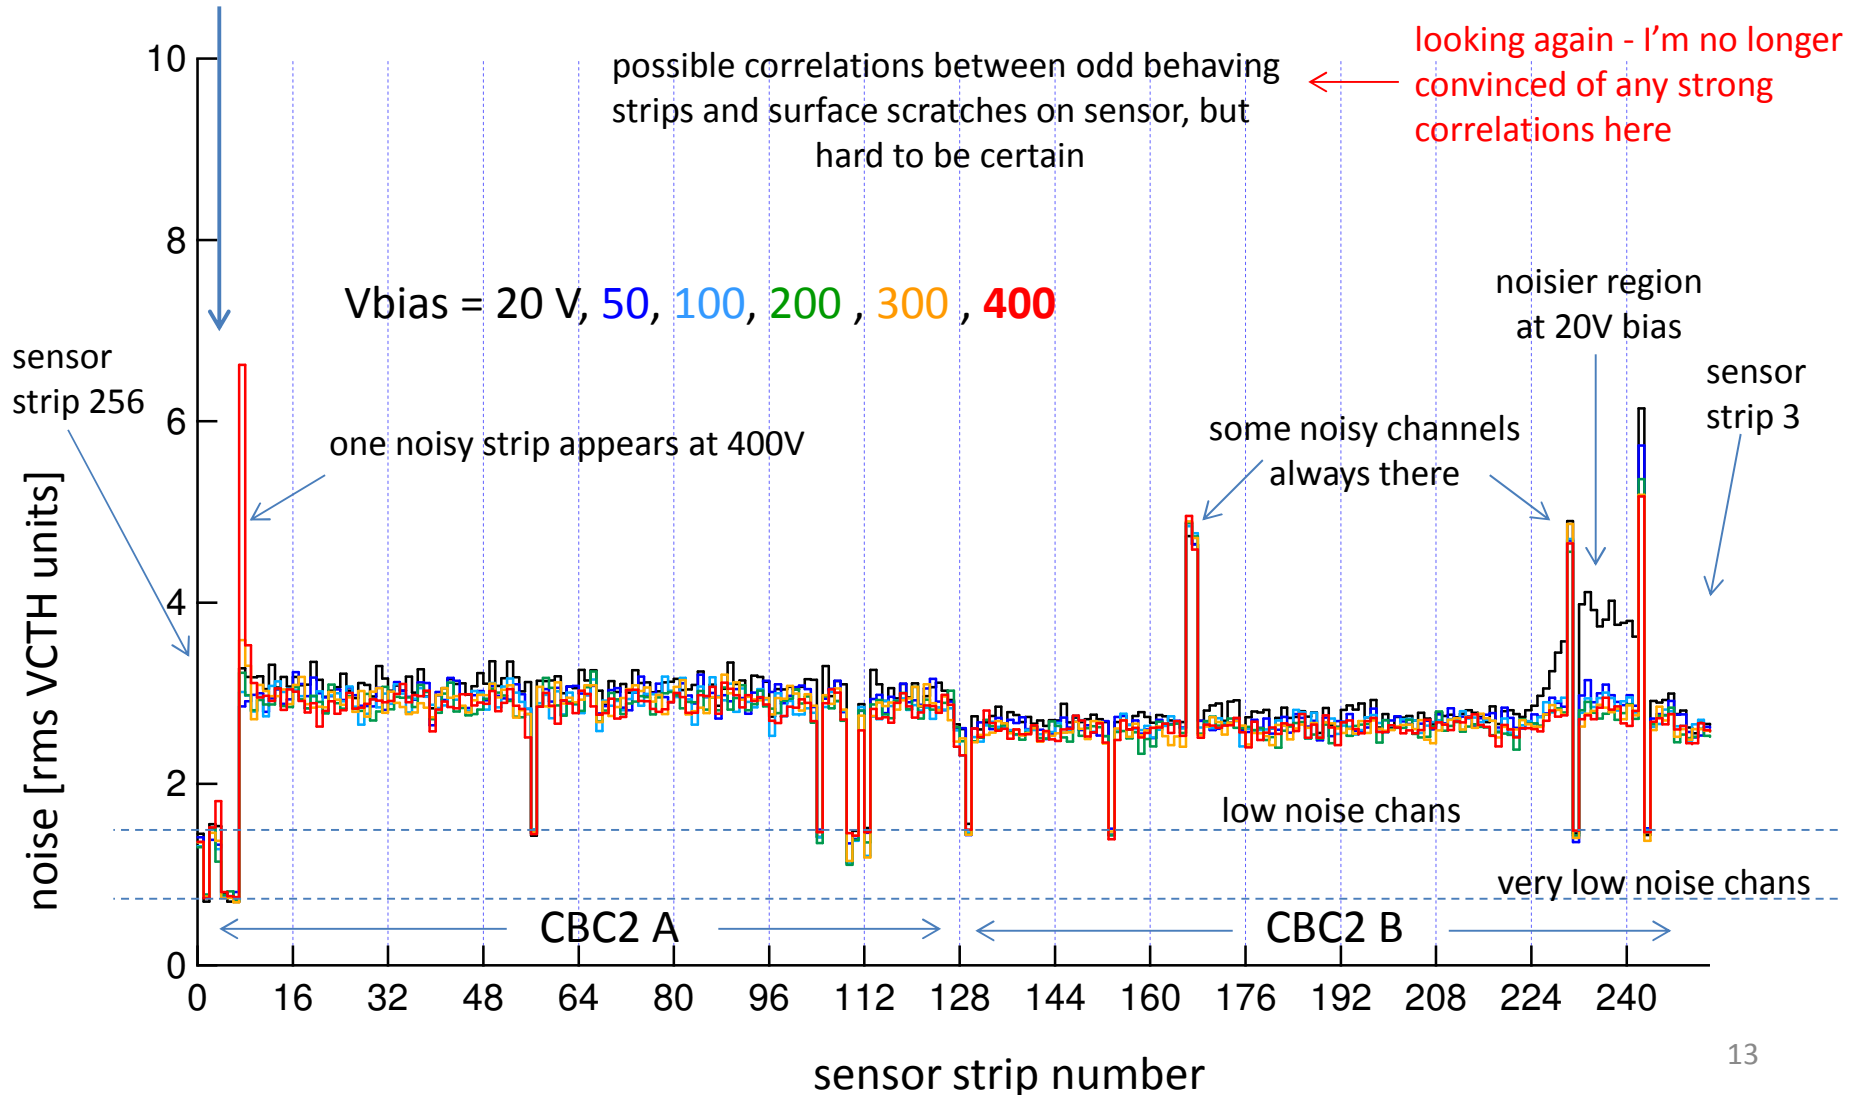
mini-module#1: **upper** sensor

some scratches in  
this area, also  
looks like 1 broken  
bond wire

noise performance vs bias => **capacitance**  
seen by chip already close to **lowest** value  
at 20V bias

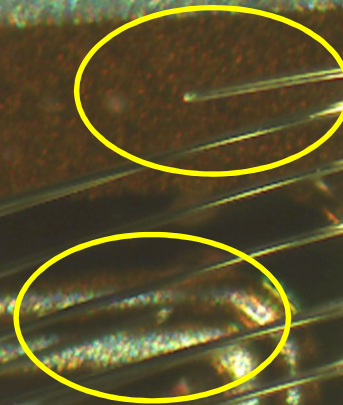
broken wire

on 2<sup>nd</sup> channel  
- could be touching bias line

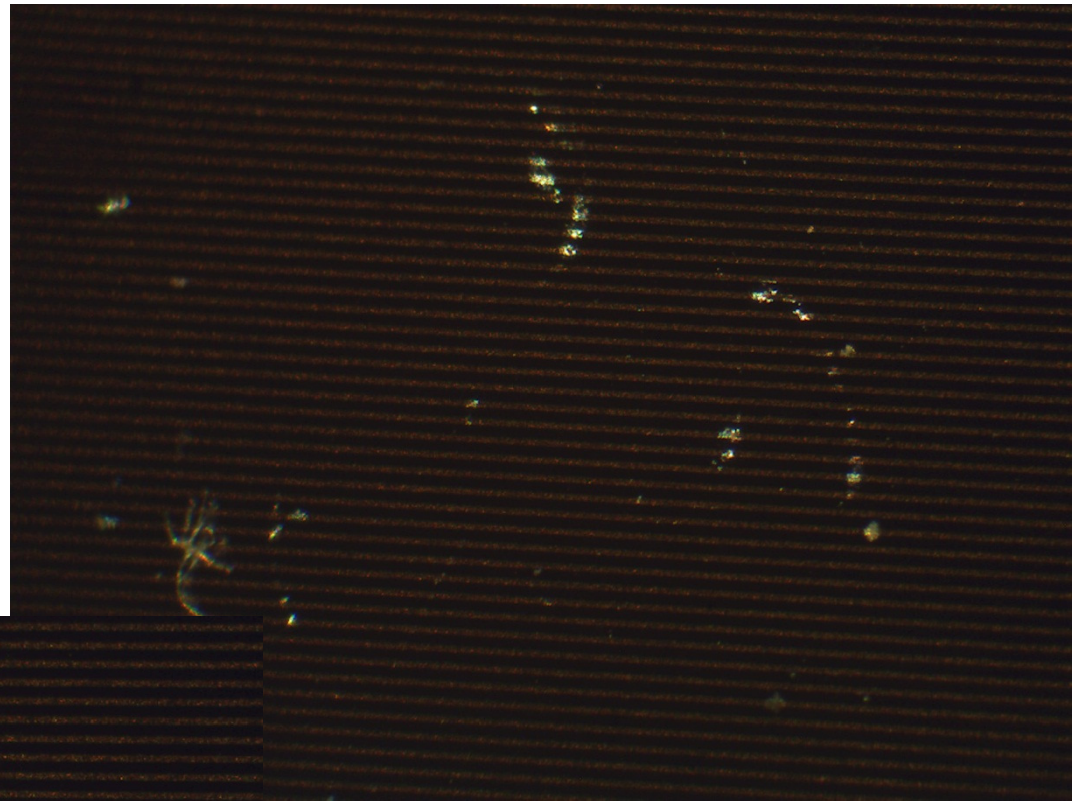
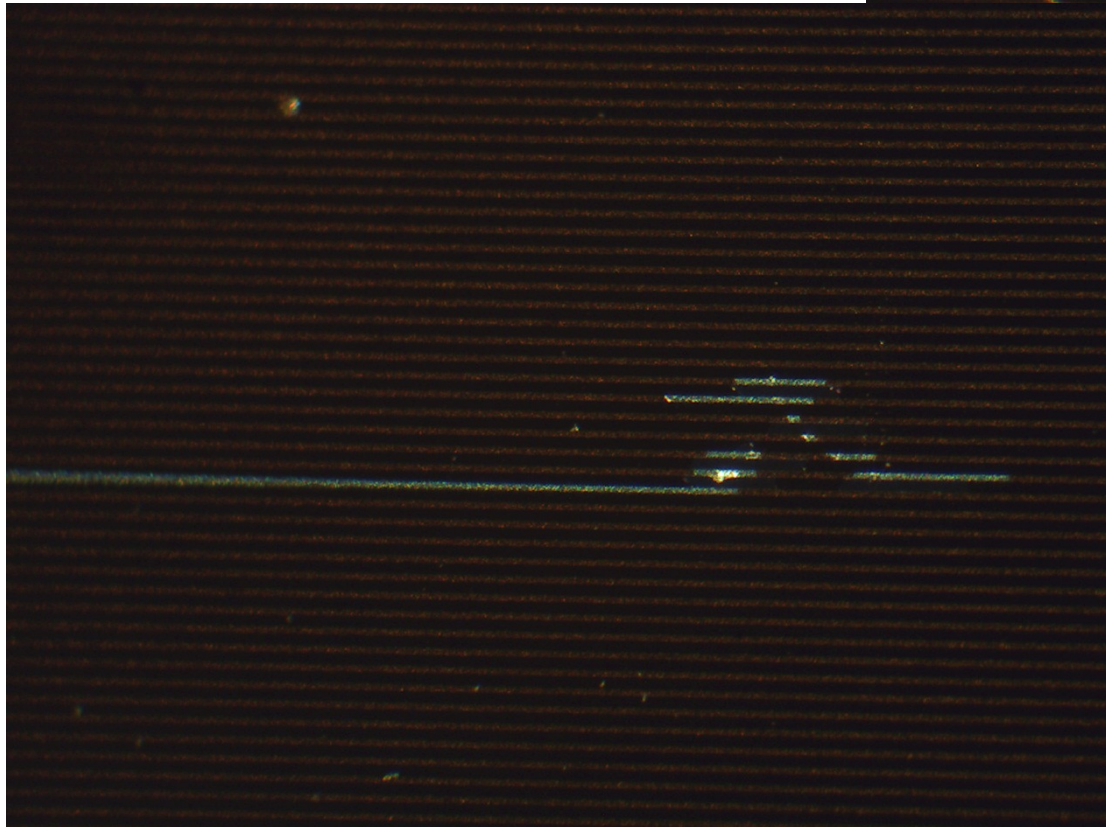
# surface scratches

but **not** so obvious correlation with  
problem channels  
(previously thought there was)

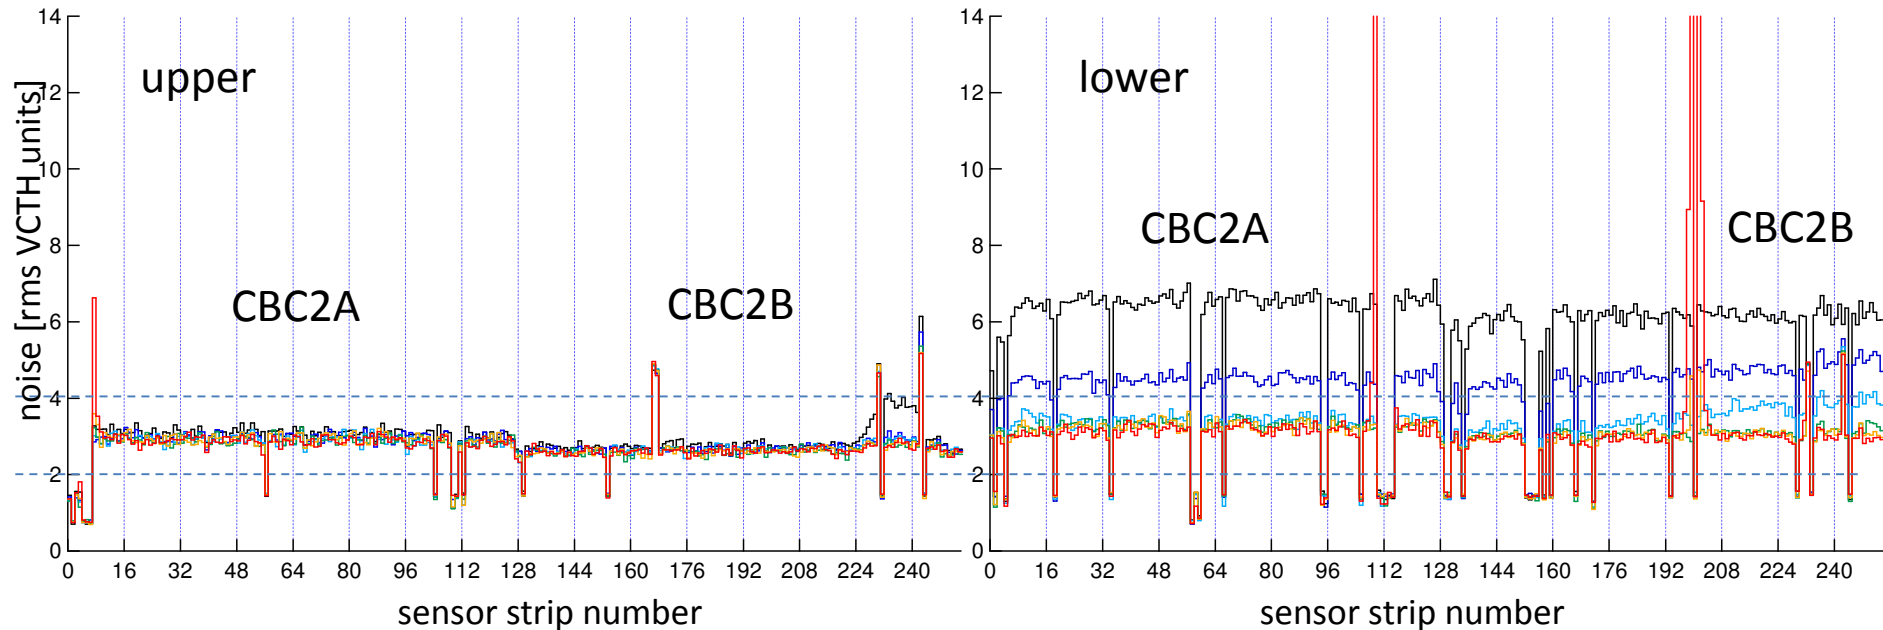
# comparison of two sensors on mini-module#1

lower sensor noise needs higher bias (>100V) before reaching minimum value

but final levels ~same - lower and upper (slightly higher on lower)

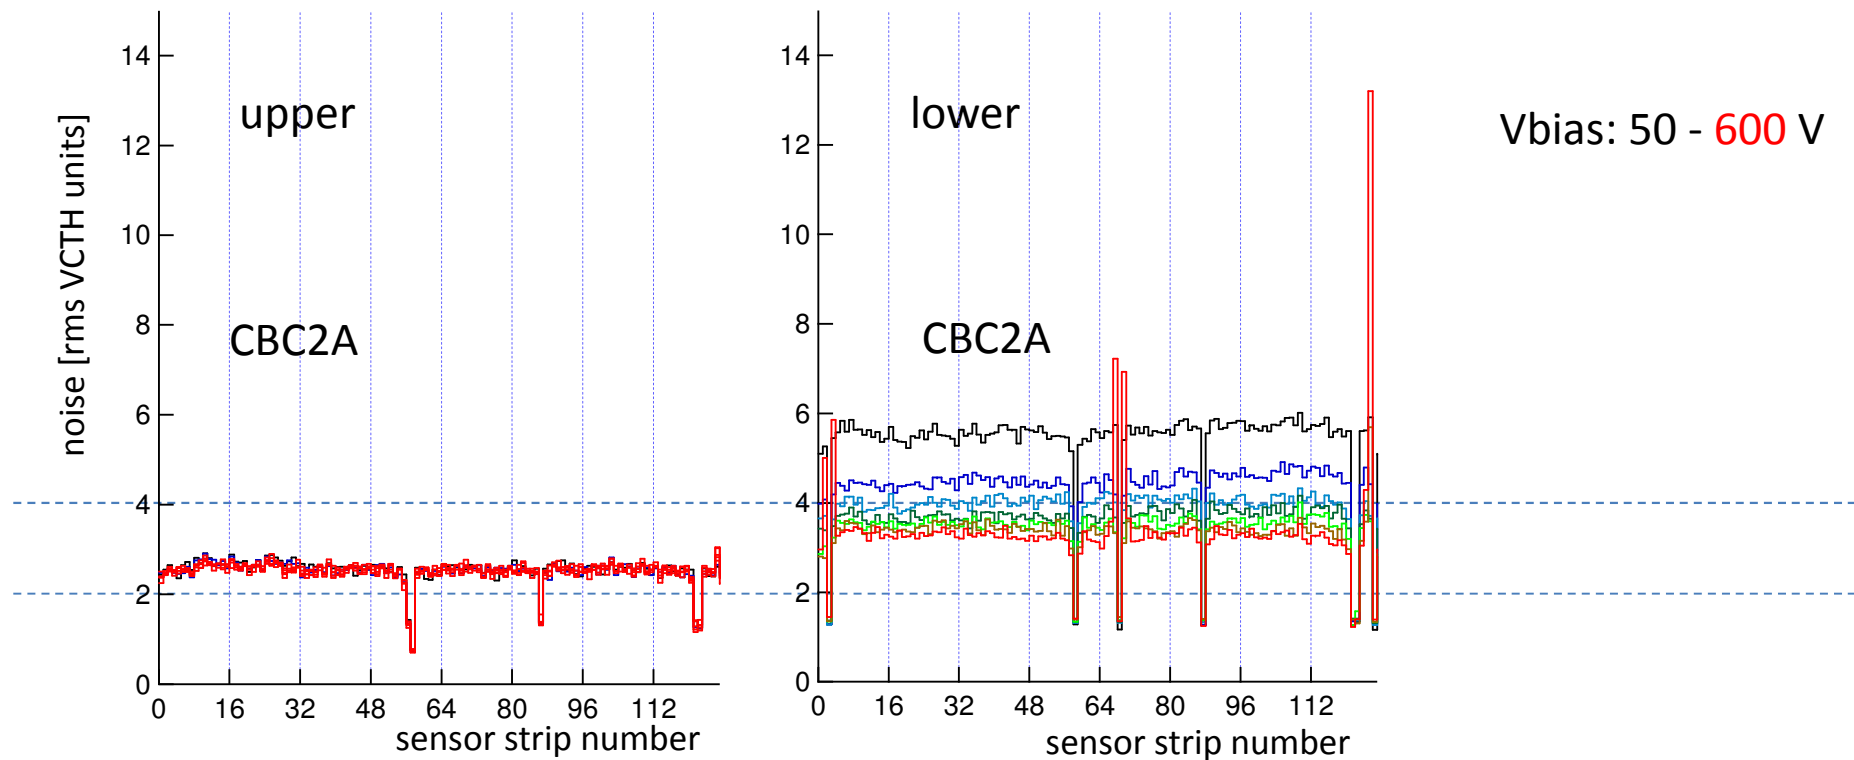
## comparison of two sensors on mini-module#2

similar behaviour, but lower sensor doesn't get to as low levels as upper before noisy strips start to develop

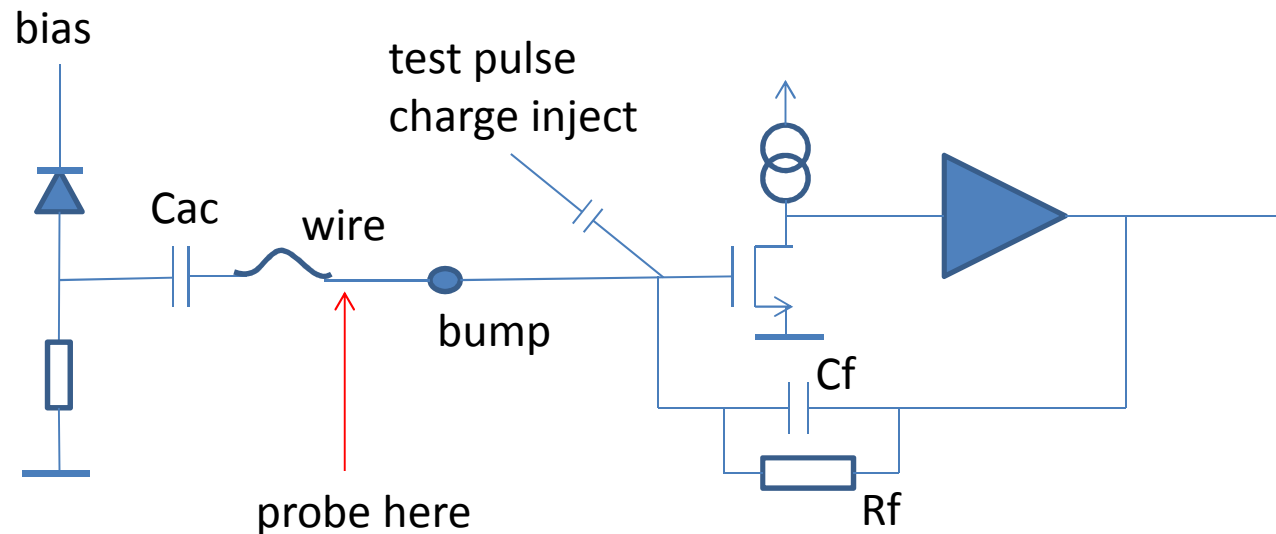
# investigating low-noise module channels

behaviour observed consistent with failure of connection between strip and amplifier  
poor wire contact? something wrong with sensor?  
failed bump-bond seems the most likely?

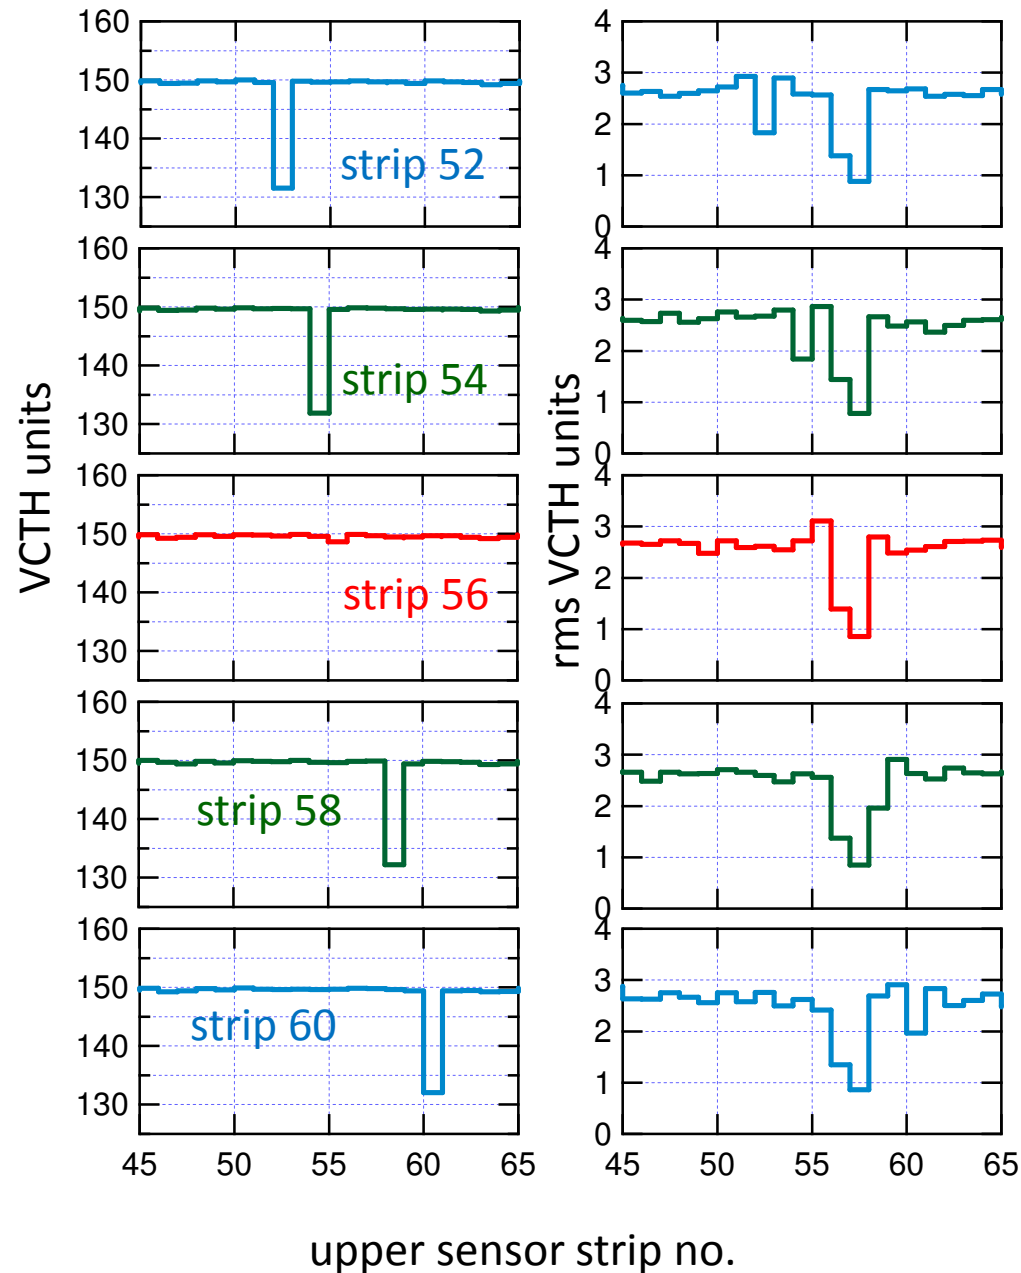
## grounding every other strip - one at a time

strip 56 still responds to the test pulse

implication is that strip 56  
(one of the two “bad” channels)  
is disconnected from the wire-  
bond pad

presumably the bump-bond has failed?

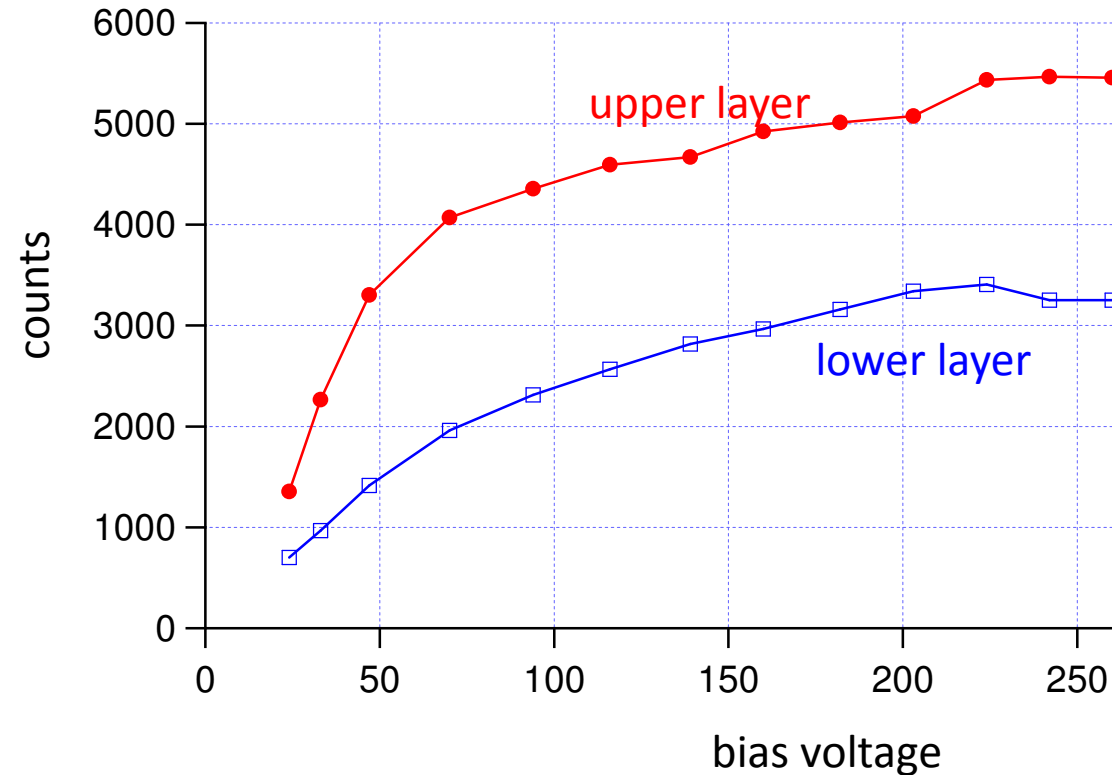
## signal vs. bias - mini-module#1

counts saturate as bias voltage approaches 250 Volts

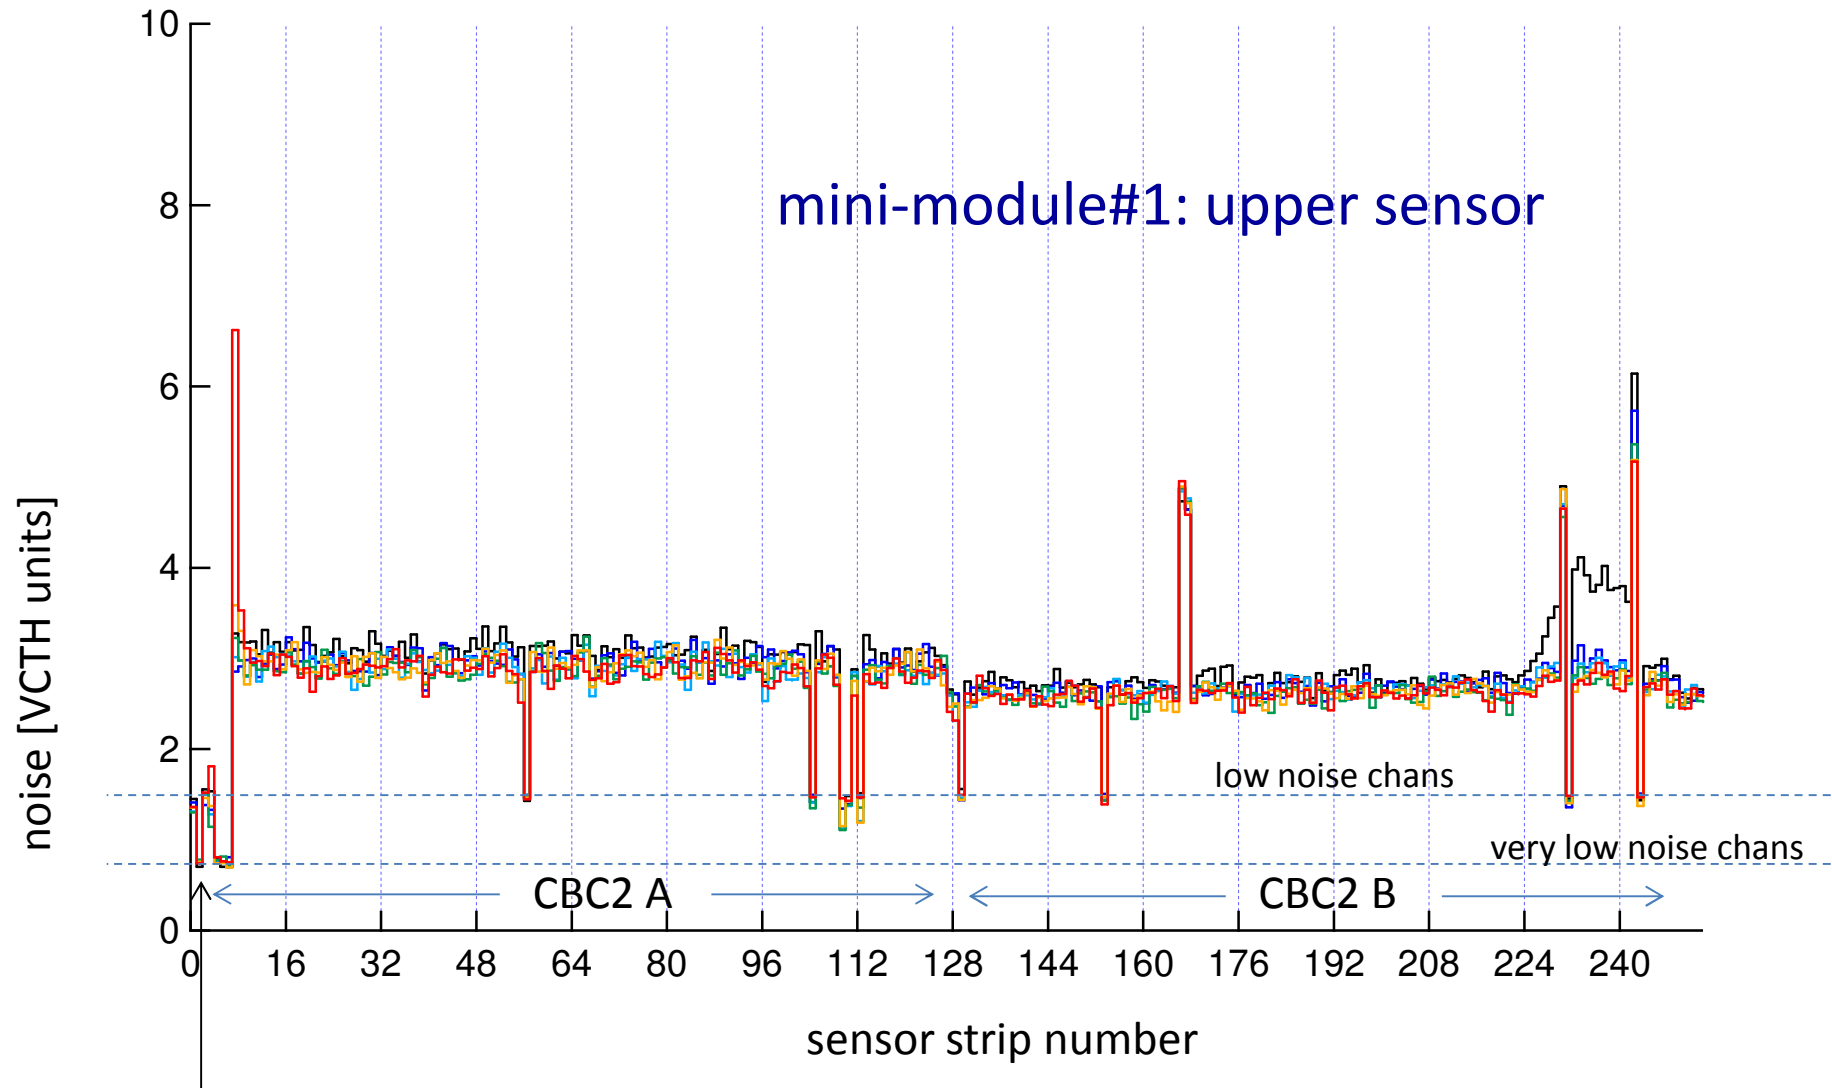
## what about very low noise channels?

this one corresponds to the broken wire - what about the others?

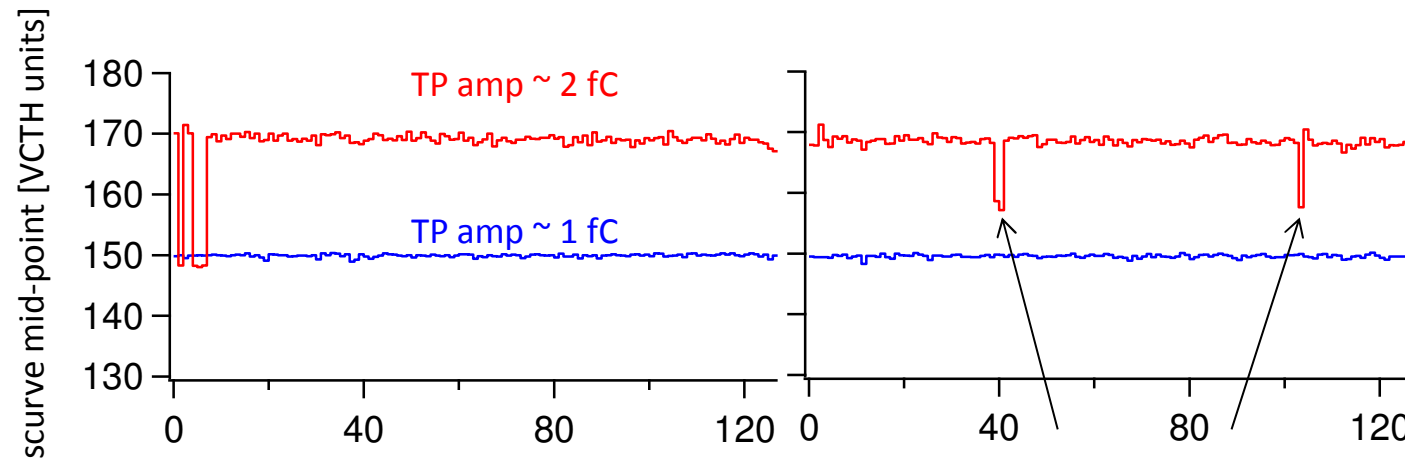
## varying test pulse amplitude: **UPPER** sensor

high noise channels show reduced response to test pulse  
symptomatic of shorted channel response  
(verified on electrical test setup)

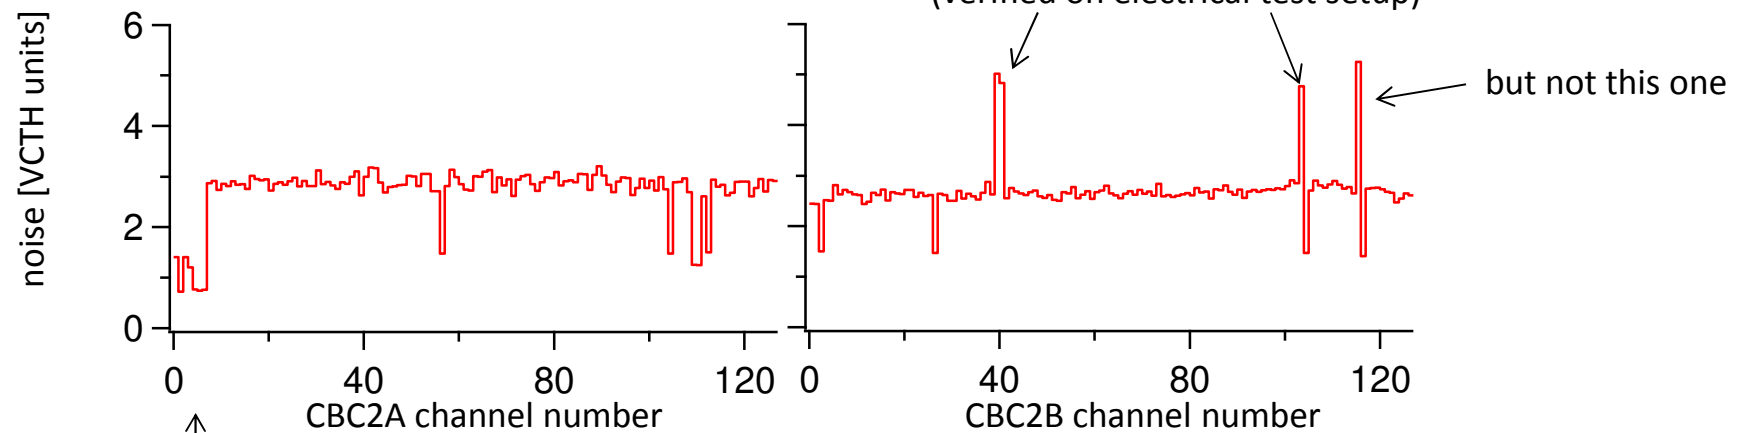
very low noise channels show no response to test pulse  
damaged amplifiers? or shorted to something?

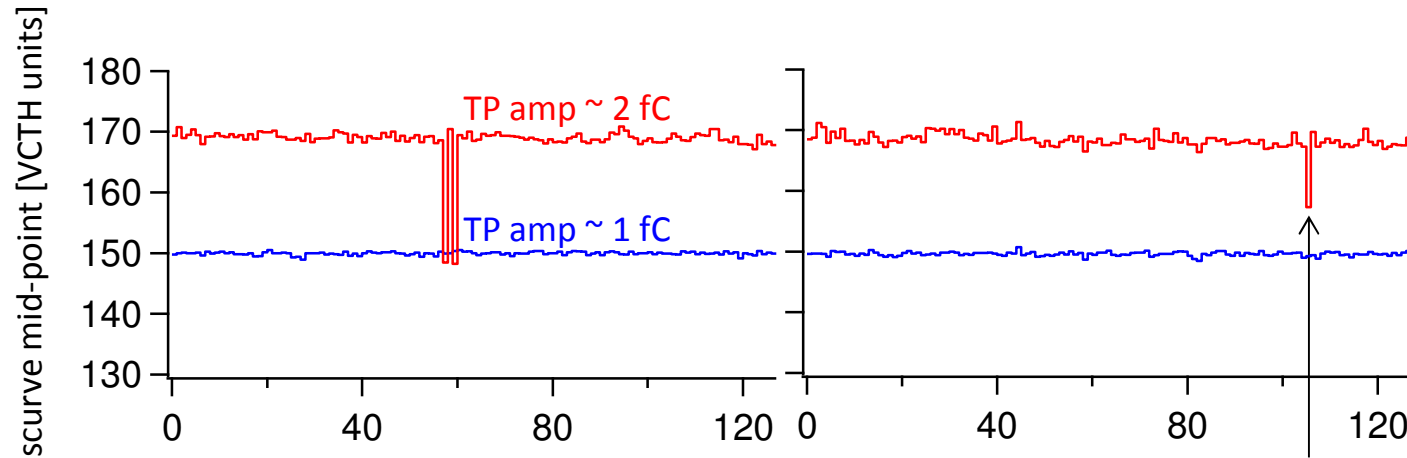
## varying test pulse amplitude: **LOWER** sensor

one high noise channels showing reduced response to test pulse  
could be shorted to neighbour channel on chip but other sensors  
(see previous slide)

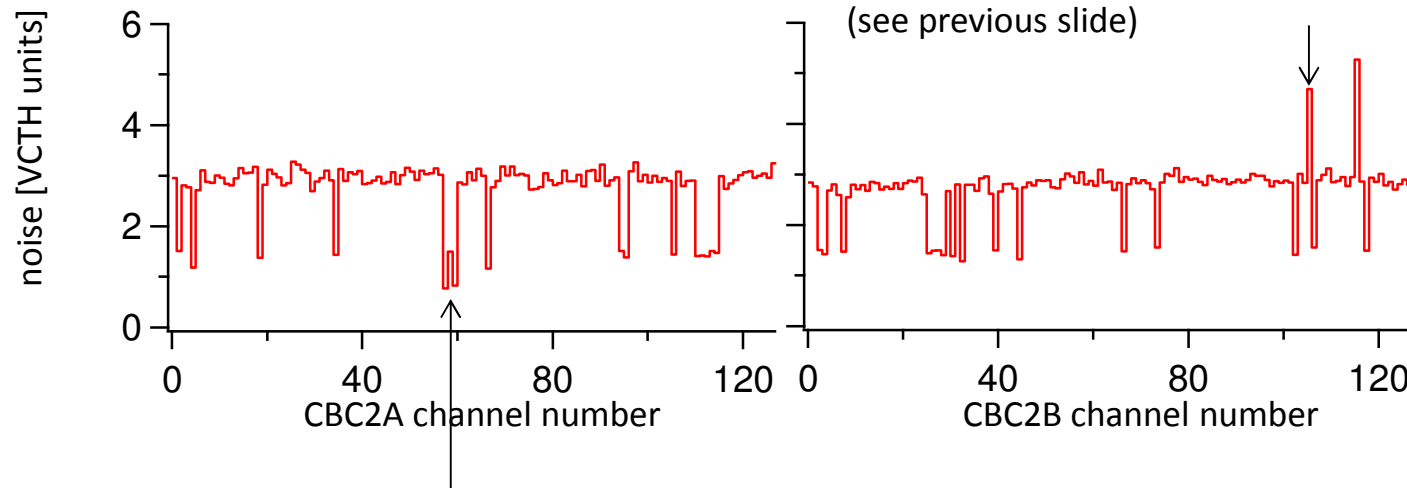
pair of very low noise channels on this sensor also showing no response to test pulse
