CBC2 CM studies

Mark Raymond

systems meeting, 13th January, 2015.

CBC2 CM issues

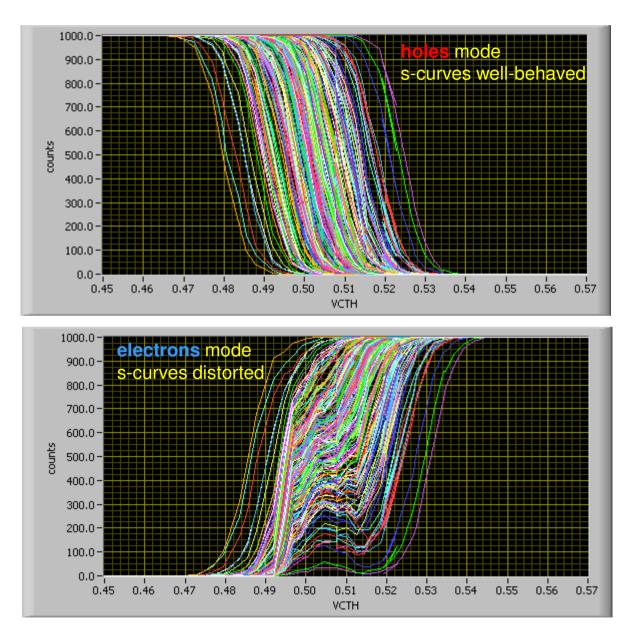
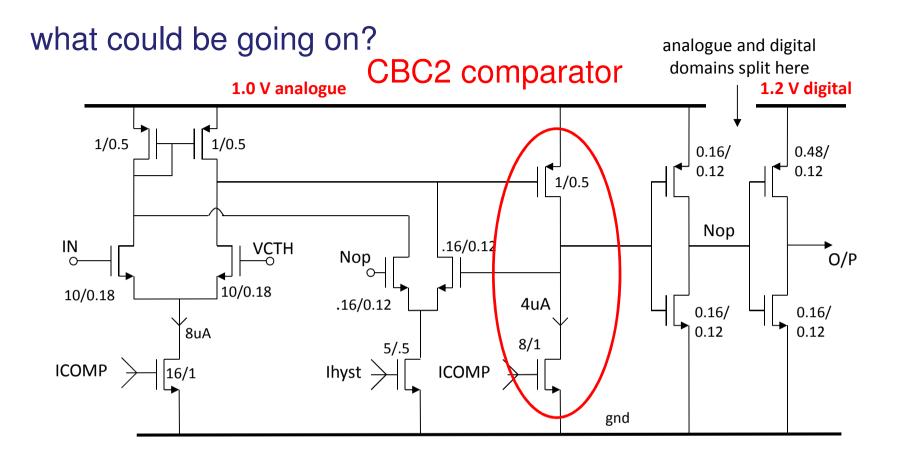
evidence - pedestals s-curves

noticeable increased sensitivity to comparator threshold in "electrons" mode

channels start to fire as threshold reduced - as expected

but at some point, when many channels firing, becomes "unstable" i.e. all channels fire, or no channels fire

this doesn't happen in "holes" mode

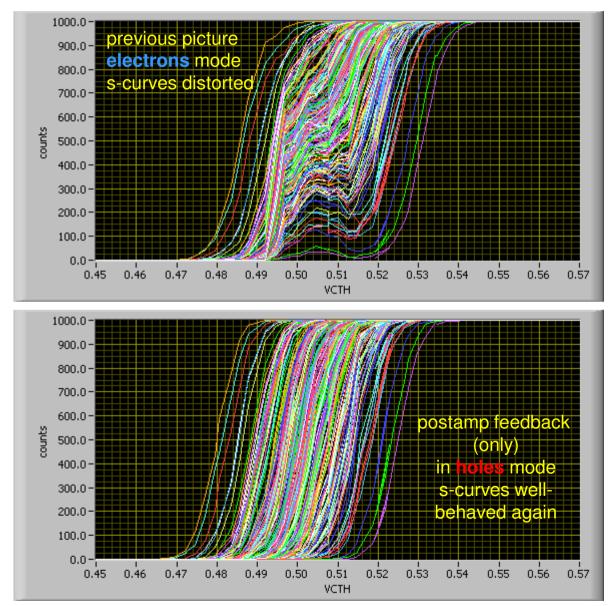
further evidence: stability returns if postamp feedback switched to holes mode

only **postamp** polarity in **holes** mode (preamp and comparator left in electrons)

3) switch postamp feedback only to holes mode

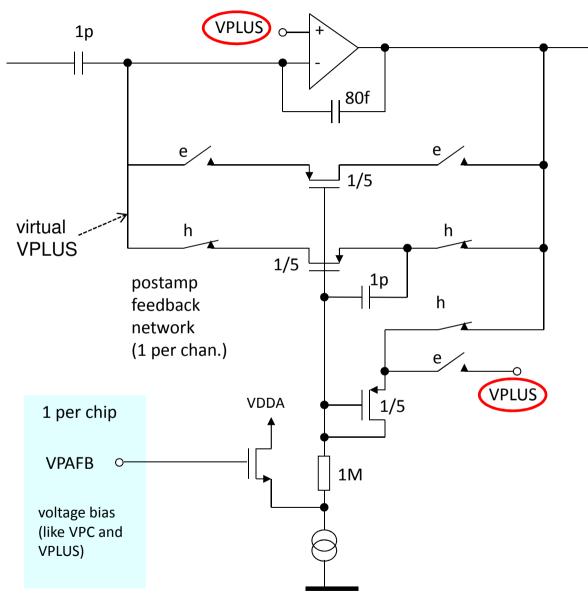
closer look at postamp(2)

suspect mirror transistor connection to actual VPLUS in electrons mode could be cause of problem

possibility for VPLUS to be affected by disturbance on VPAFB source follower node (1M/254 = 4k)

=> possibility to affect noninverting node of op-amp

in holes mode this is not the case

VPAFB generated by current through resistor to ground

=> susceptible to disturbance on ground

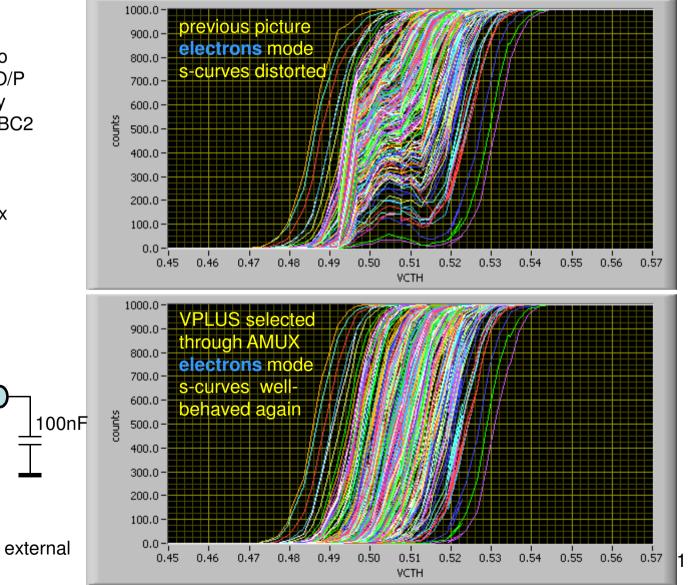
even further evidence: stability returns if VPLUS externally decoupled

program Analog MUX to select VPLUS. AMUX O/P is decoupled to GND by 100nF capacitor on 2CBC2 support board

(set 5 bit AMUX field in TP Cntrol & Analog Mux register to b00001)

2) select VPLUS using analog mux, and couple to external capacitor

CM instability goes away capacitors present for both chips on 2CBC2 system not on 8CBC2flex system unless can add on support board (using test connector?)

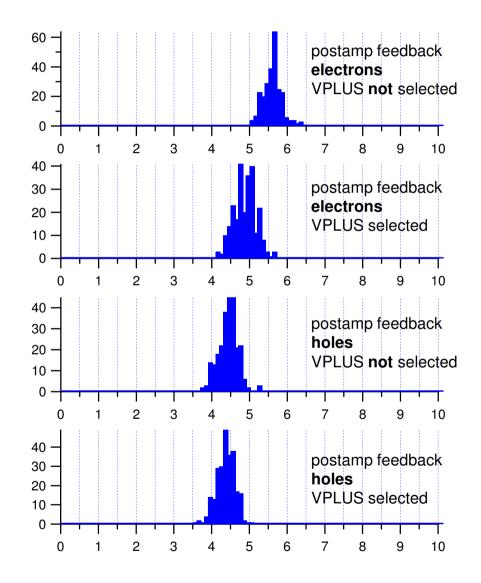
"normal" noise measurements

"normal" noise = noise determined from s-curves measured 32 channels at a time (VCTH translated to mV)

postamp in electrons mode

decoupling VPLUS by selecting through AMUX gives ~10% improvement

=> 32/254 channels occupancy enough to cause excess noise

postamp in holes mode

noise appears slightly less when postamp in holes mode (but pulse shape may be slightly different)

decoupling makes no difference

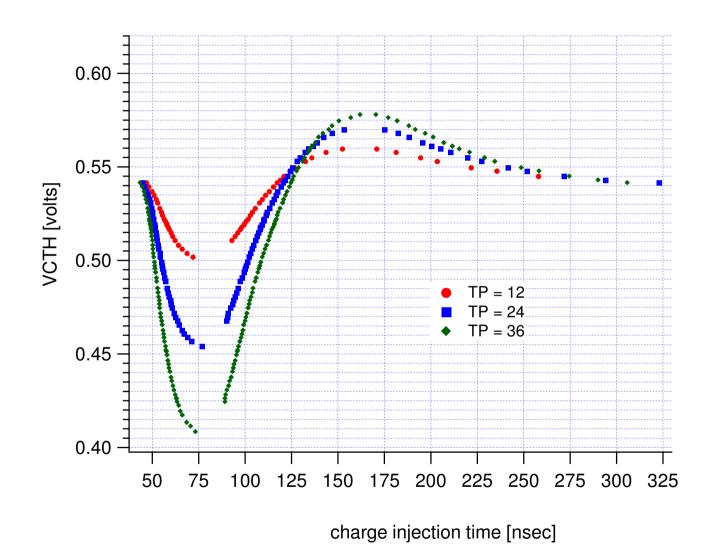
pulse shape measurement - electrons mode

electrons polarity signals

postamp feedback in electrons mode

overshoot limited (cf holes measurement on next slide)

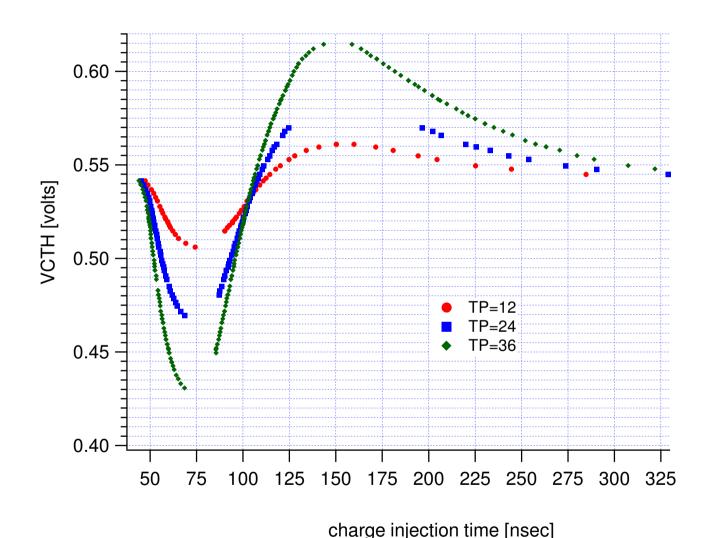
pulse shape measurement - holes mode

electrons polarity signals

but postamp feedback in **holes** mode

reduced signal amplitude

signal duration reduced

significantly more overshoot

but no reason why chip can't be used in this mode
