# **CBC3 Lot2-3 wafer testing results**

2020-02-25 Johan Borg, Kirika Uchida and Geoff Hall Imperial College London with thanks to:

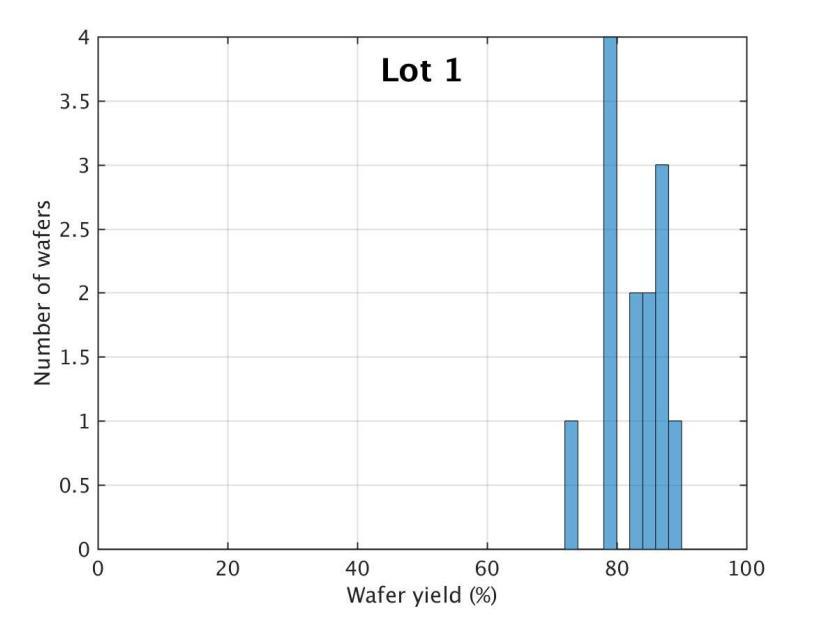
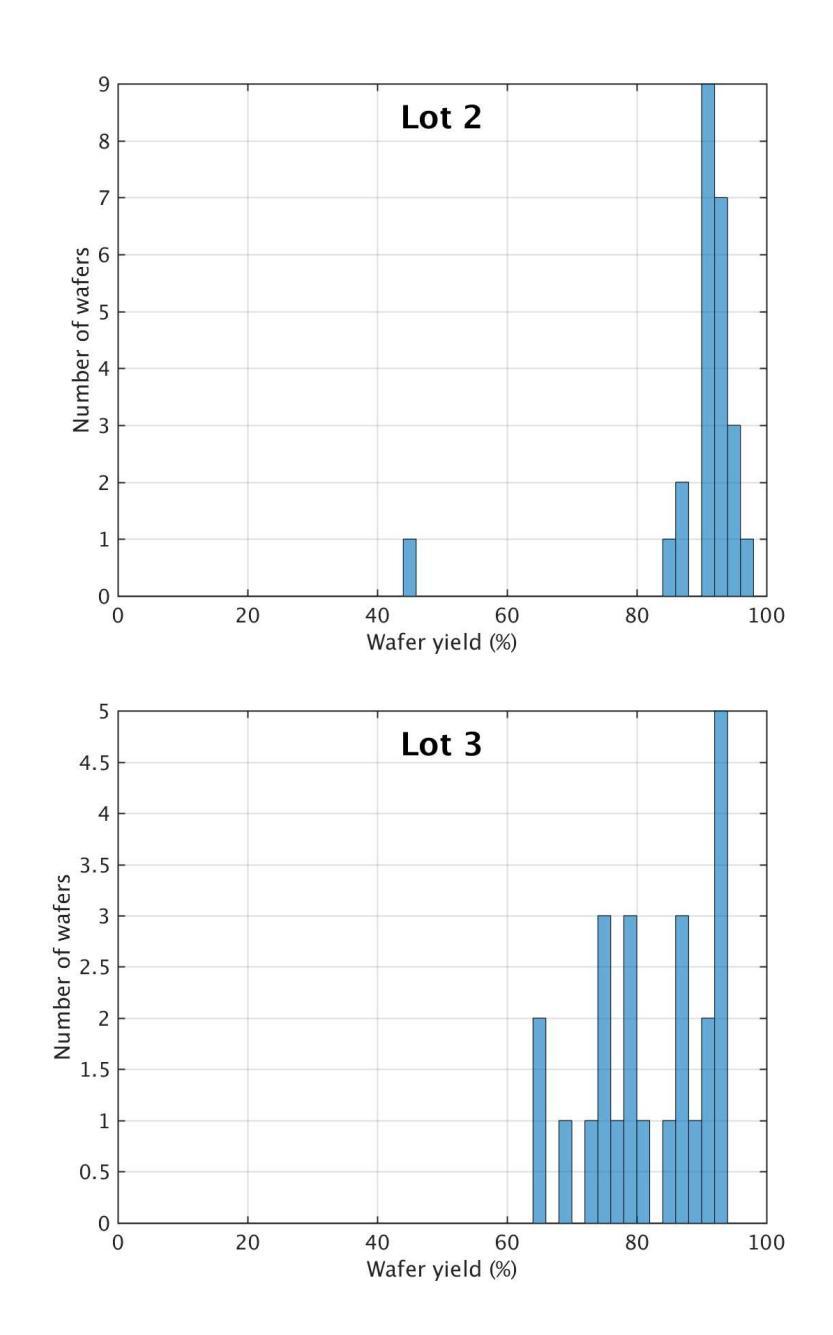
# **Yield histograms**

- Lot 1: 82.5%
- Lot 2: 89.7%
- Lot 3: 82.1%
- Large yield spread for Lot 3.

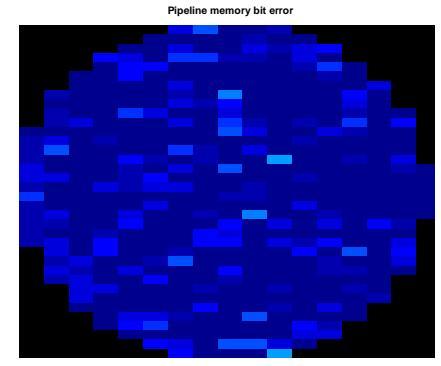
### Pipeline bit

Note the sharp circular pattern of errors on lot 3

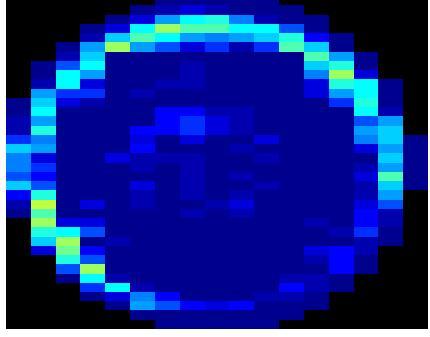
Pipeline addr

Pipeline address error

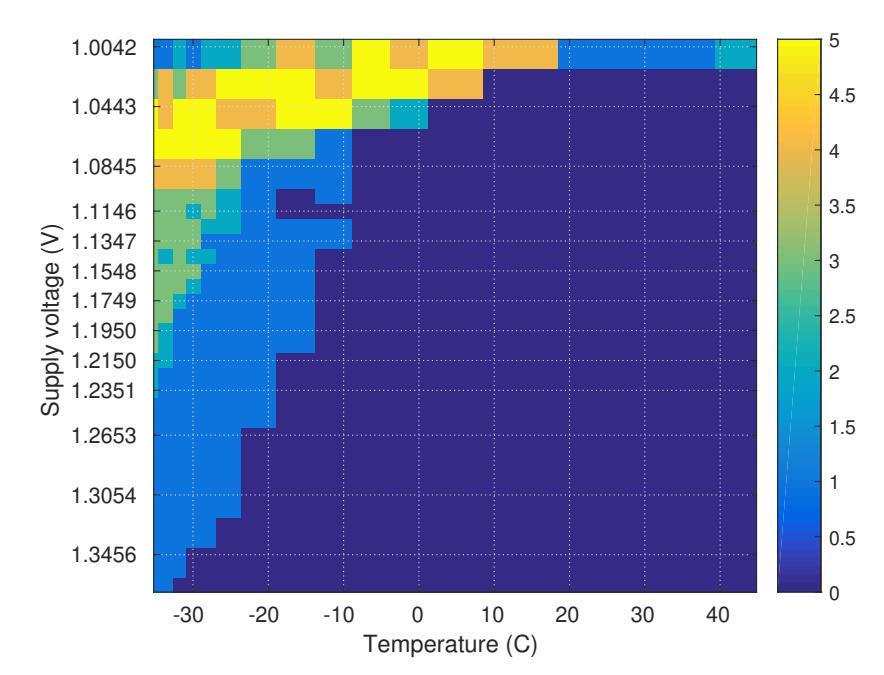
- Significantly more Pipeline address errors
  - Harmless during normal operation
  - Temperature dependence observed for wire-bonded Lot1 chips
- Some pipeline data memory errors observed at reduced supply voltage (see next slides)

- No significant impact on performance expected unless fraction approaches detector occupancy
- Low temperature wafer tests implemented to study the impact on the yield in more detail
- To date one Lot 2 and one Lot 3 wafers have been re-tested over temperature and supply voltage, but the anomalous performance of Lot 3 is not yet understood

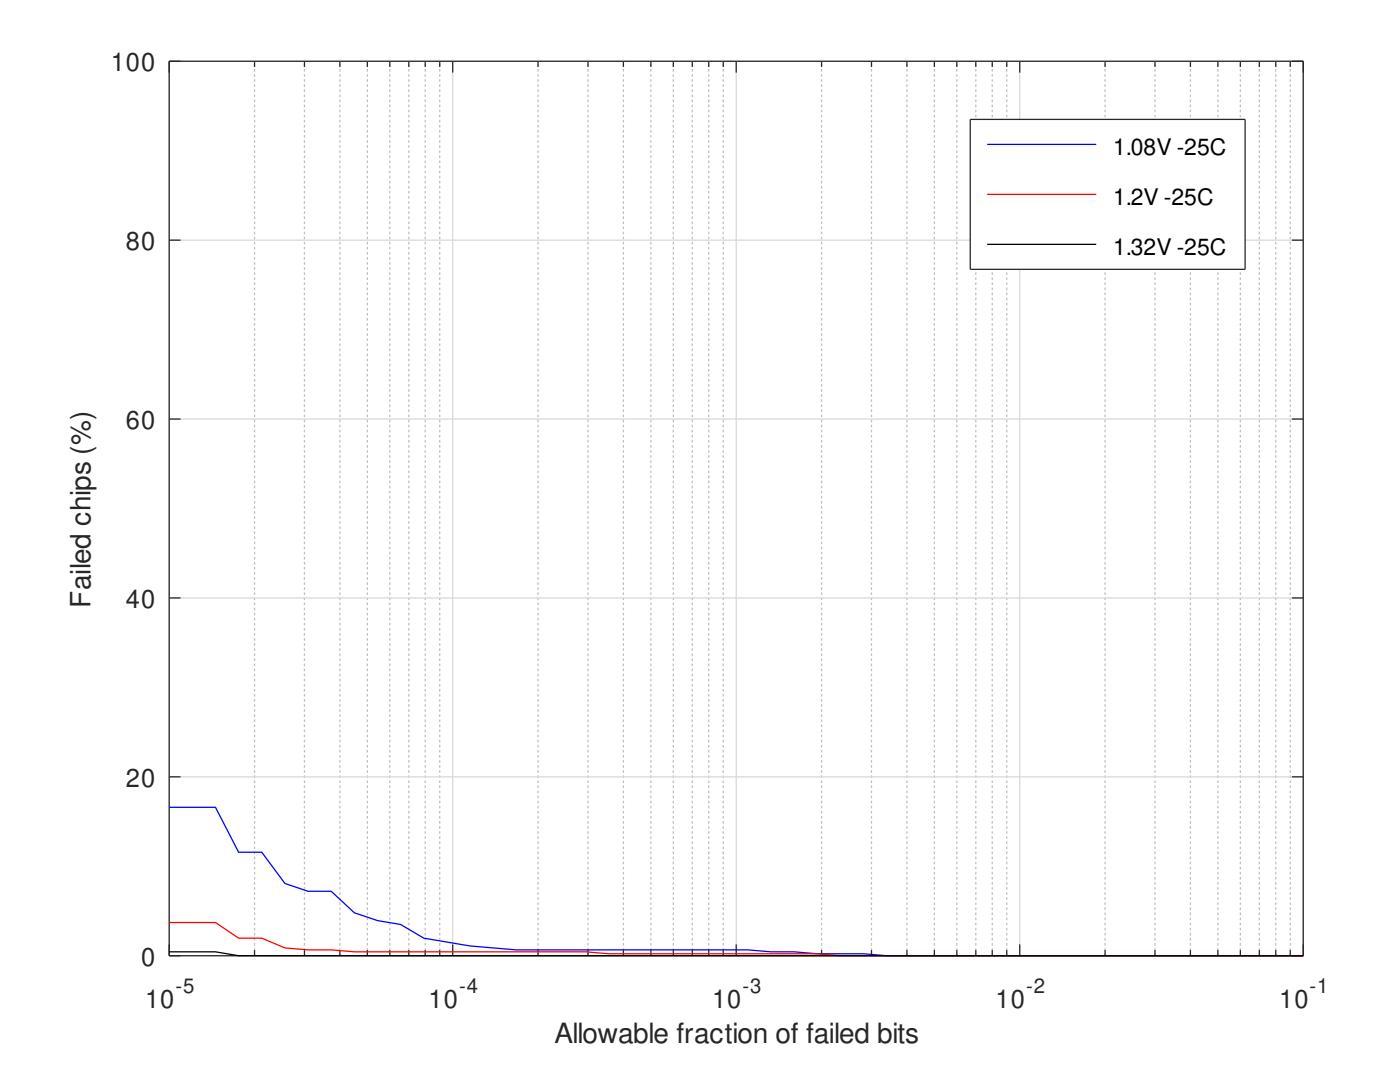
### Lot 2 pipeline bit errors at -25

Lot 2 chips exhibits a small number of errors at low supply voltage

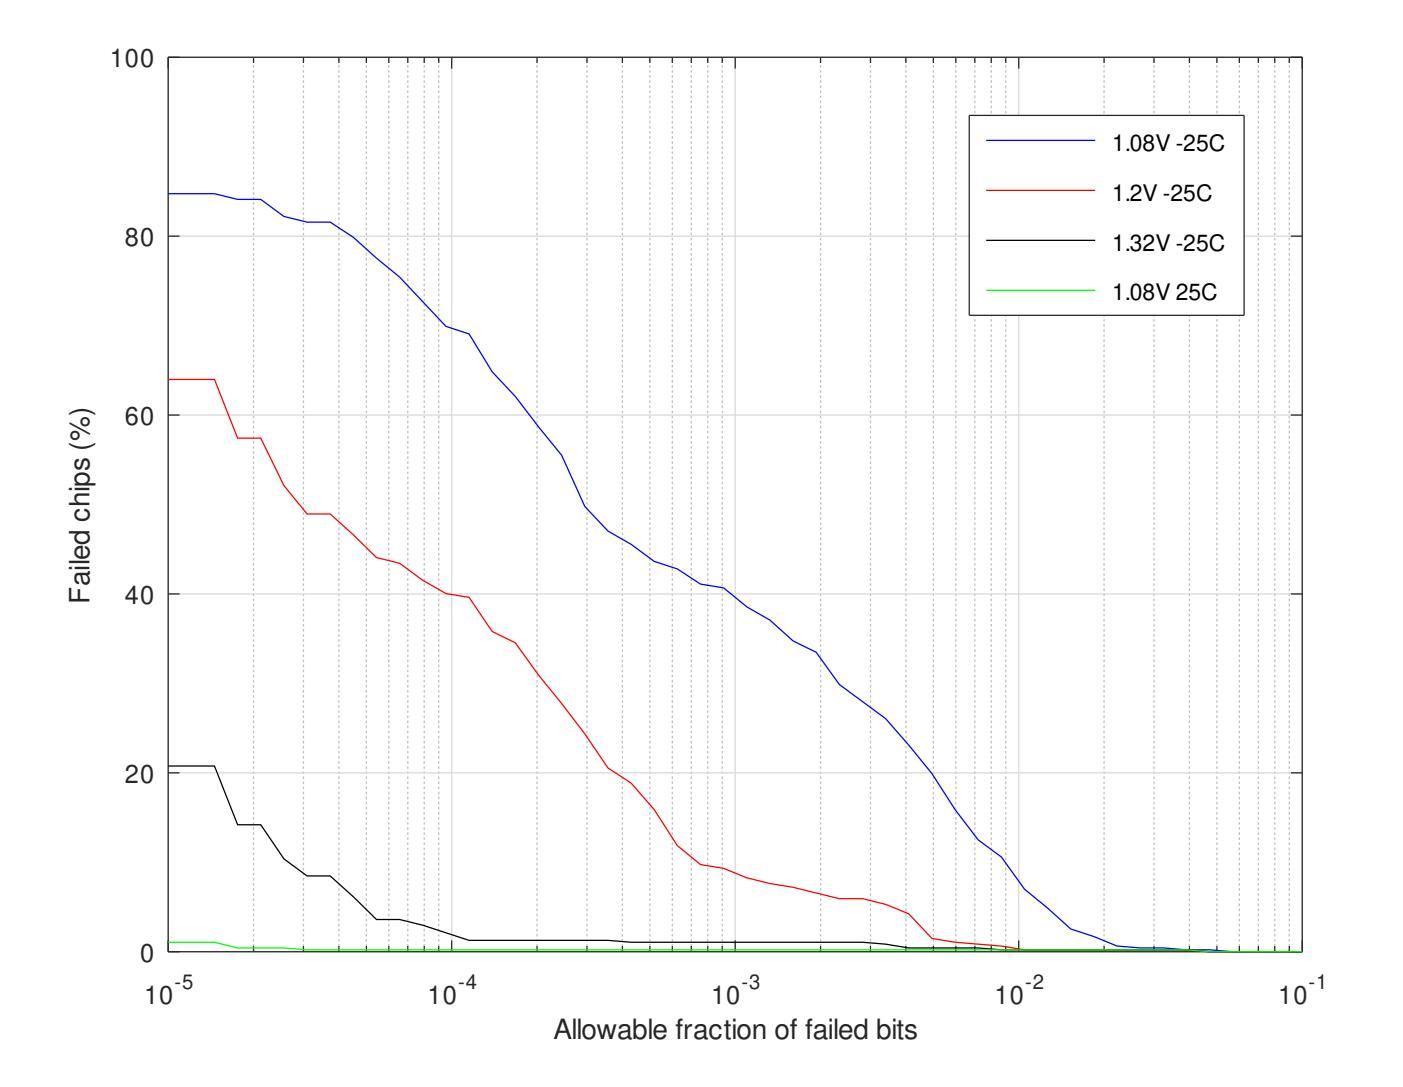
### Lot 3 pipeline bit error at -25

Lot 3 is clearly different, reduced yield at nominal supply voltage.
