CBC3 status

wafer probe testing status LDO measurements some more digital problems discovered

systems meeting, 23rd February, 2017

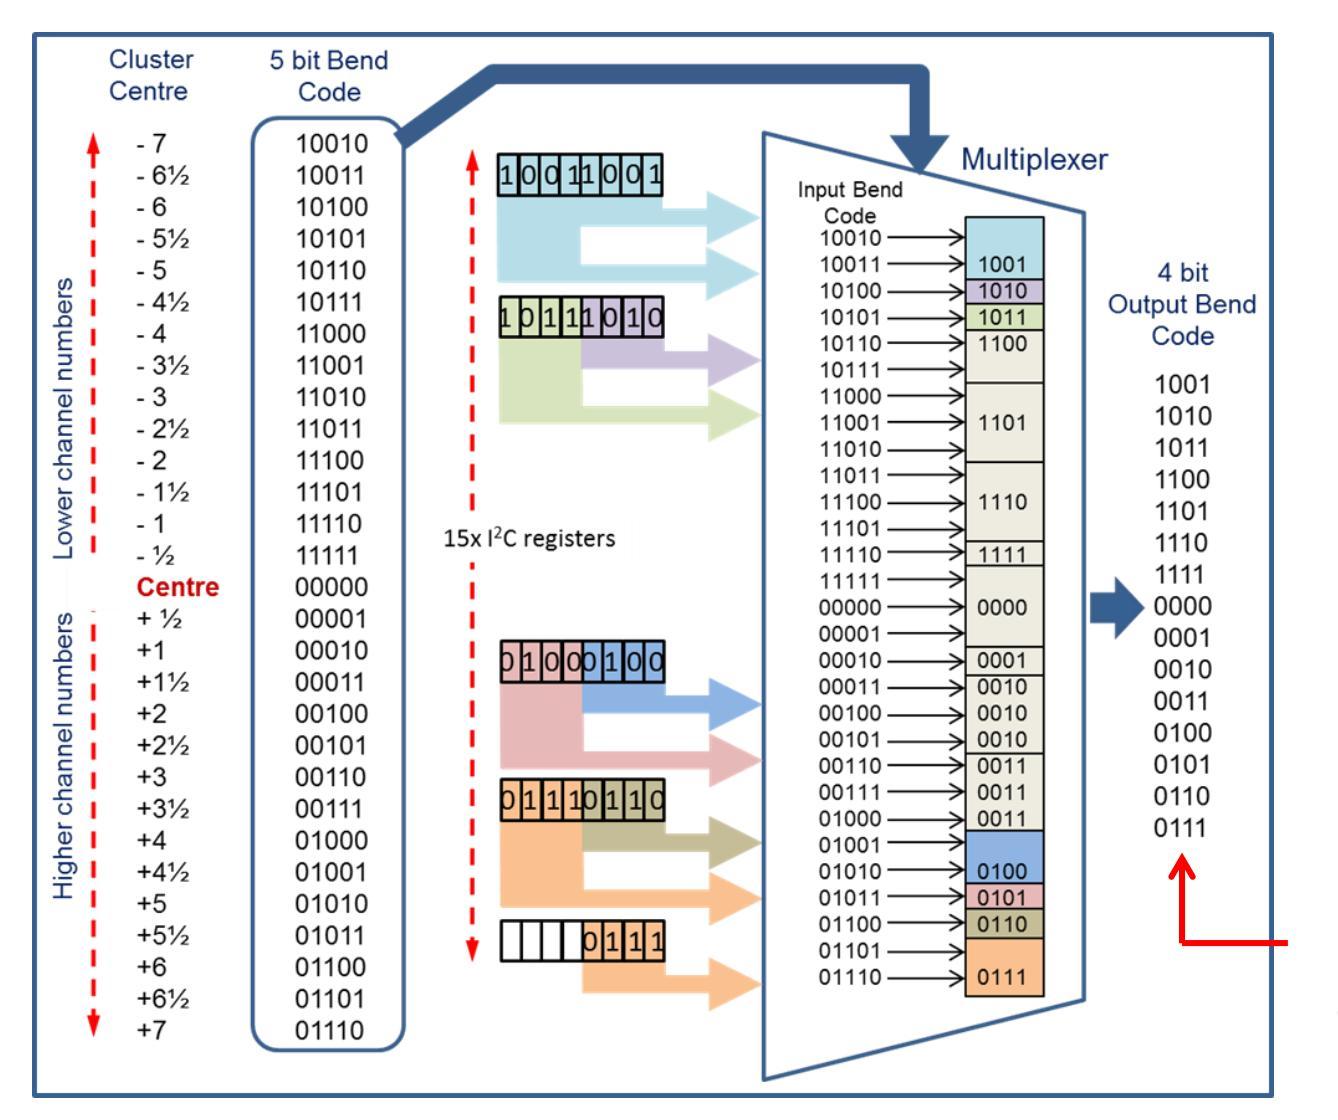
but turns out that logic has been coded to generate stub address + invalid bend code (b1000)

invalid bend code b1000 does not appear

example 2: cluster occurs outside programmed window
 but inside maximum possible window
 get stub address + invalid bend code (b1000)
this is not ideal, wastes off-chip stub address bandwidth
not a problem for CBC3 users

stub address from cluster outside window will need to be suppressed with logic change

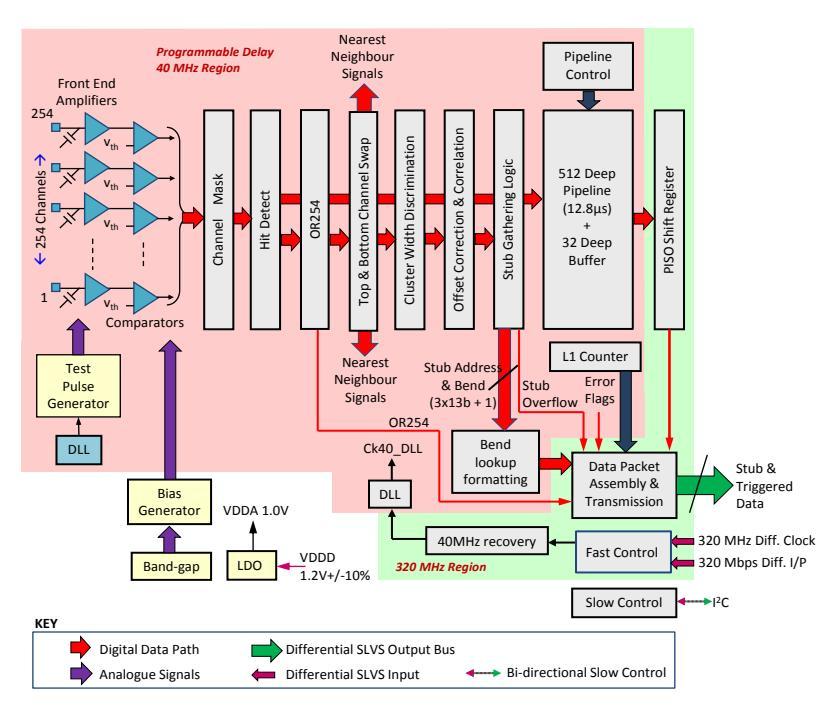
example

Ck40 DLL setting = 2

4 consecutive triggers sent

test pulse timed to be in 2nd frame

readout data looks ok

header spacing 950 nsec.

Ck40 DLL setting = 3

same triggering and test pulse conditions

header spacing reduced to 925 nsec.

2nd frame test pulse data only starts to appear ~ third way through second frame, and spills over into 3rd frame

more detailed look shows header pipe addresses not correct

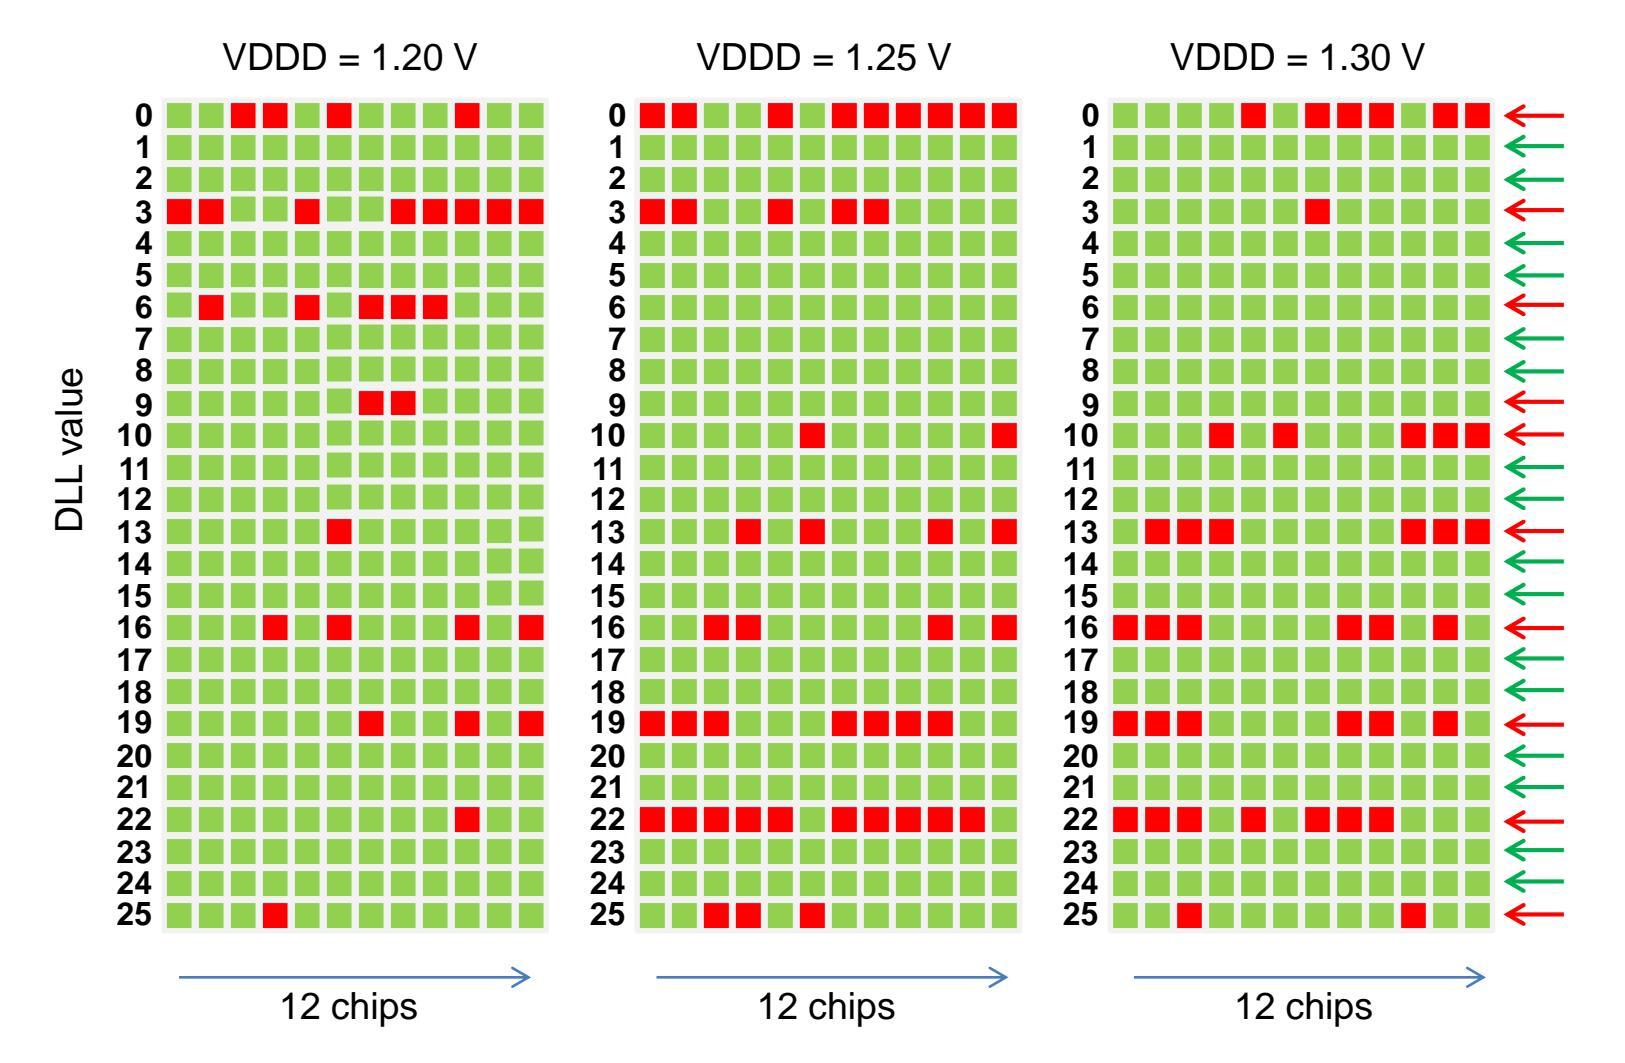
the problem: results for 12 chips

observations

problem DLL values depend on VDDD, and are not the same for all chips but appear to always occur at ~3 nsec spacings (probably related to 320 MHz clock) DLL values in between the 3 nsec problem spacings show no problems

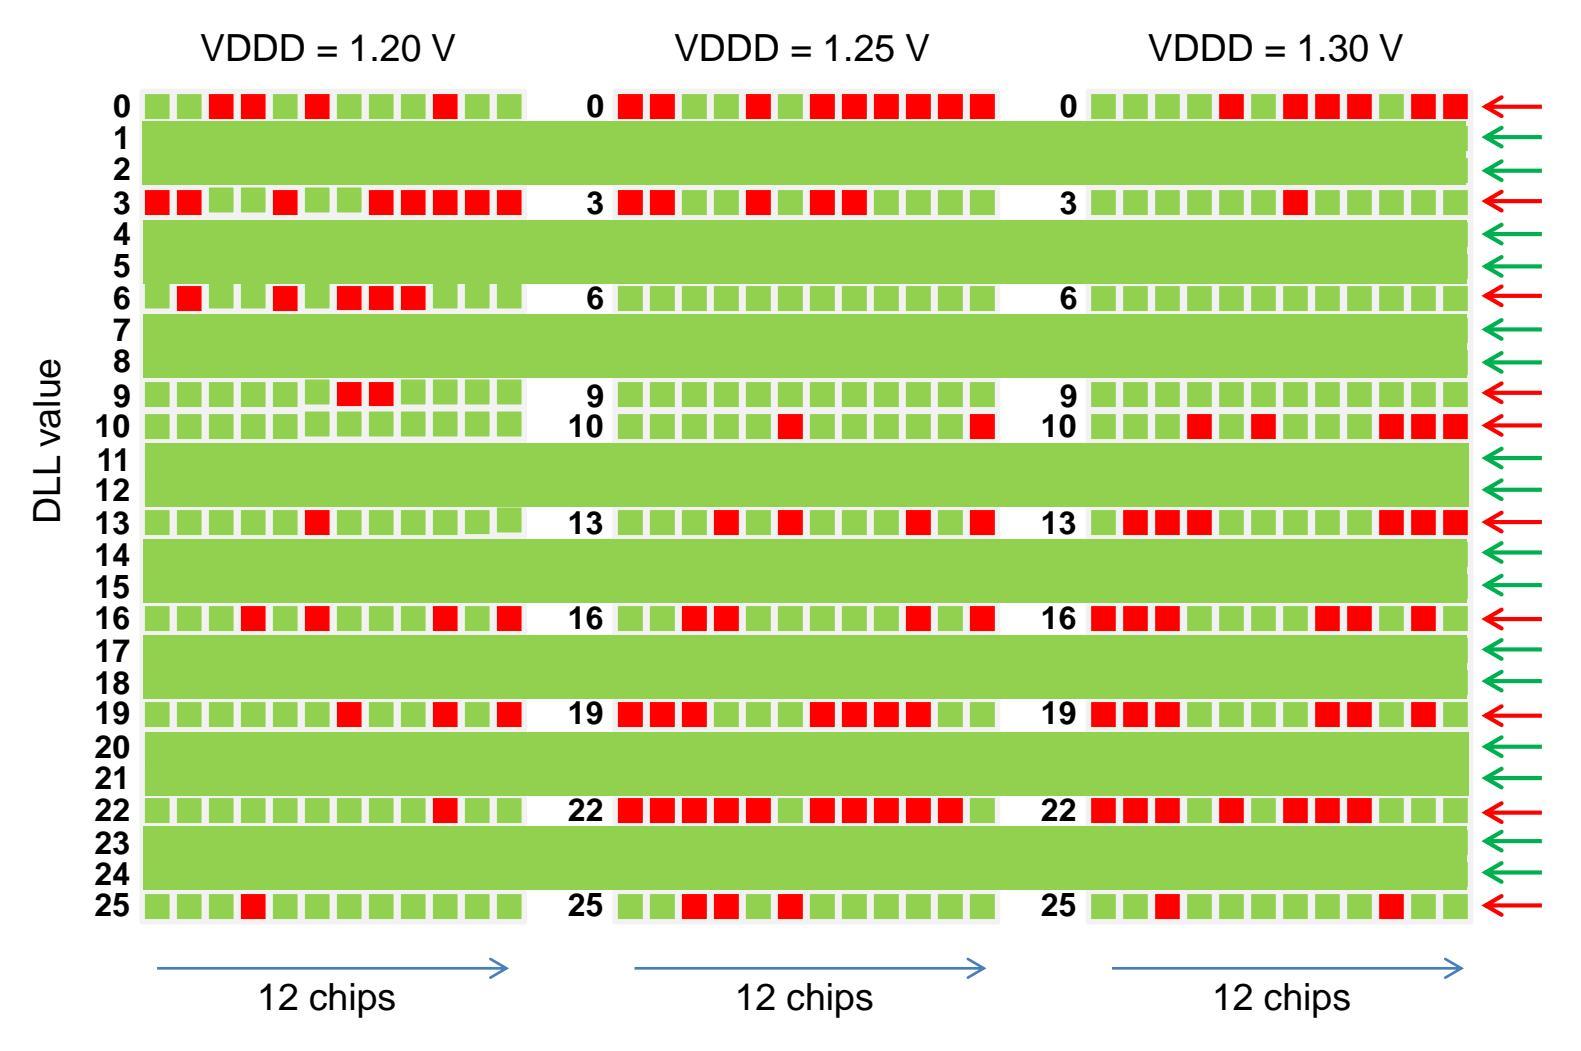
the problem: results for 12 chips

clear "bands" of 2 DLL settings where problems don't appear

=> should choose one of these when operating the chip in conditions when trigger spacings less than 950 nsec

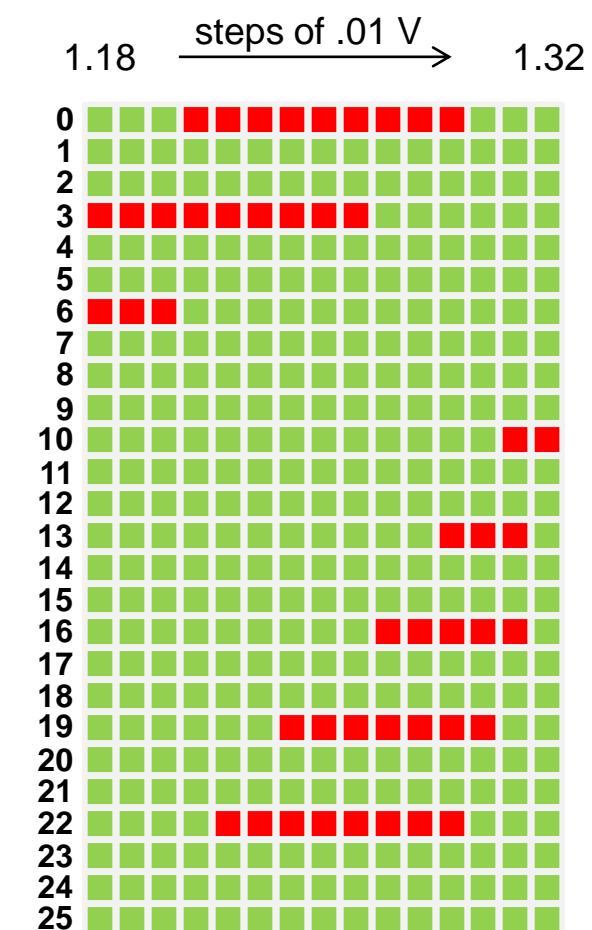
the problem: one chip, finer VDDD steps

problems migrate between DLL values as VDDD changes

"safe" DLL settings remain clear of problem
