CBC3 wafer probe test status

systems meeting, 4th April, 2017

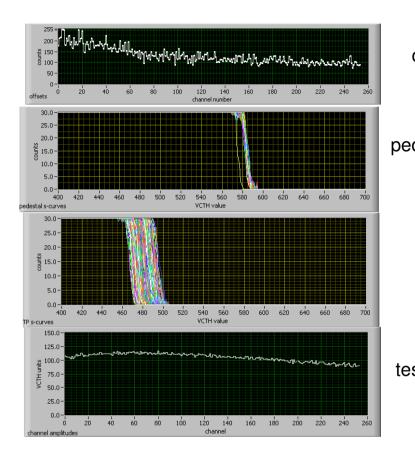
this chip shows an obvious trend across the chip in the gain picture, and also in the offsets after tuning

this problem more often observed on chips at the edge of the wafer

this chip shows a problem on several channels

problem typical of chip in centre of wafer

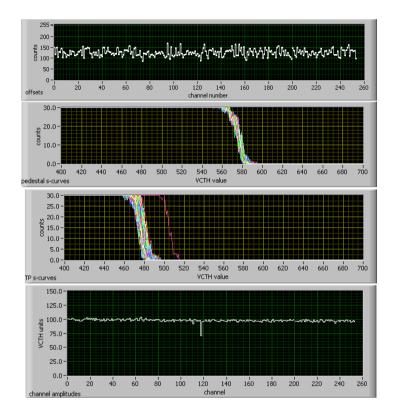
single channel with low gain

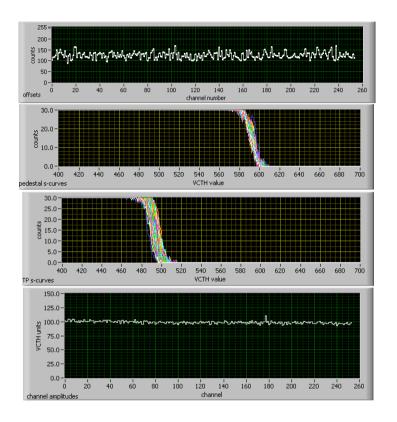
single channel with slightly high gain but still a failure

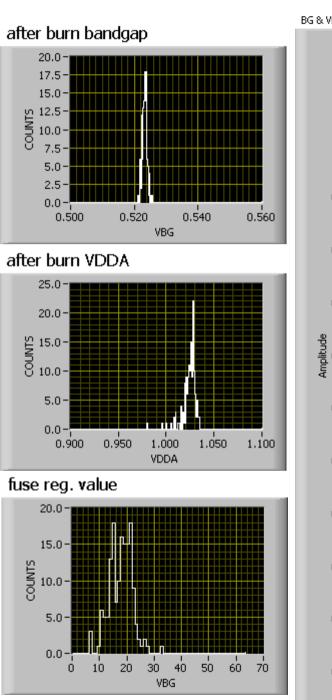
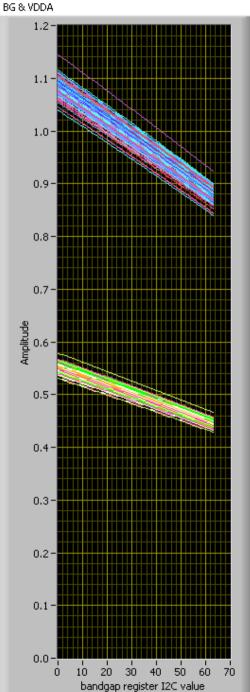
all these chips were passed

after fusing bandgap values distribution narrow

larger spread in VDDA values - suspect due to variable probe contact

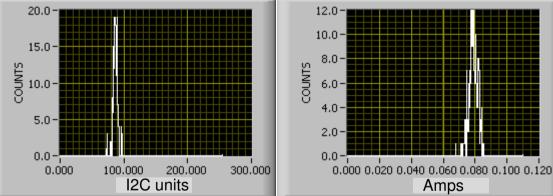
all these chips were passed - no obvious performance issues

few chips with low VDDD current values - suspect measurement issue

maybe power supply current not given enough time to settle - needs further investigation
