# 3D 'O' Ring Vacuum Tests – PART II

Updated 21<sup>st</sup> July 2011

by Ian Clark, Trevor Savidge & Peter Savage

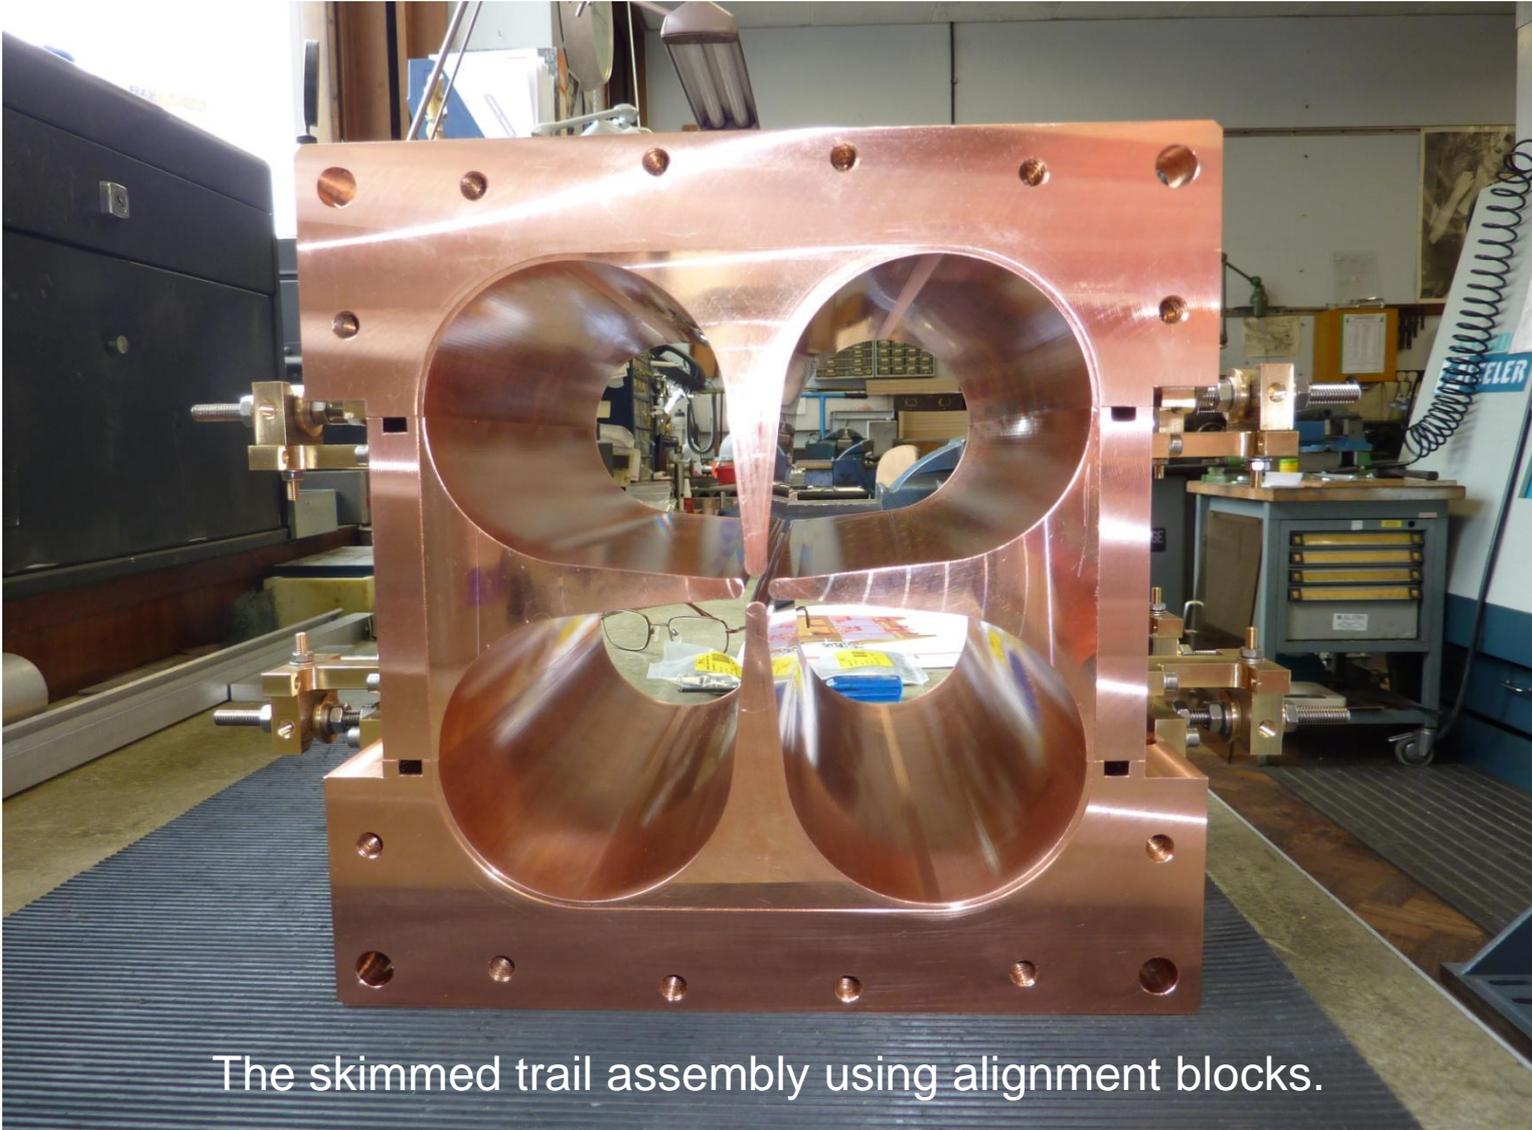
The skimmed trail assembly using alignment blocks.

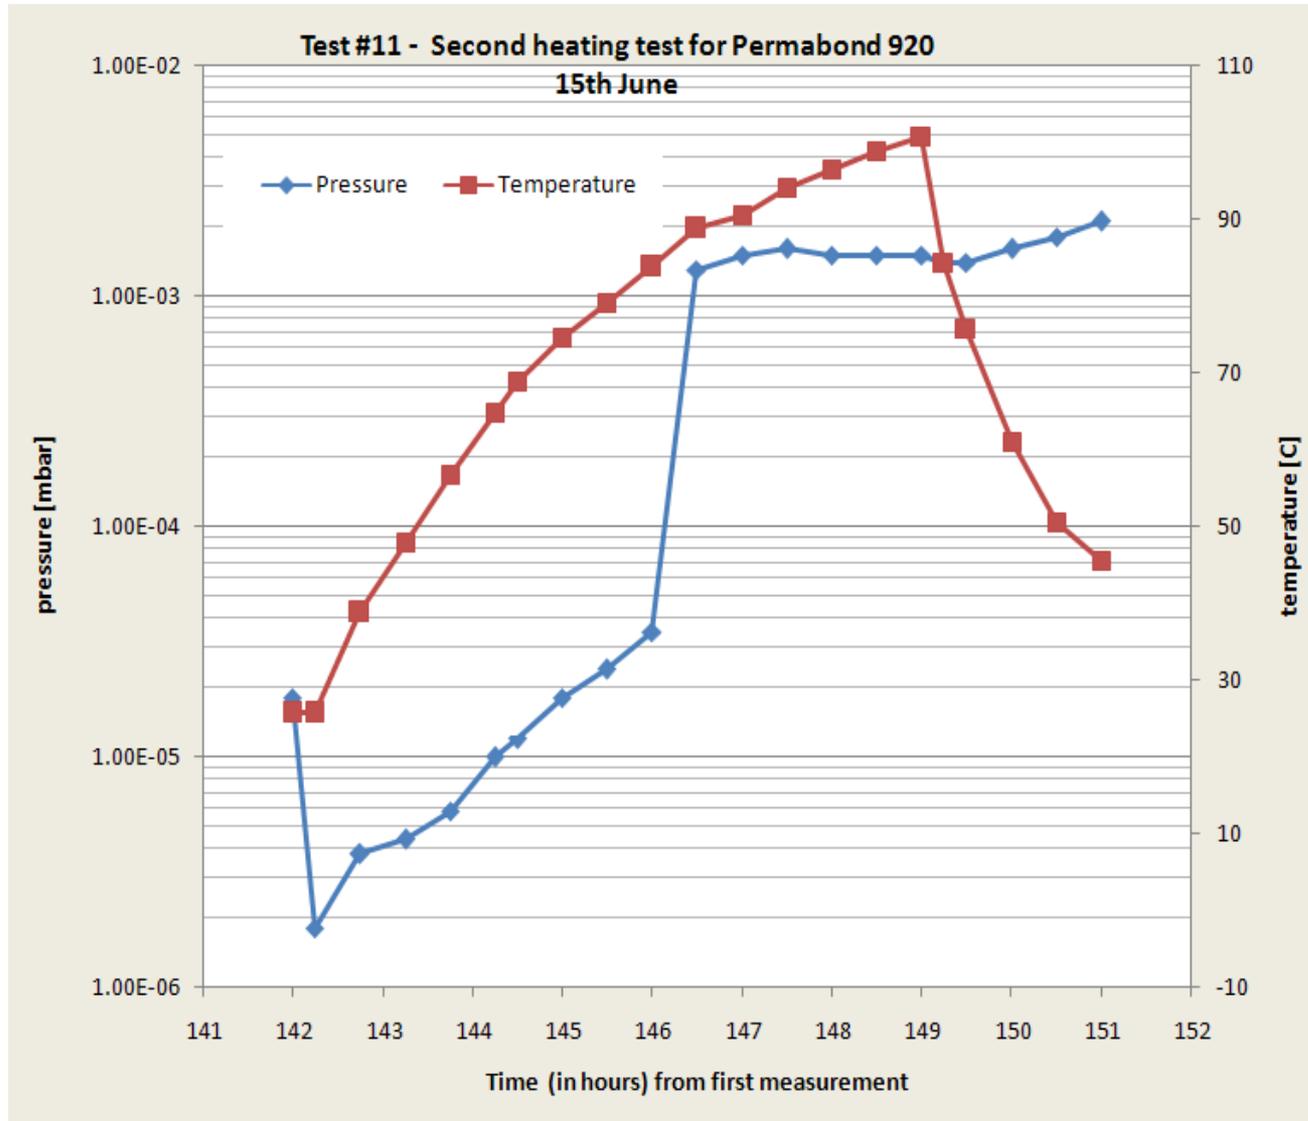
## Second heating test.

Using one heating tape but this time wrapping in tin foil.

Pressure rose with temperature as it should.

At a recorded temperature of 85°C the pressure suddenly increased and did not recover.

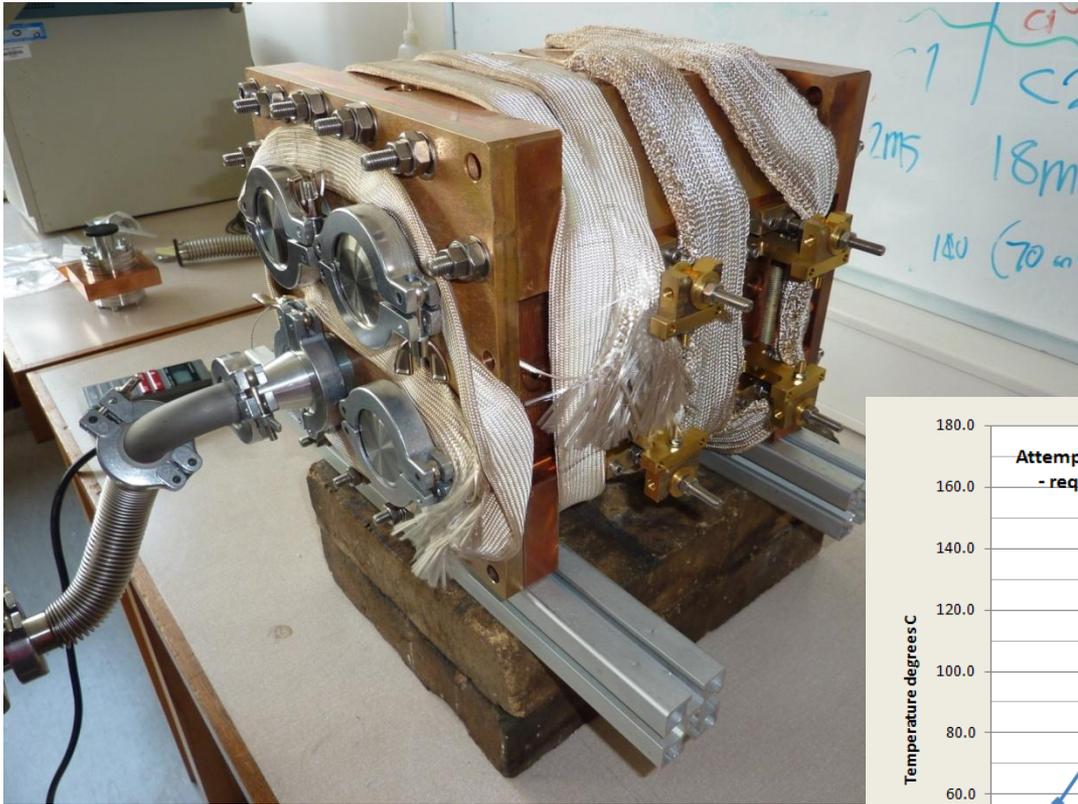
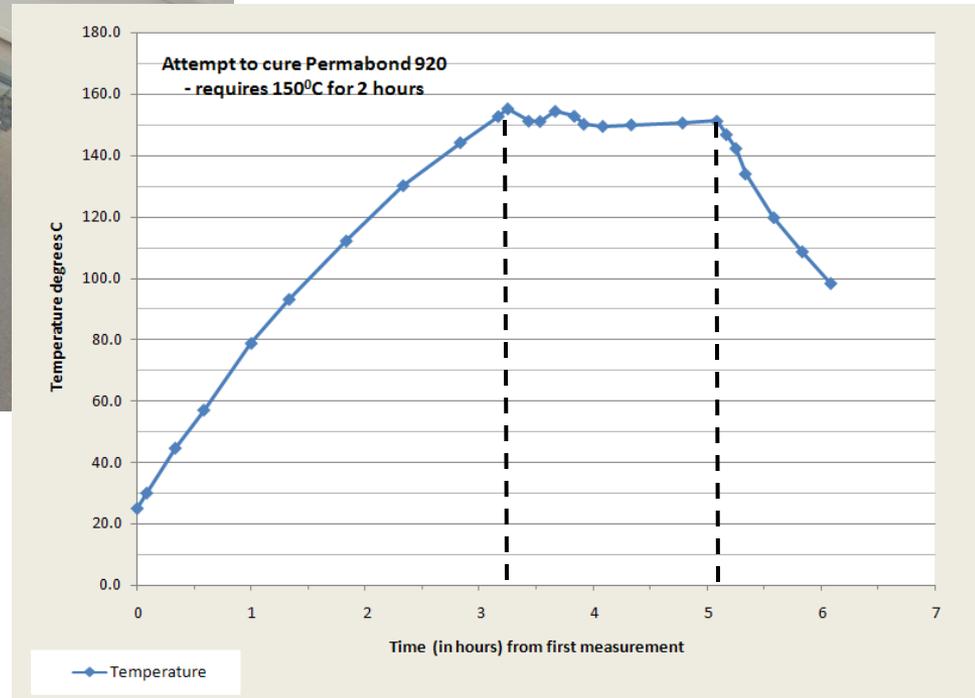
The 3D 'O' ring was not cured to the manufacturer's recommendation therefore leaving the 'O' ring in place the plan was to attempt to cure the adhesive. (Test #20)

Using both heating tapes (600W total) and wrapping in tinfoil was sufficient power to reach the required 150°C. This temperature was held constant for two hours by turning off one heating tape.

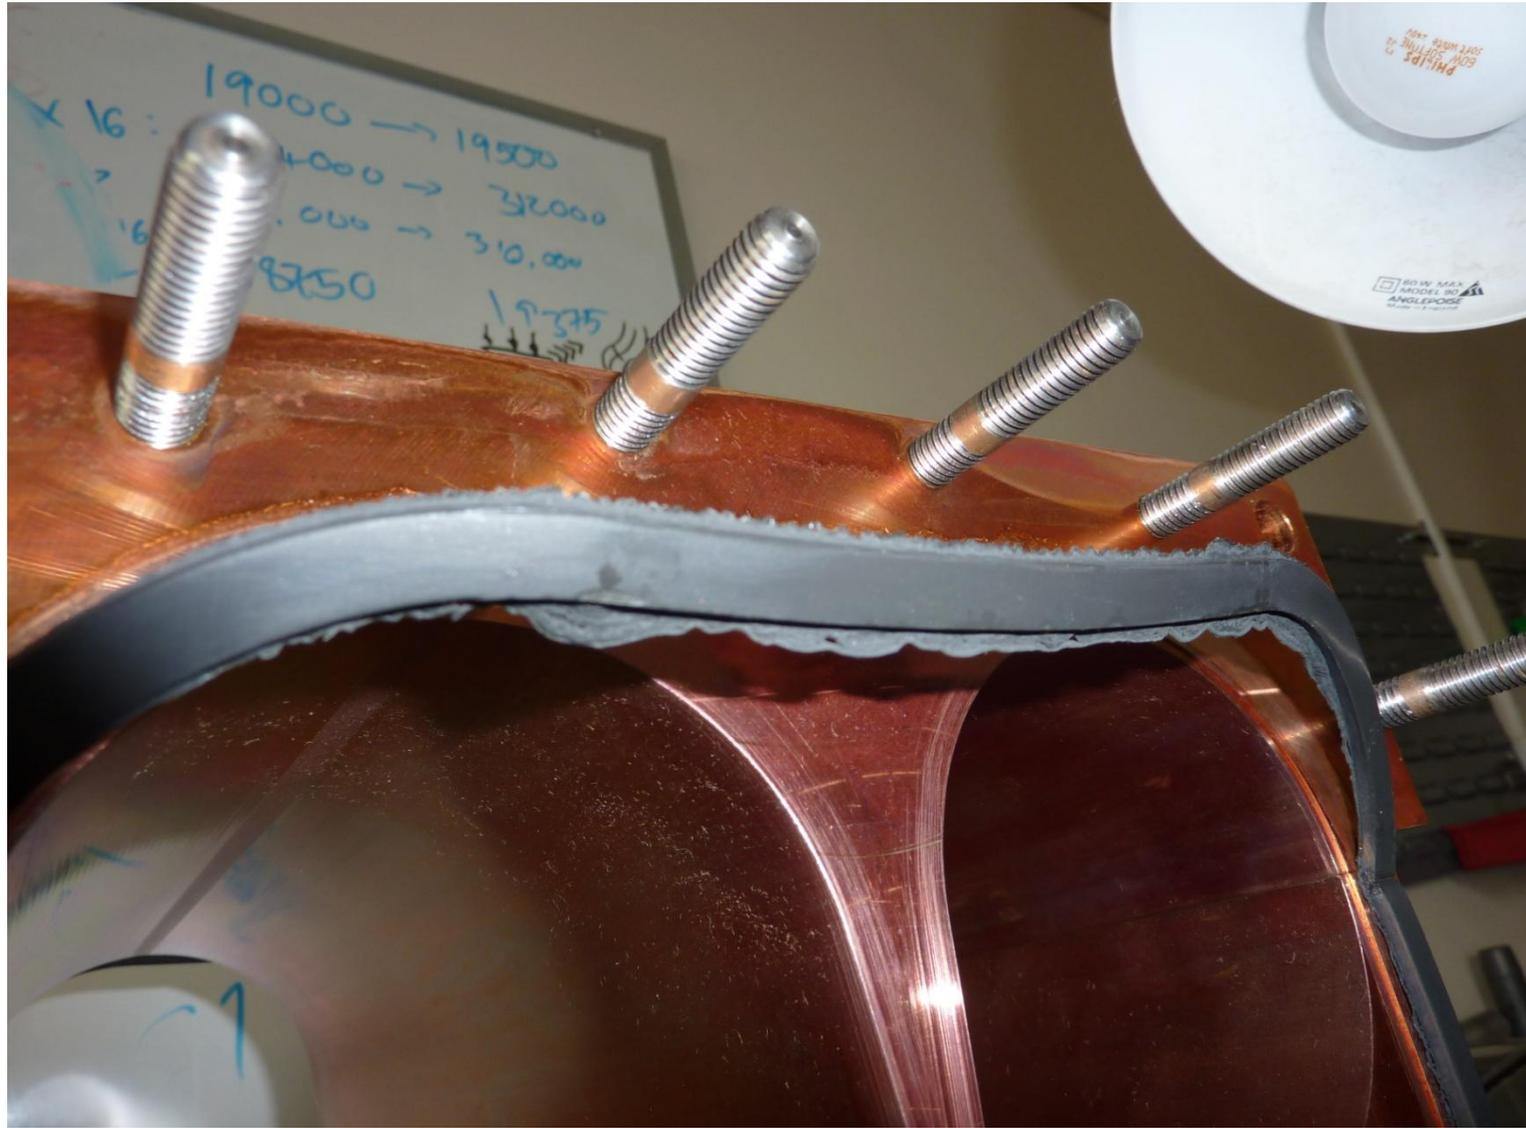
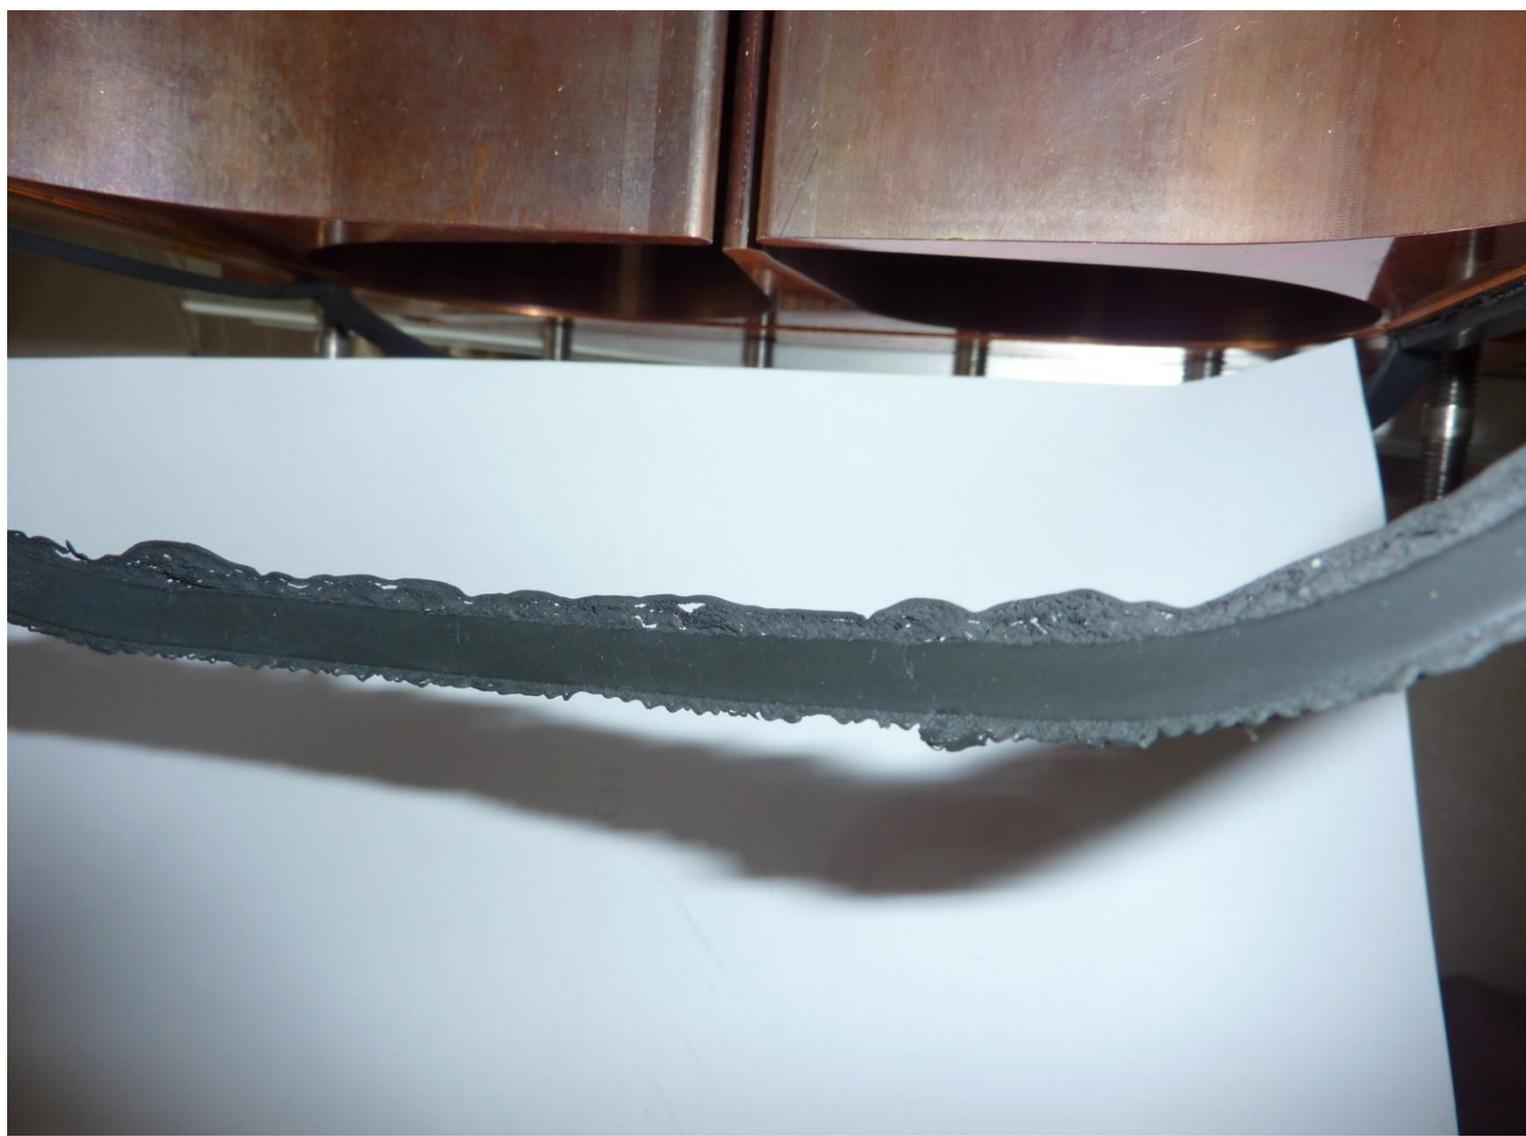
## 2) Flash

Observation - rubber has been deposited on the weld test model.

- Do not know the cause.
- Is the temperature measurement reliable?
- Is it a feature of square profile 'O' ring?
- Does it matter? – it would probably still have maintained a vacuum seal.

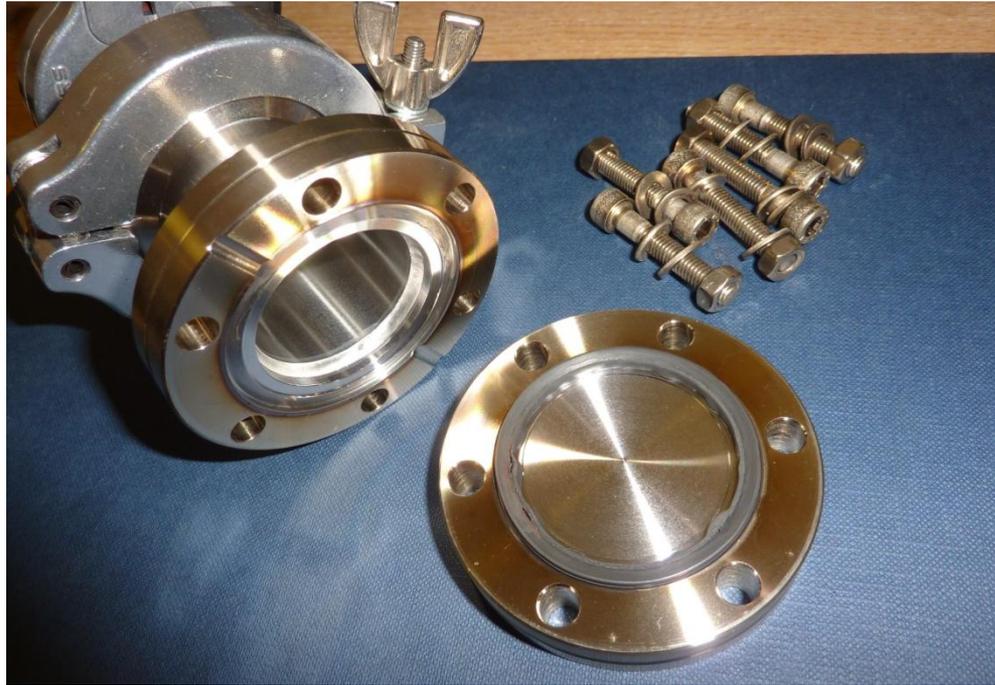
Test #29.....

Opening up the DN40CF flanges revealed that the stainless steel is discoloured and the 'O' ring has started to deteriorate. The 'O' ring was lightly stuck to the stainless steel and after peeling it off some rubber was left behind.
