Electrical Tapes & Optical Links

- **Electrical tapes**
 - Al/kapton tapes for SCT
 - Wiggly tapes for SCT EC
 - Lessons learned.
- **Optical Links**
 - Survey reliability in ATLAS
 - Focus on problematic systems
 - Lessons learned and being learnt.

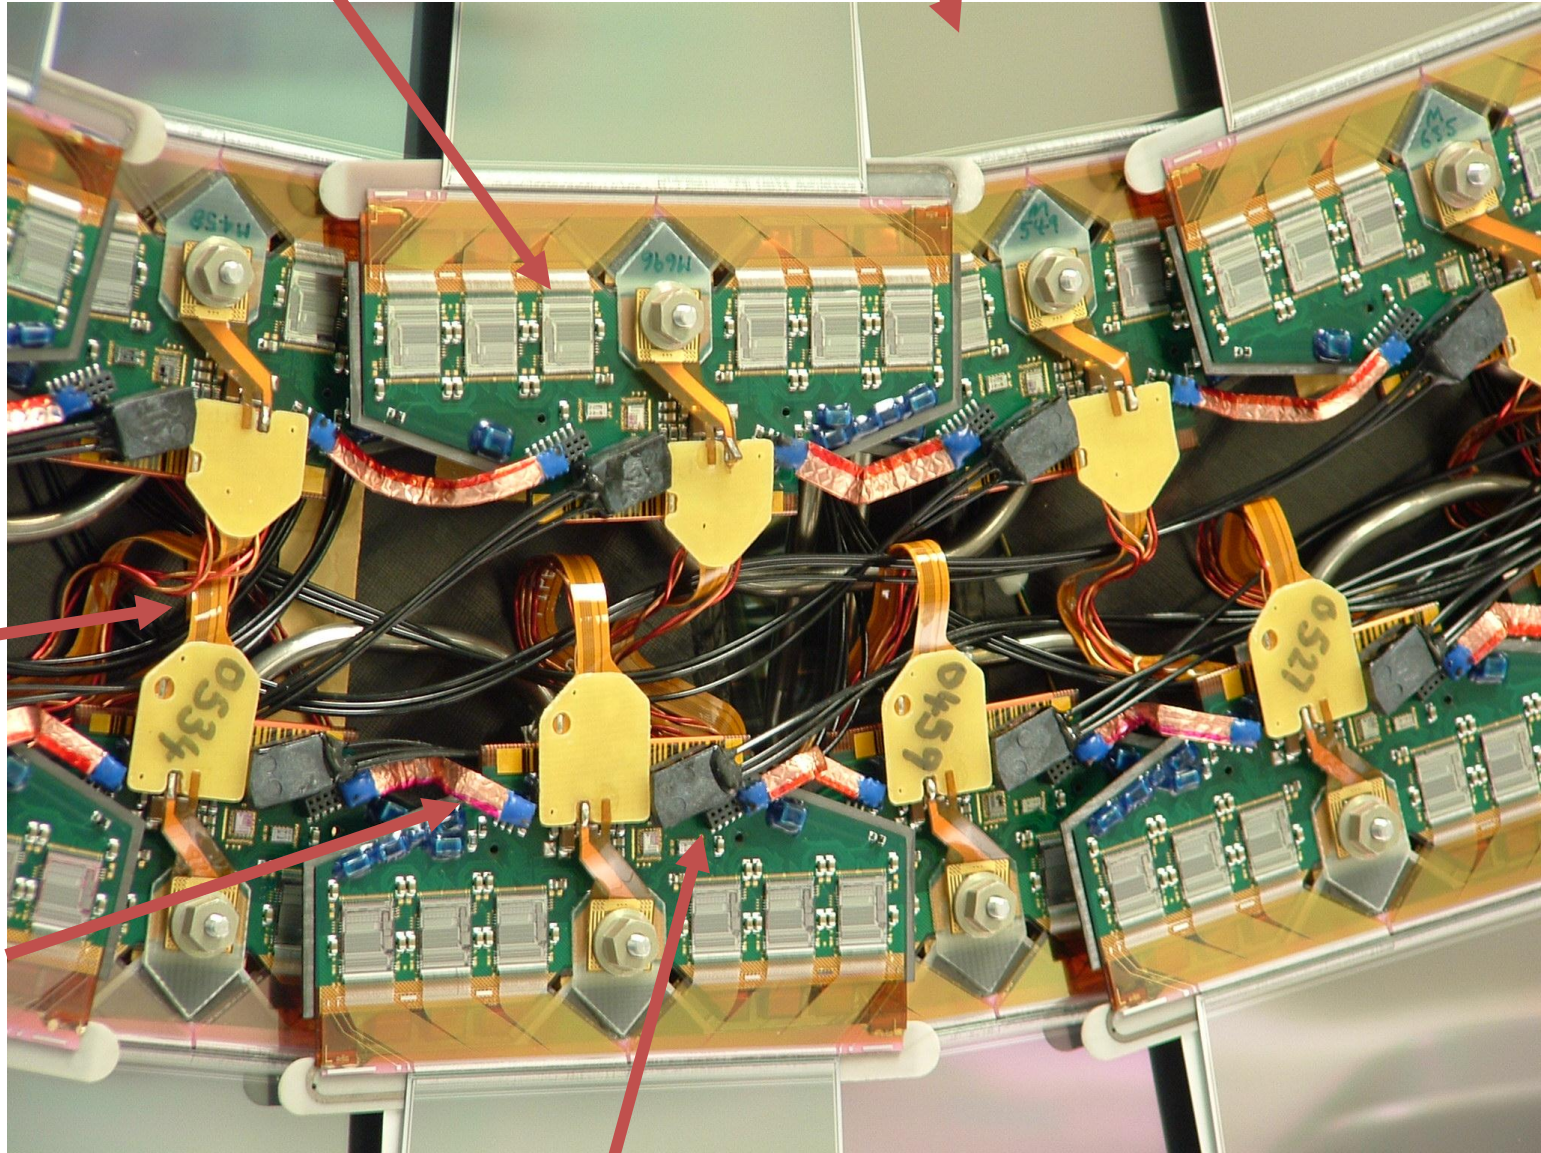
- **Cu/kapton tapes for HV and control signals.**
- **CCA twisted pair for LV.**
- **Twisted pair attached to Cu/kapton → photos.**

Module with ASICs

**Flex
Circuits**

**Redundancy
links**

Opto-package with fibres

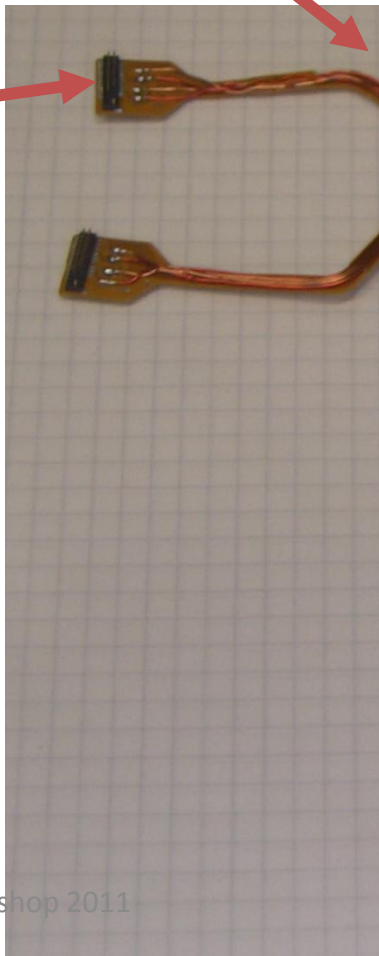
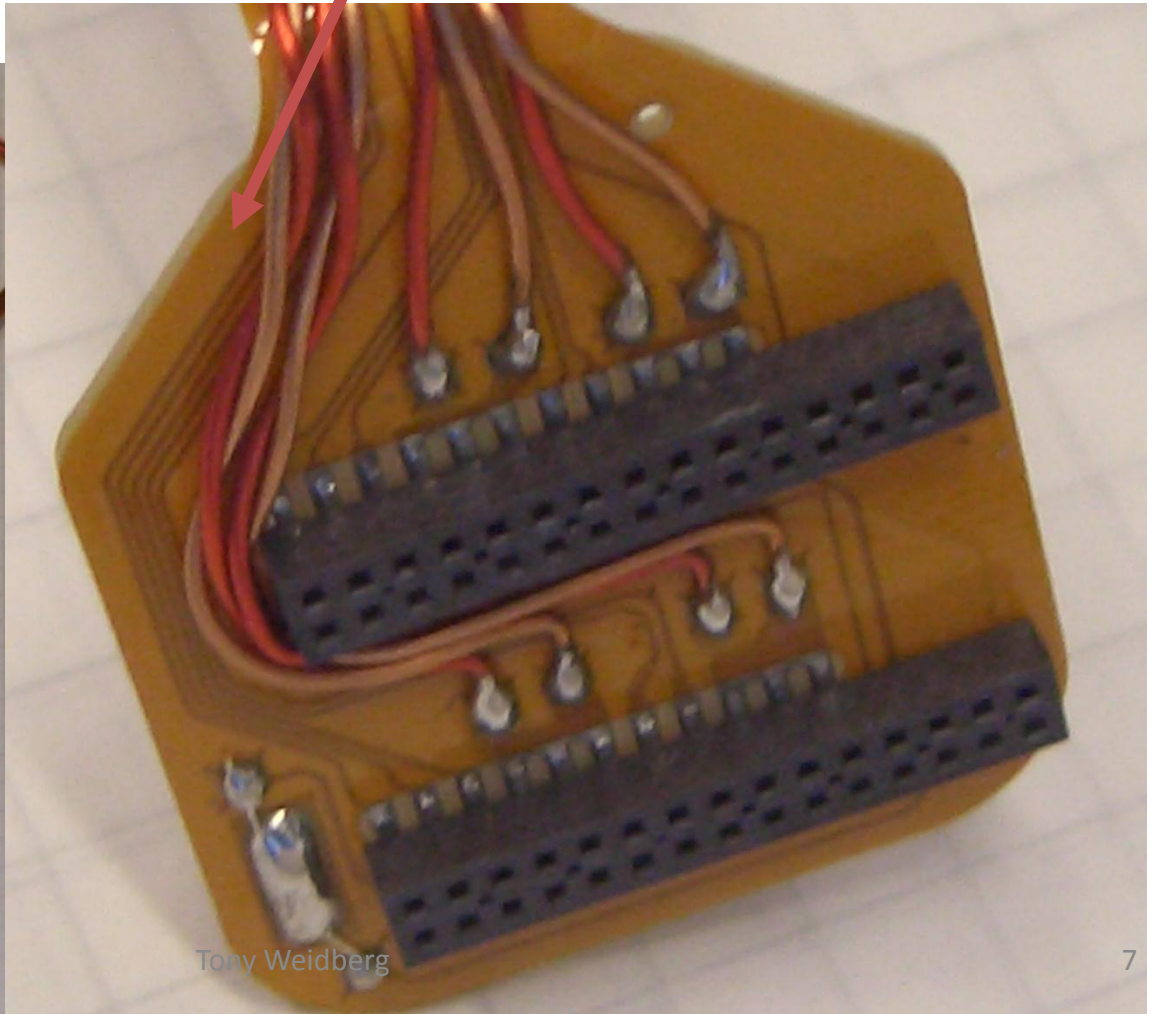
End Cap Flex Circuits

CuKapton for HV and control signals

CCA twisted pair for high current (DC power)

Stiffener

- First tapes made by Samtec with new photo-imageable cover layer → bad idea, too fragile.
- Even with conventional cover layer had many breaks on Cu/kapton.
 - Problem is CCA wires much stiffer than Cu/kapton → caused breaks when tapes were bent (Cu/kapton alone was very robust).
 - Shouldn't have tied CCA to Cu/kapton

- Test tapes in realistic routing during R&D not during production/detector integration.
- Al/kapton tapes can be used in future but we should connect with wire bonding not soldering.

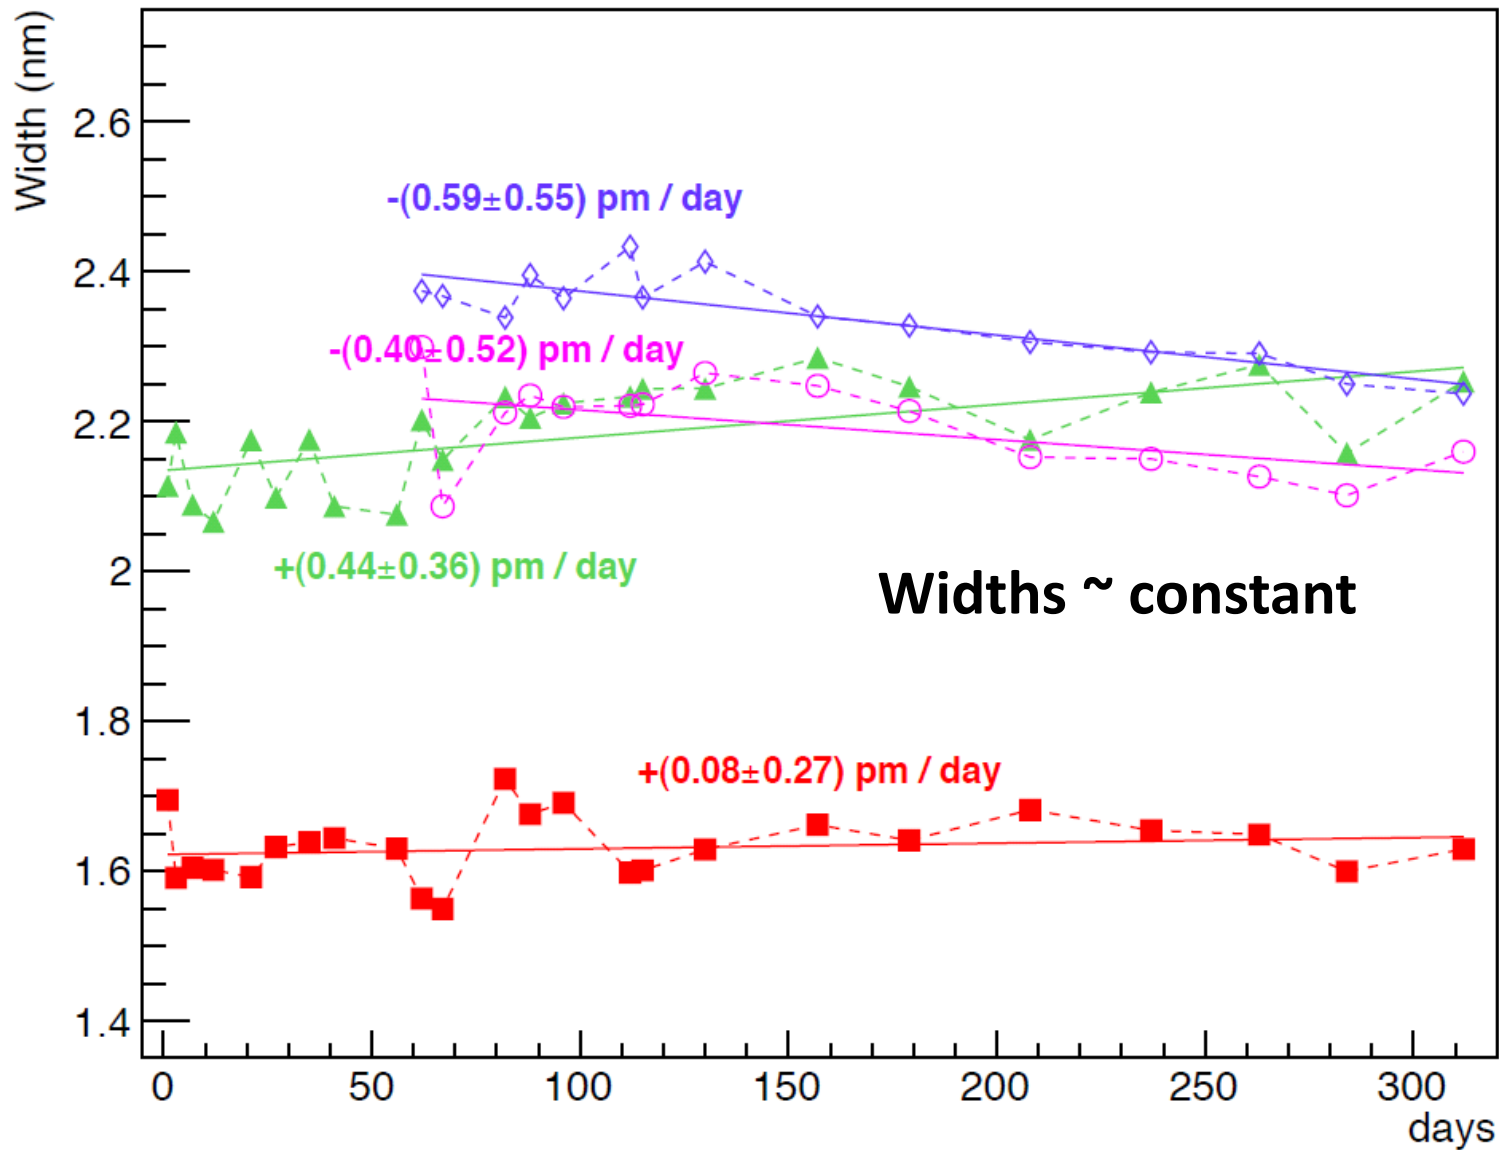
Development of spectral width, VCSELs kept in nitrogen

- **Why have none of these devices failed yet?**
- **Is all the data compatible with humidity being the only cause of failure?**
 - Try to fit all data to common accelerated aging model.
 - More lessons to be learnt here ...

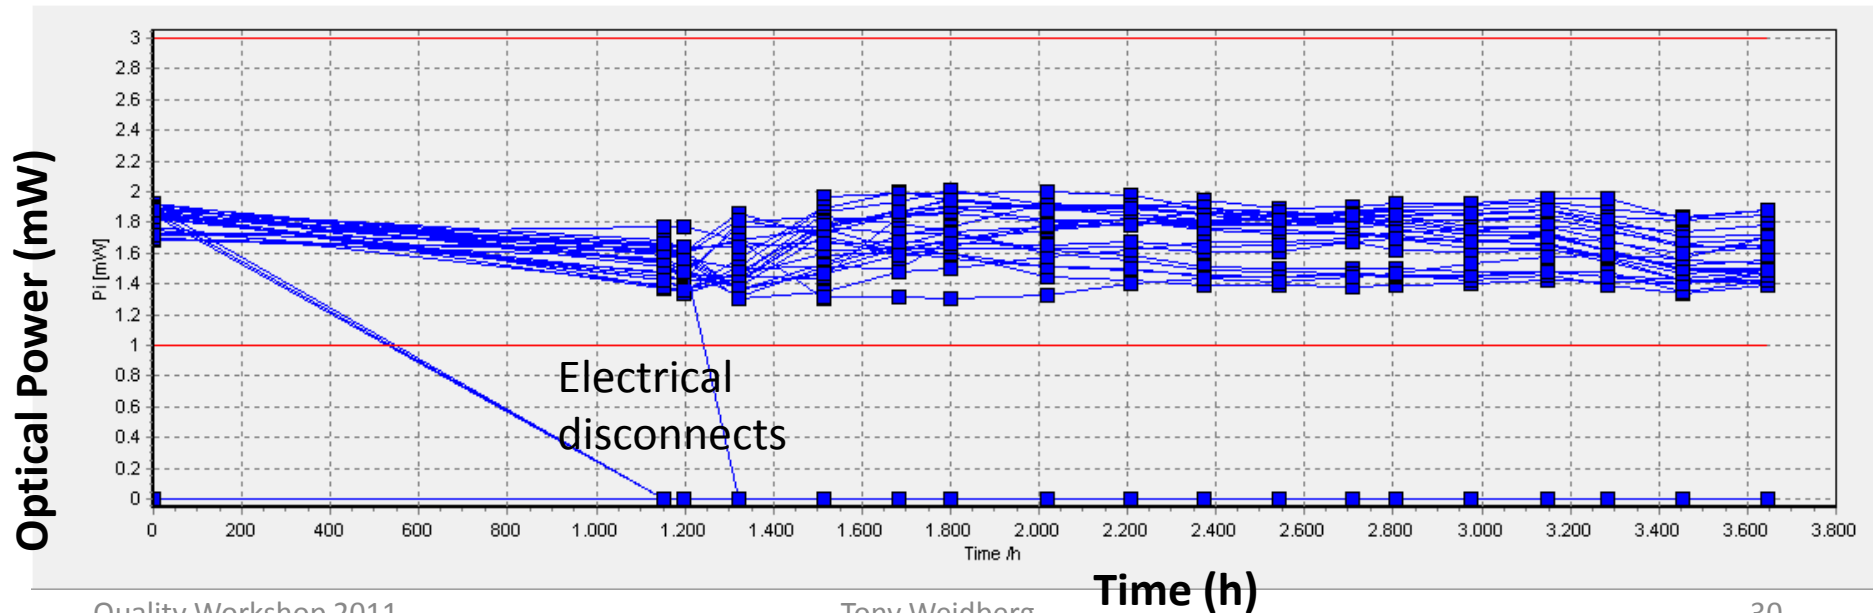
- Same Truelight VCSEL array/MT package as for the SCT/Pixel off-detector arrays which are failing
- But inside detector very low RH
- Accelerated aging tests for Truelight arrays at low RH: no deaths for 24 channels, $T=85^{\circ}\text{C}$, $I=10\text{ mA}$, 2100 hours → lower limit on lifetime = 49 years

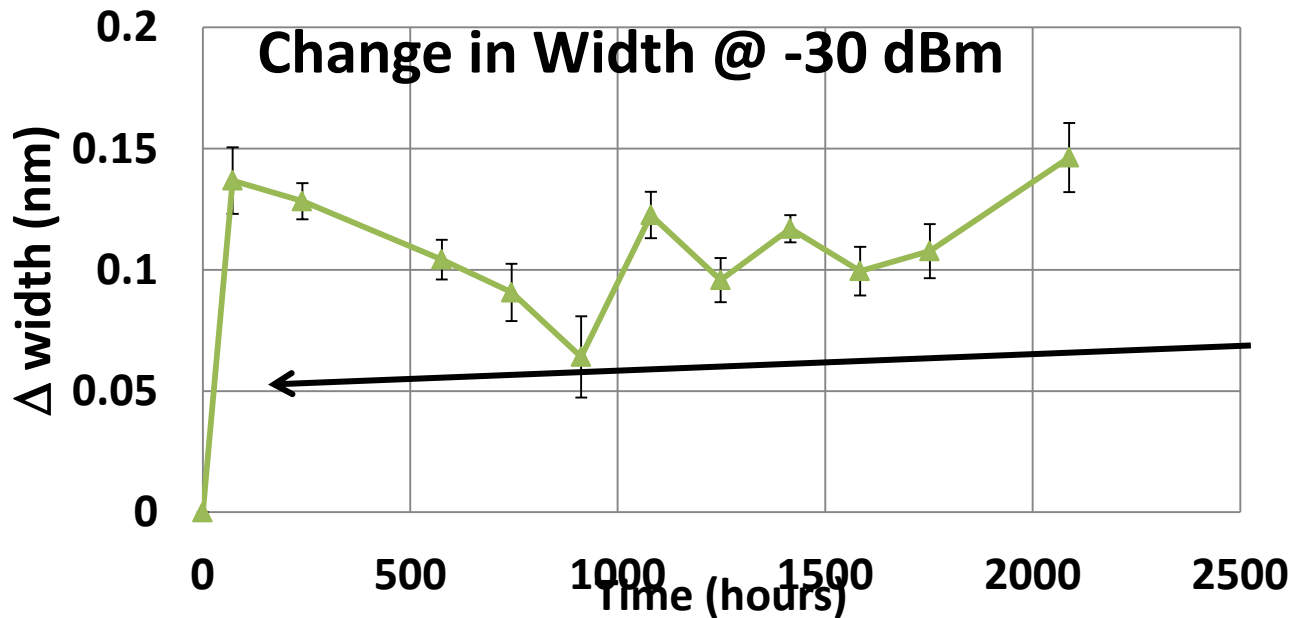
- Bare AOC arrays
- $I=8$ mA DC, 85C/85% RH
- No deaths for 31 channels after 3200 hours
- AOC arrays packaged by CSIST
 - $I=10$ mA DC, 70C/85% RH, 60 channels used
 - No significant change in spectral widths for 2000 hours

Initial increase when T increased from 20C to 70C
