# APV25 Production Testing Status

Mark Raymond, Imperial College

April, 2003

CMS tracker electronics

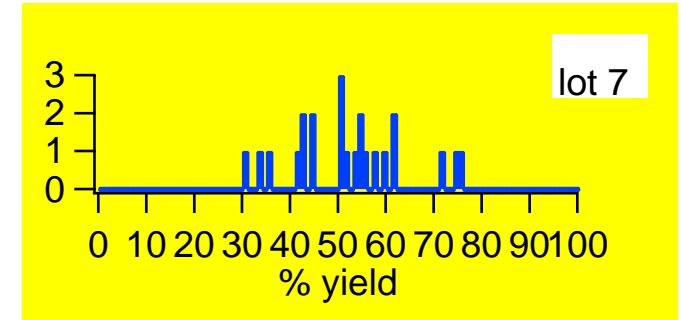
**Jan:** APV lots 6 and 7 delivered

lot 7 -> average 52%, but lot 6 close to zero

manufacturers notified (via CERN)

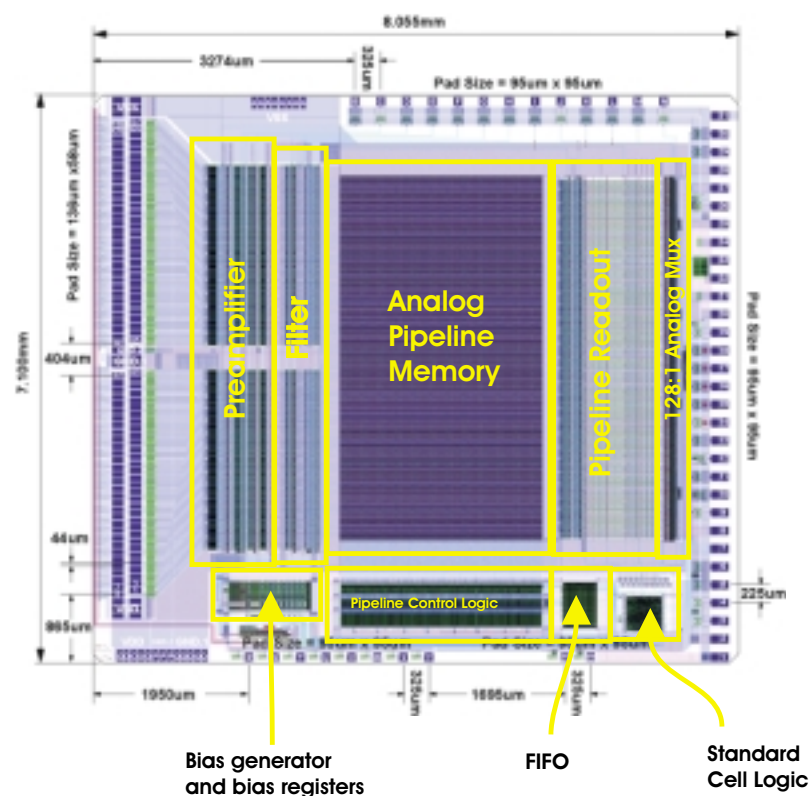
# Modified wafer test protocol

test continues to end even if gross defect found early on to provide as much info as possible to FA team

sort failures into 5 categories:

- power
- channel (pedestal or response to CAL)
- bias register (stuck bits)
- pipeline logic (digital header incorrect)
- other digital

try to associate failure with particular functional area on chip

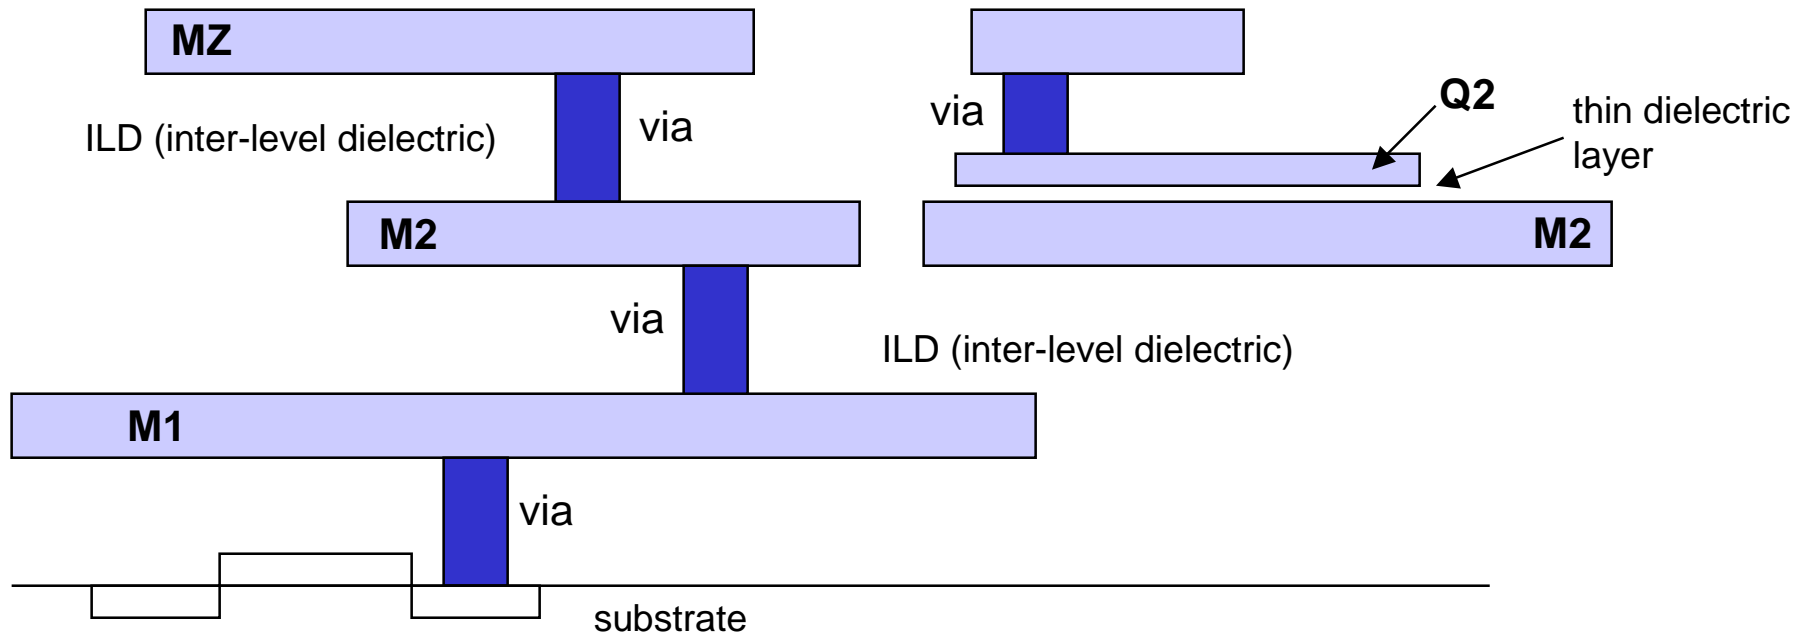
# Metallization X section

APV uses 3 metal layers (up to 6 possible)

floating capacitors implemented by Q2/M2 structure – only used in analogue parts of chip

production process divided into 2 distinct phases

Front end of line – transistors defined

Back end of line – metal layers and interconnecting vias added
