# mini-module characterization

2 mini-pT modules exist

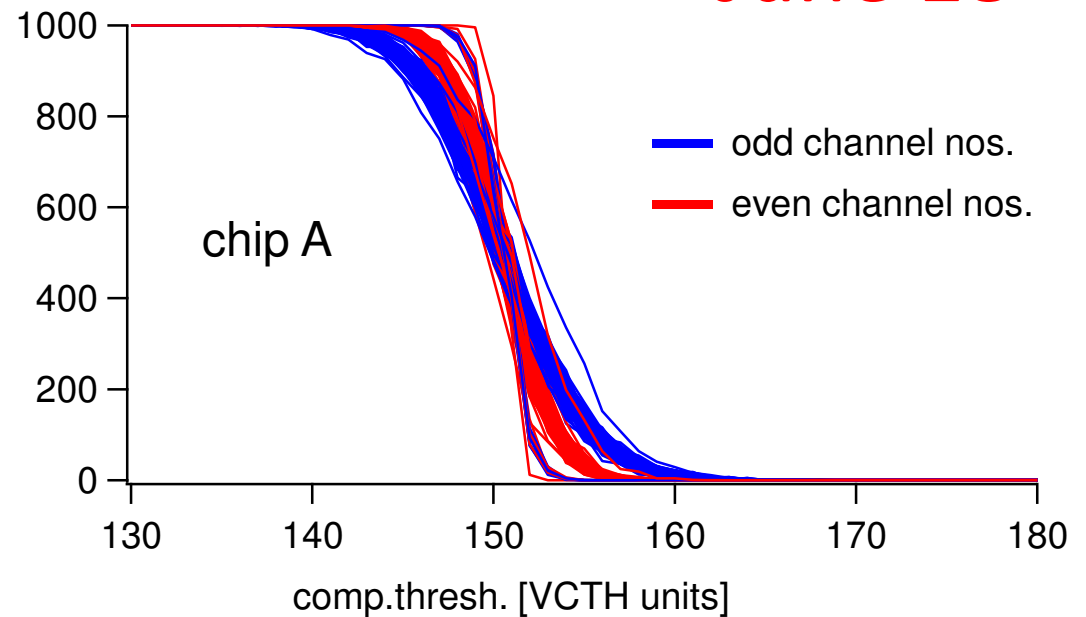
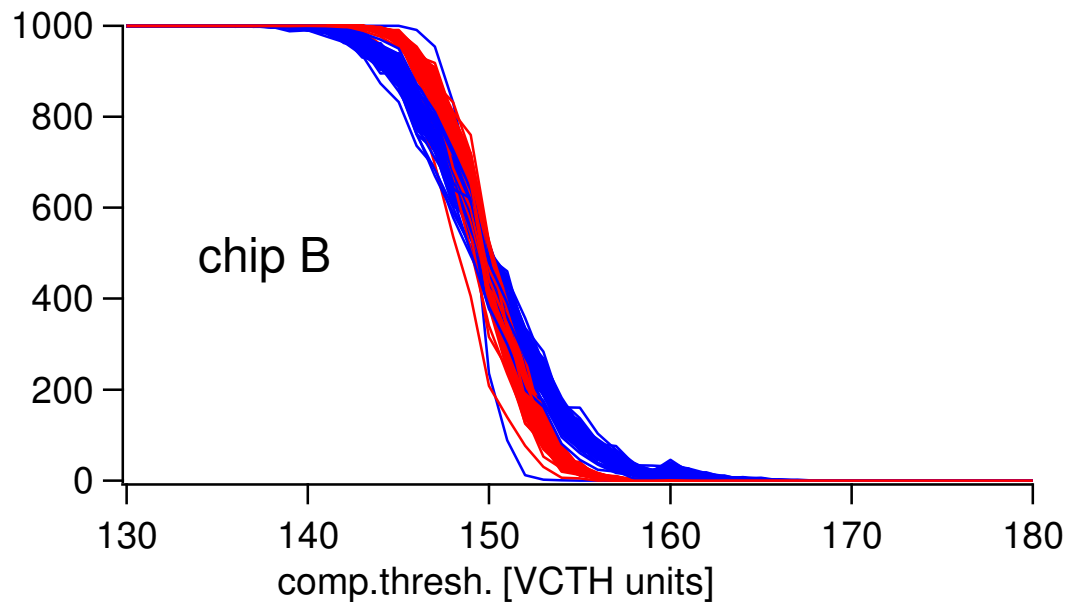
## s-curves

2 clear families corresponding to  
**odd** & **even** chip channel numbers

odd CBC channels show more “stretched  
out” s-curves  
=> higher noise

odd channels correspond to lower sensor

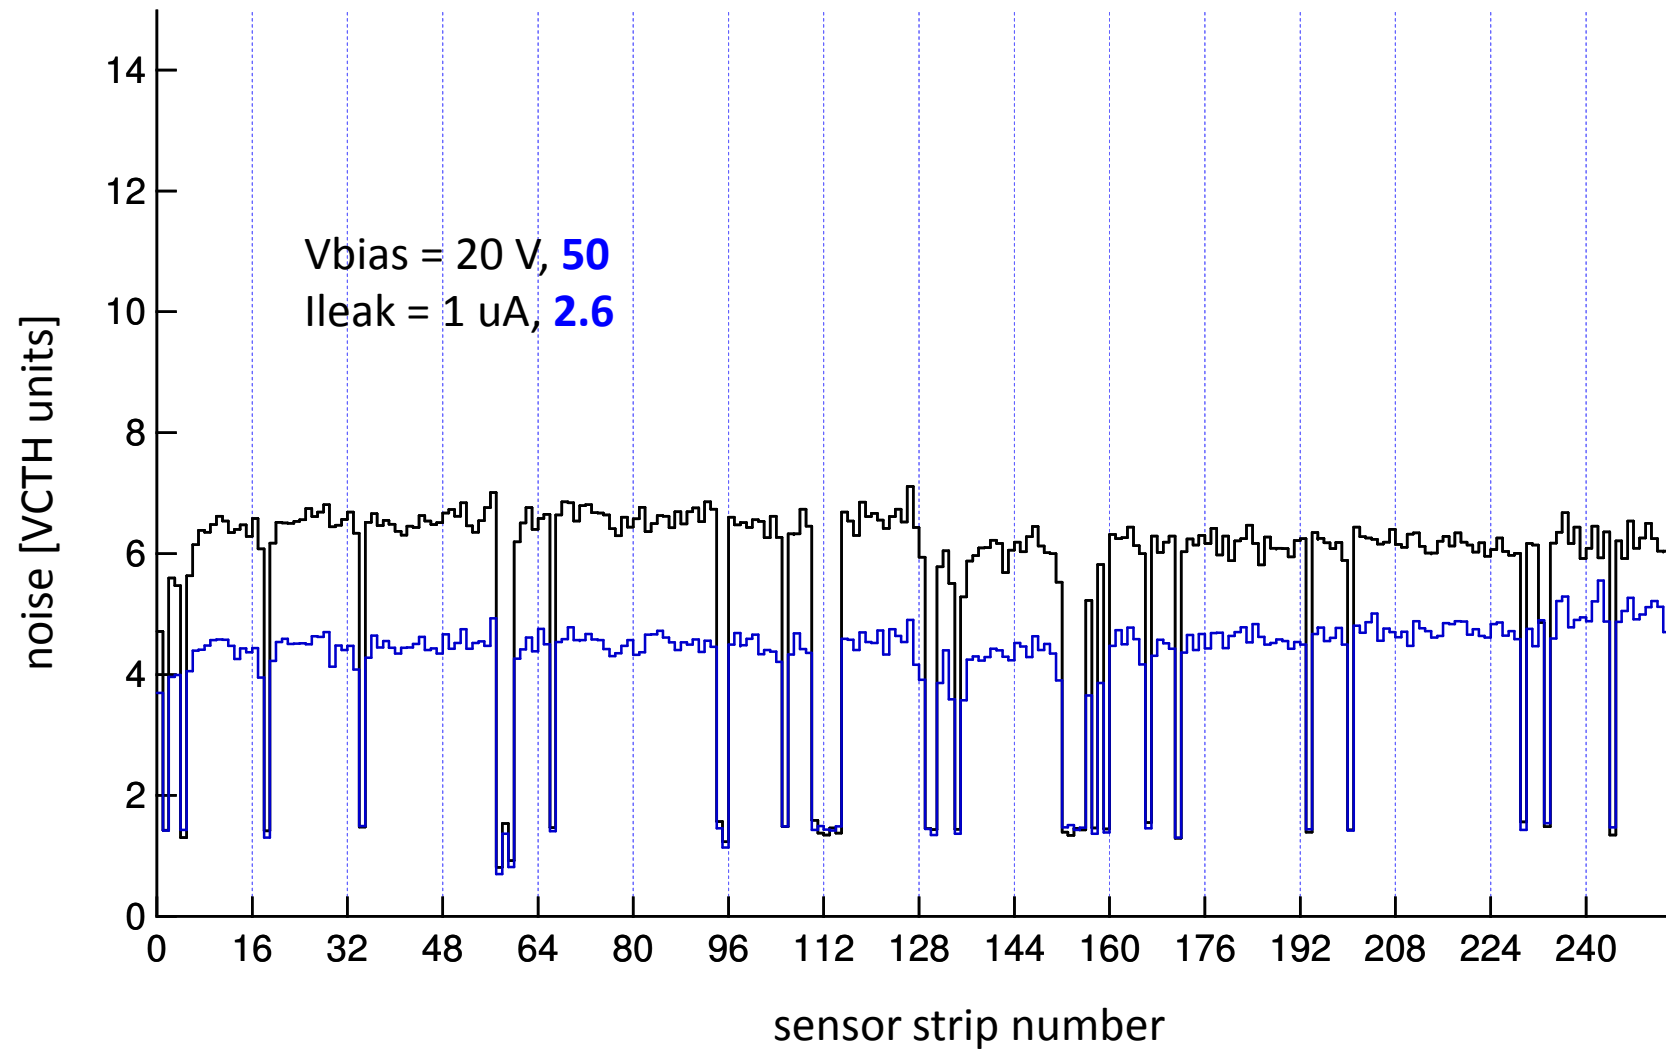
## mini-module#1: **lower** sensor

sorting noise data by sensor strip number: lower sensor, 20 & **50V**

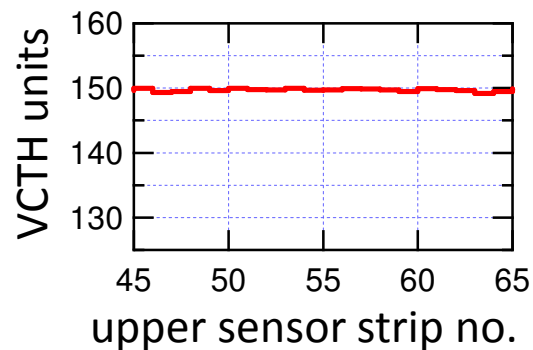
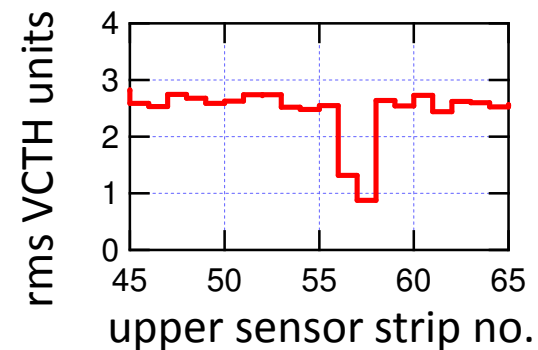
gain plot shows s-curve mid-points resulting from  $\sim 1fC$  test pulse  
(after tuning comparator offsets to value of 150)

will concentrate on region around these two “bad” strips

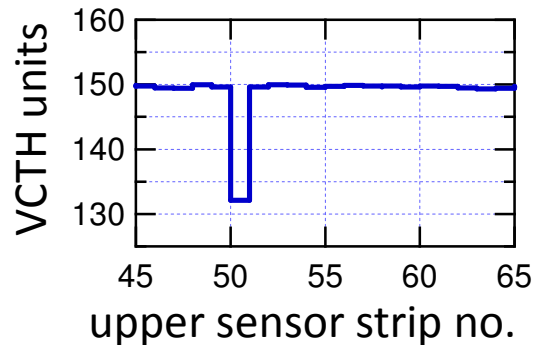
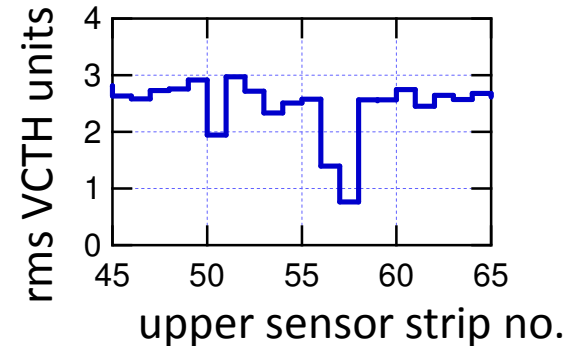
now place grounded probe on strip 50 wire-bond pad

for a normally behaving channel (strip 50), grounding the wire-bond pad which is connected (via bump-bond) to CBC input, means that that channel no longer responds to the test-pulse

amplitude (strip 50) drops to pedestal level  $\sim 130$

noise of that channel also drops

not to zero, but possibly noise introduced by the probe passes through the preamp feedback capacitor  $C_f$

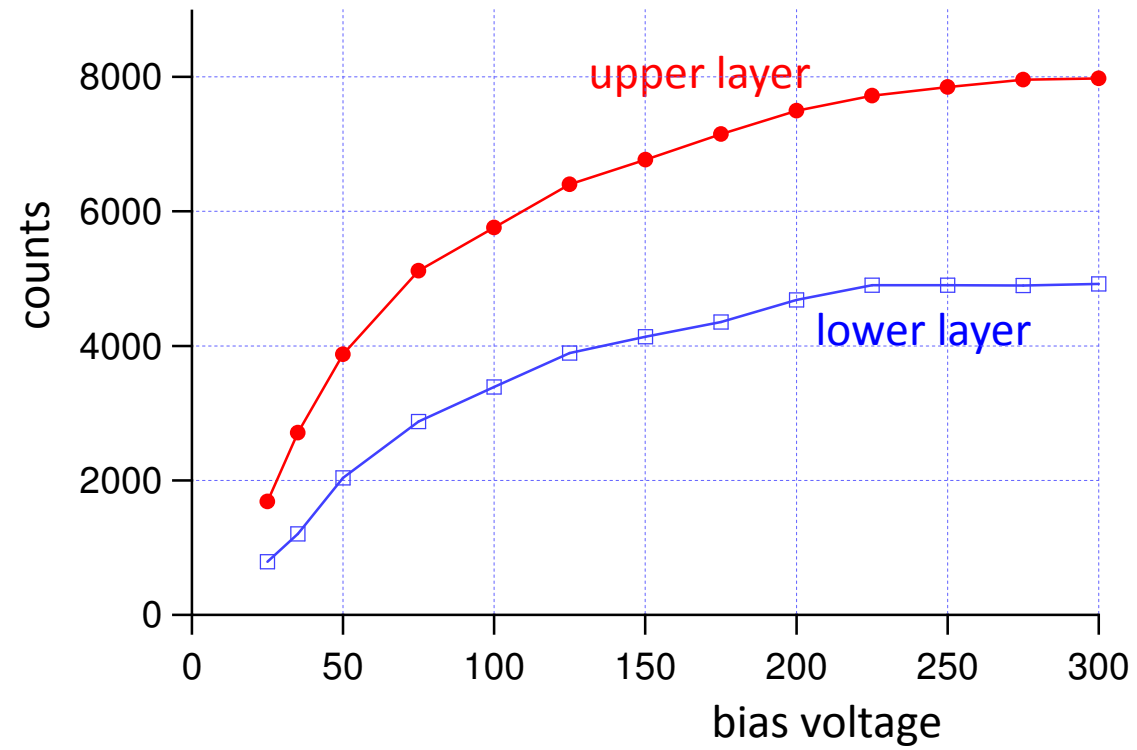
## signal vs. bias - mini-module#2

similar result

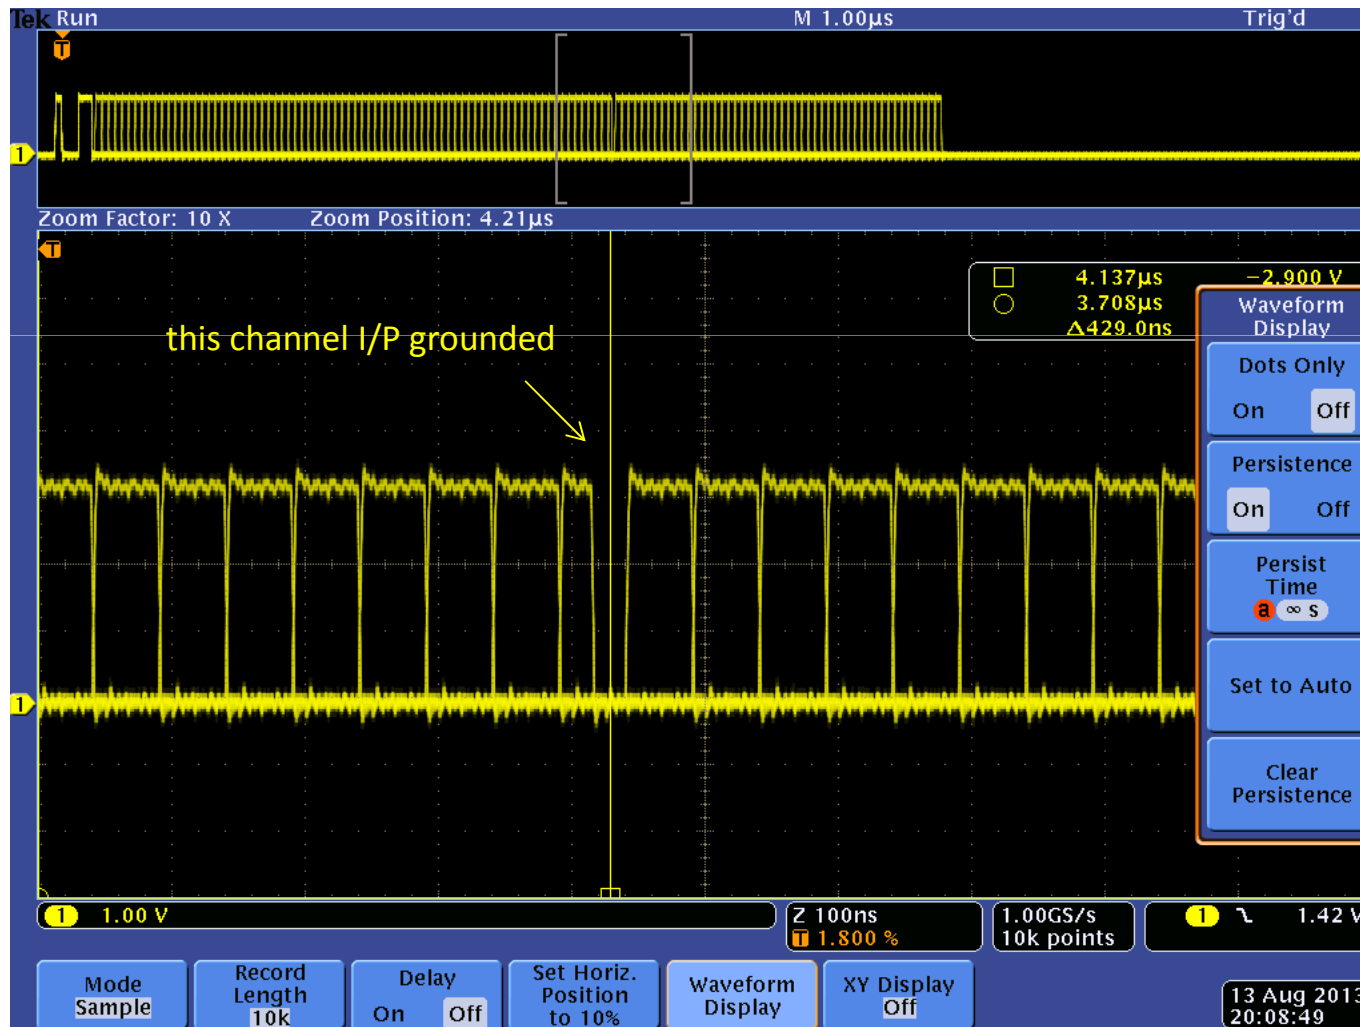
**underfilled hybrid #U03**

cycle test pulse continuously through all chip channels  
view chip output frames on scope - infinite persistence  
lower grounded probe tip on wire-bond pad - signal should disappear for that channel  
repeat for all channels

all channels verified connected
