CBC2 CM studies

Mark Raymond

systems meeting, 13th January, 2015.

CBC2 CM issues

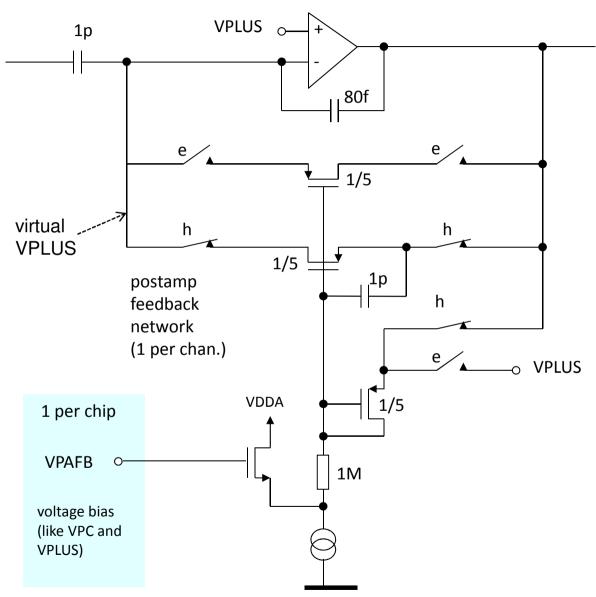
closer look at postamp(1)

bit complicated - because of need to switch PMOS feedback FET polarity depending on polarity of signal swing (electrons/holes)

suspect mirror transistor connection to actual VPLUS in electrons mode could be cause of problem

possibility for VPLUS to be affected by disturbance on VPAFB source follower node (1M/254 = 4k)

=> possibility to affect noninverting node of op-amp

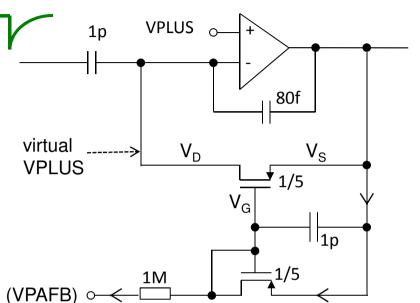
postamp feedback FET biasing - holes mode

"current mirror" biasing technique allows to exploit FET characteristic to get high resistance in signal direction and lower for overshoot (quicker restoration to baseline)

postamp output supplies current mirror bias current

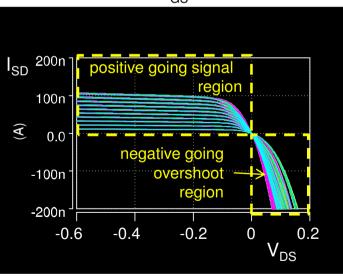
postamp feedback FET biasing - electrons mode

same technique in electrons mode but use actual VPLUS for mirror transistor source node (virtual node cannot supply DC current)
