CBC3 status

wafer probe testing status LDO measurements some more digital problems discovered

systems meeting, 23rd February, 2017

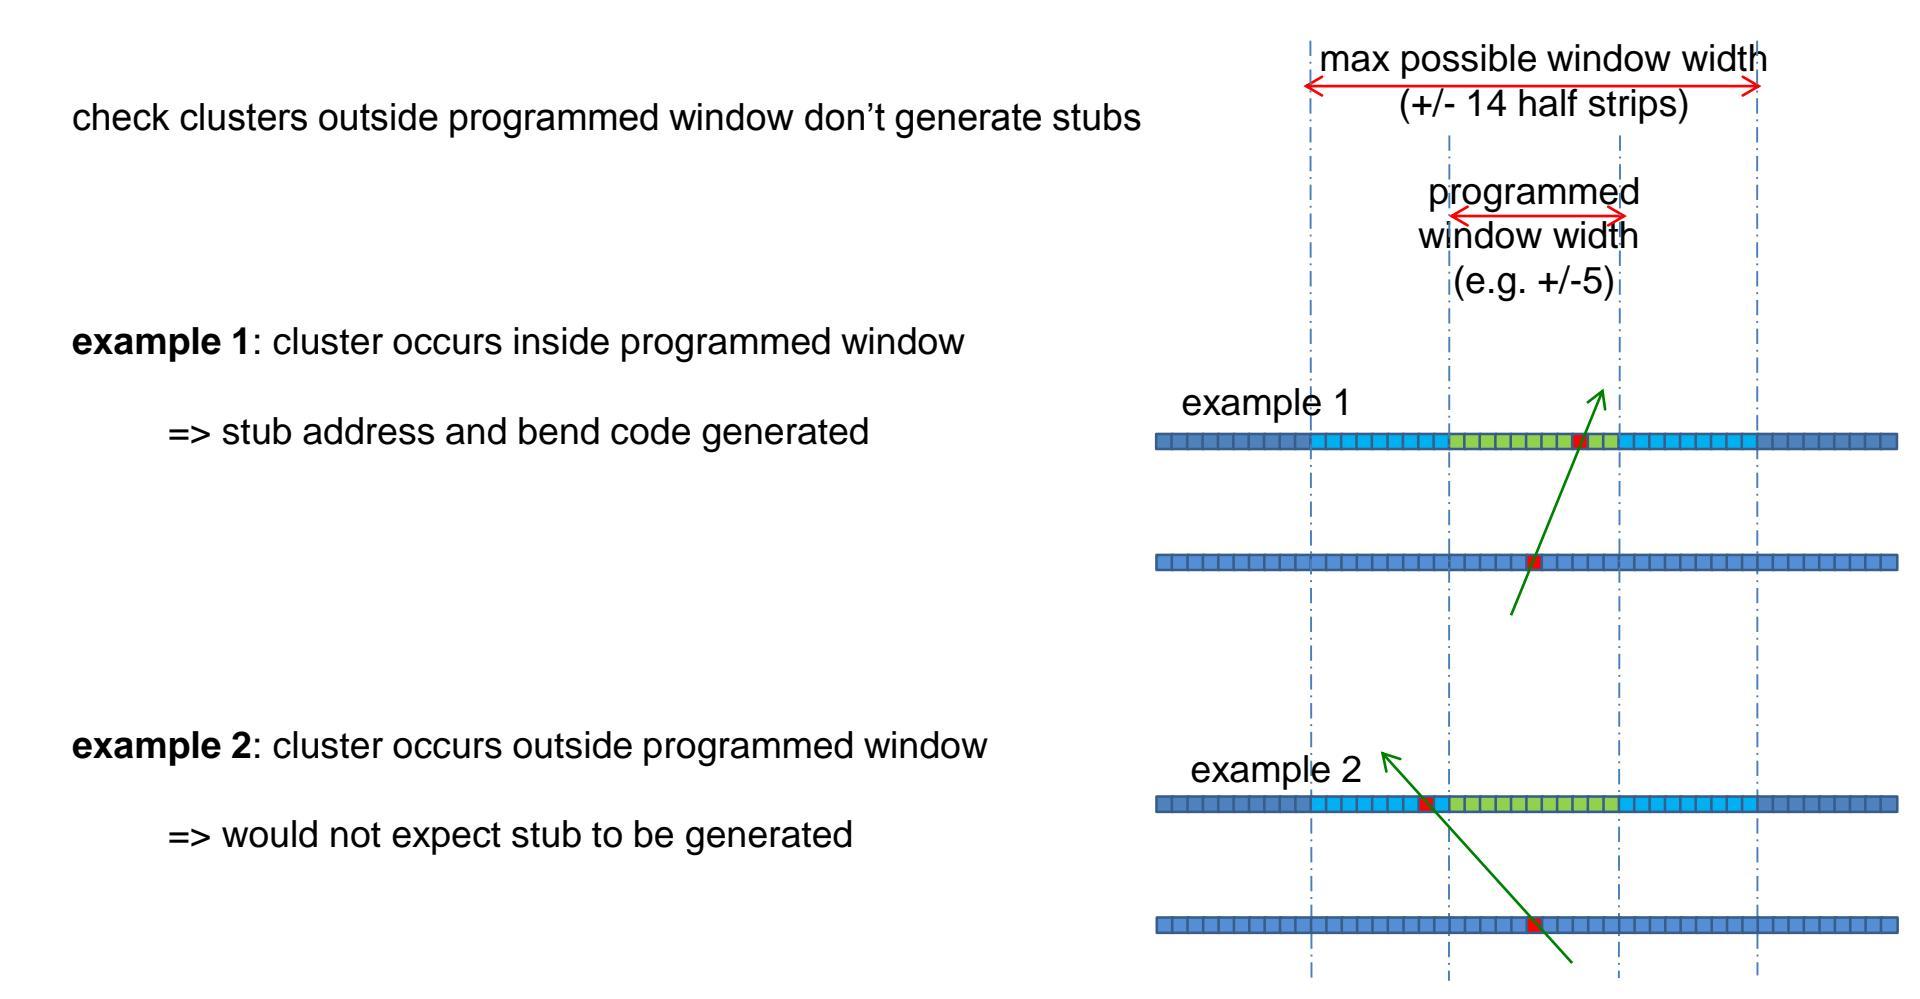
but turns out that logic has been coded to generate stub address + invalid bend code (b1000)

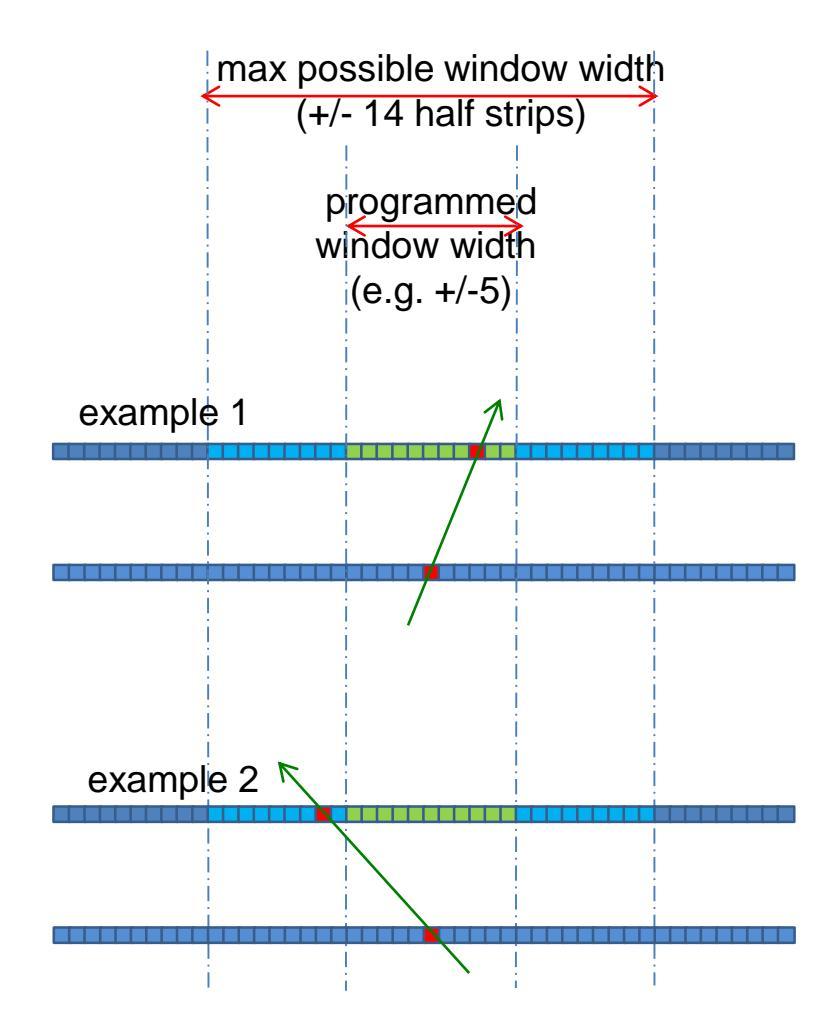
example 2: cluster occurs outside programmed window
 but inside maximum possible window
 get stub address + invalid bend code (b1000)
this is not ideal, wastes off-chip stub address bandwidth
not a problem for CBC3 users

stub address from cluster outside window will need to be suppressed with logic change

CBC3 wafer probe test implemented by checking for invalid bend code from clusters outside programmed window

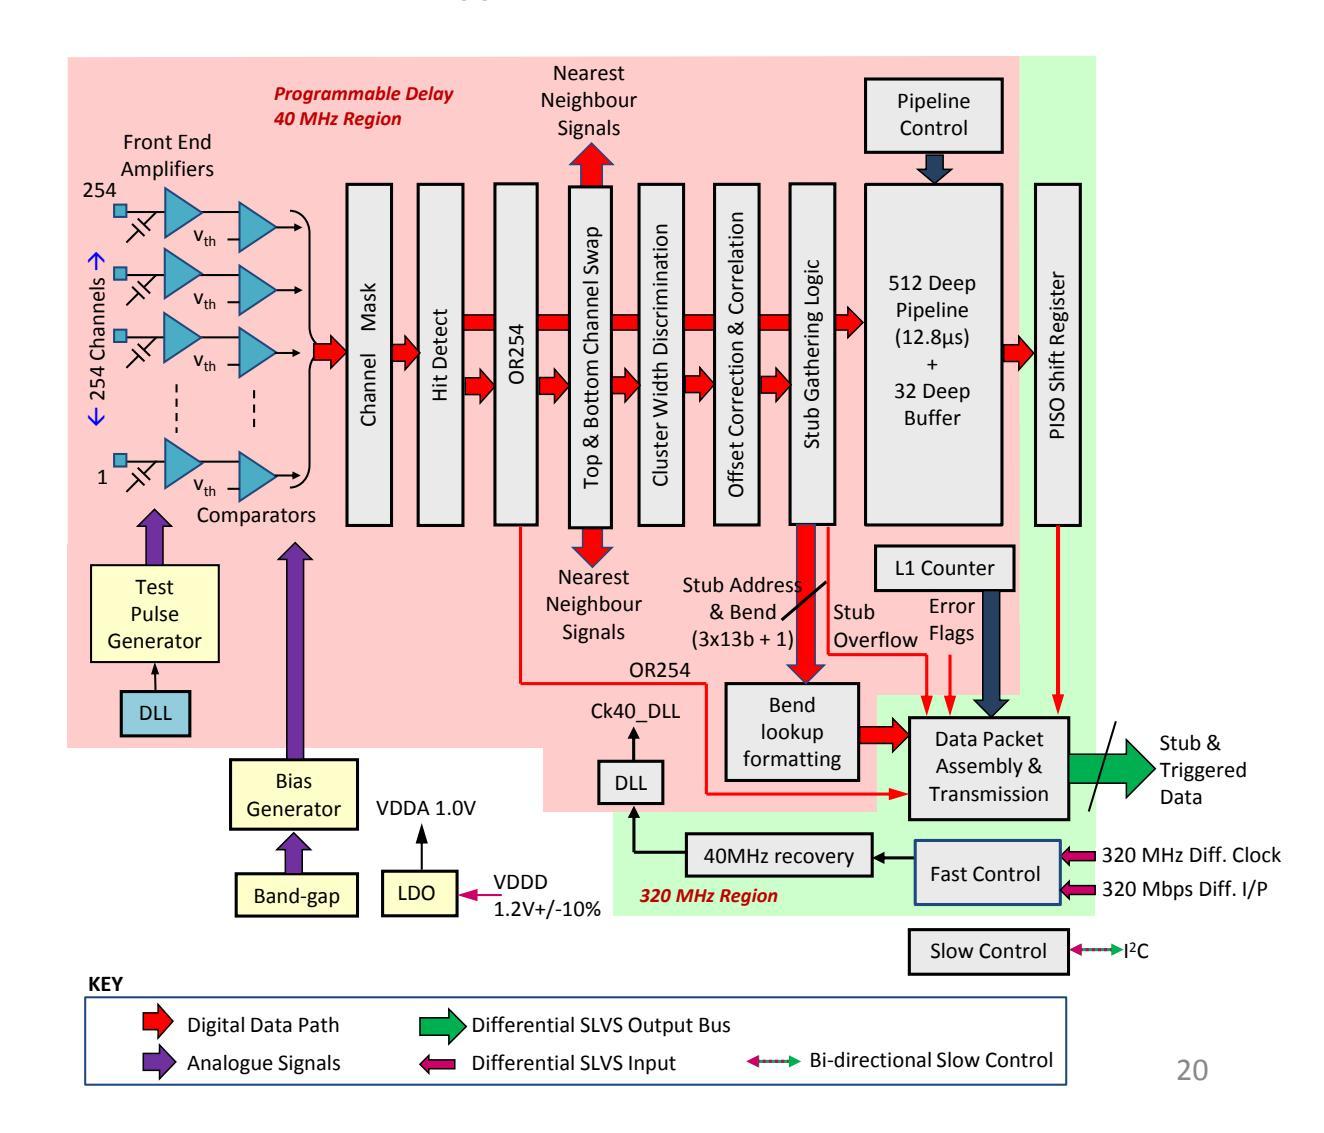
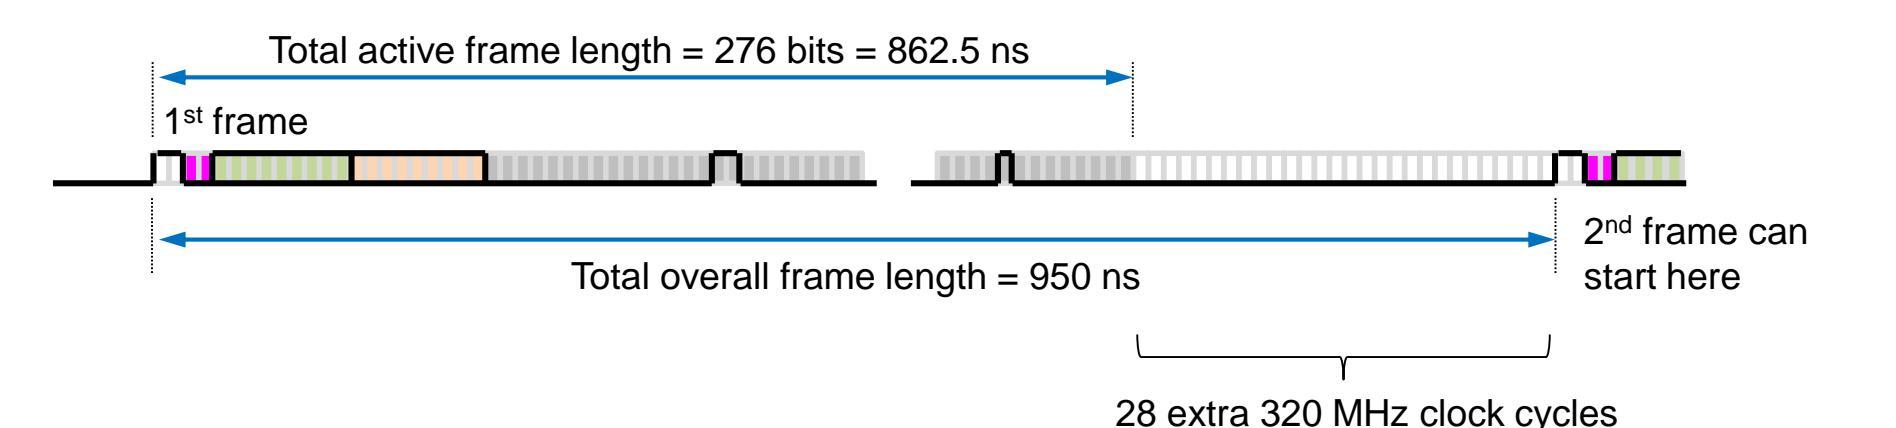
L1 readout problem

have discovered problems in the L1 data readout

for some DLL settings, but only when multiple triggers are sent

for some values of DLL setting (1 nsec resolution) the L1 data readout logic malfunctions if two (or more) triggers are applied

but only if the trigger spacing is less than 950 nsec

frame separation reduces to 925 nsec.

data, including header, from 1st frame is repeated in 2nd frame

multiple frames appear, not corresponding to triggers

=> should choose one of these when operating the chip in conditions when trigger spacings less than 950 nsec

this problem needs to be understood and fixed

engineers are working - already found a timing issue in the triplicated control logic for the Buffer RAM to PISO interface

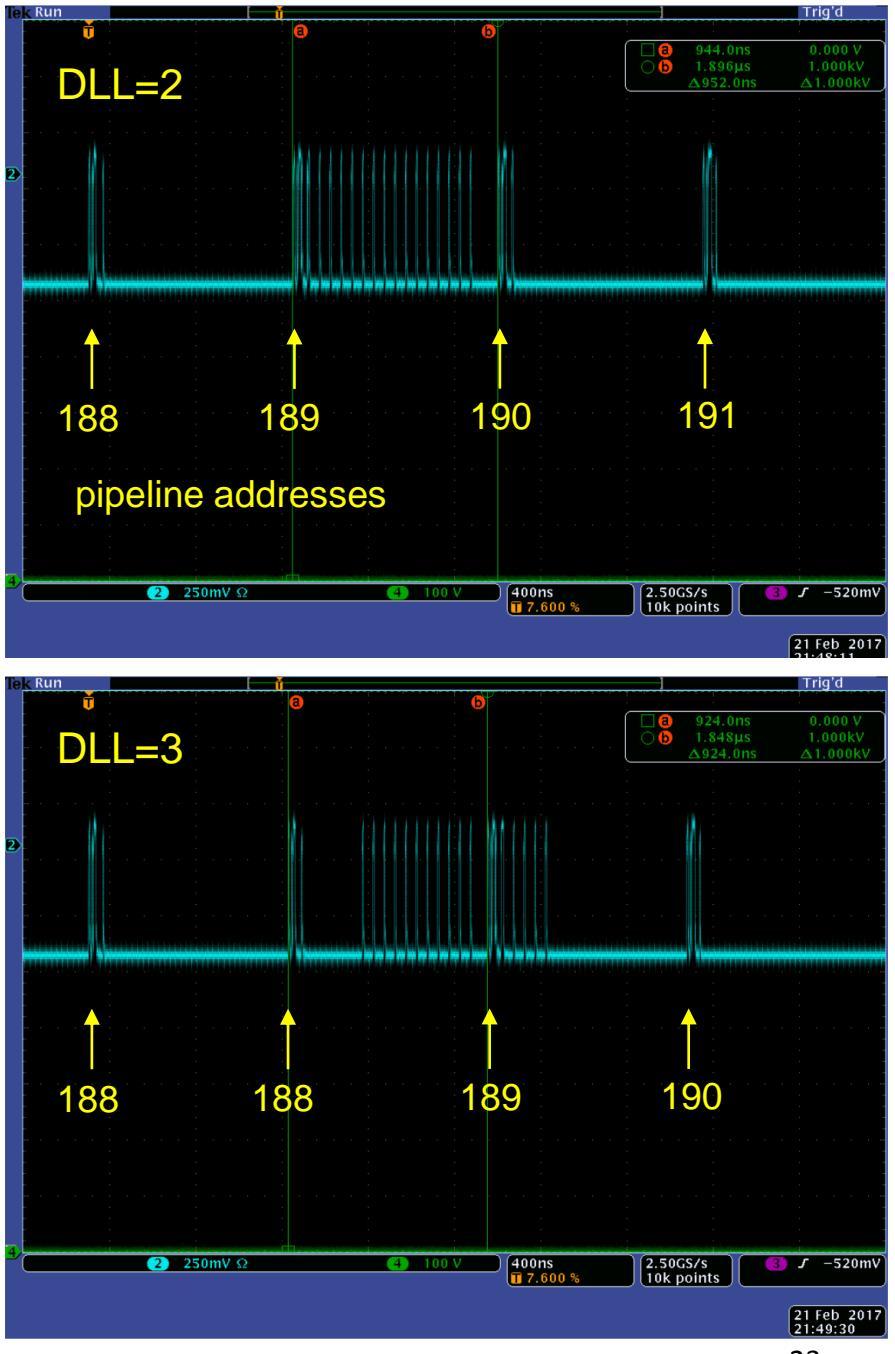
the problem: results for 12 chips

observations

problem DLL values depend on VDDD, and are not the same for all chips but appear to always occur at ~3 nsec spacings (probably related to 320 MHz clock) DLL values in between the 3 nsec problem spacings show no problems
