CBC3 wafer probe test status

systems meeting, 4th April, 2017

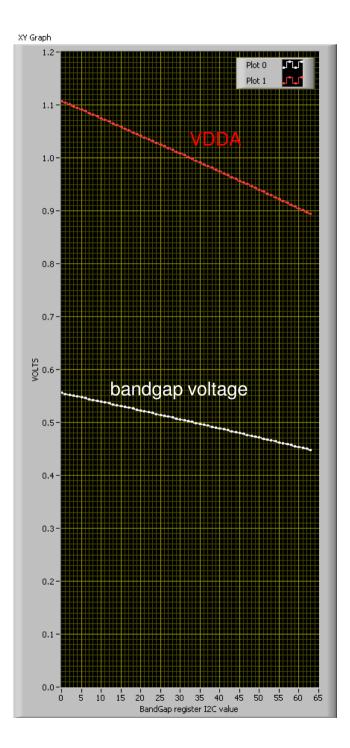
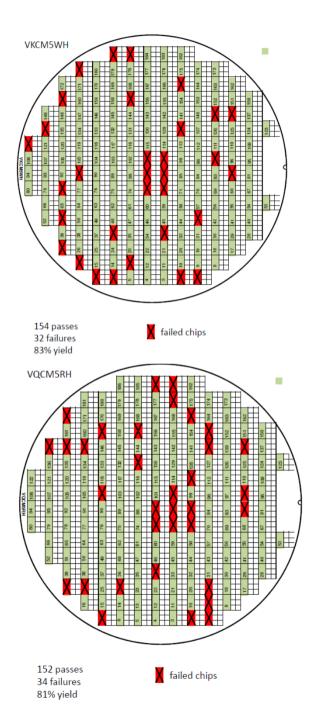
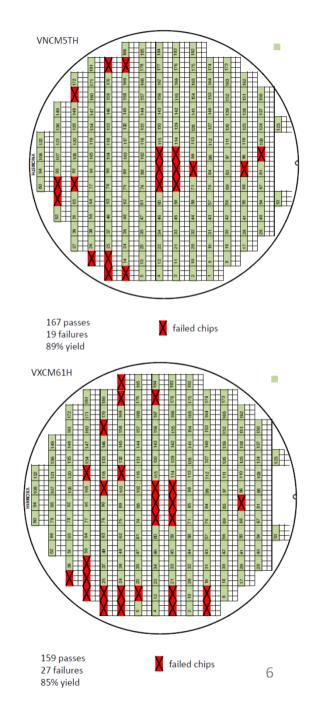
24 failures 87% yield

most (~all) of failures in centre of wafers are channel failures

yield quite high (> 80%) but noticeable pattern of failures in centre of wafers
