Tera-Pixel APS for CALICE

Progress meeting, 17th September 2007

Jamie Crooks, Microelectronics/RAL

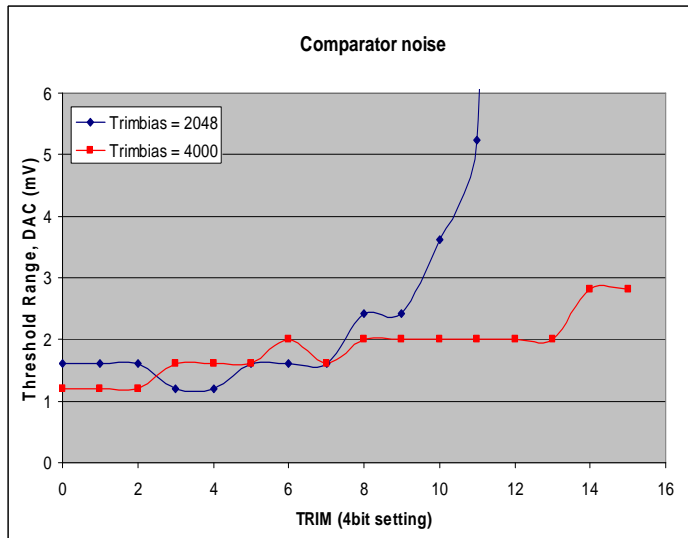
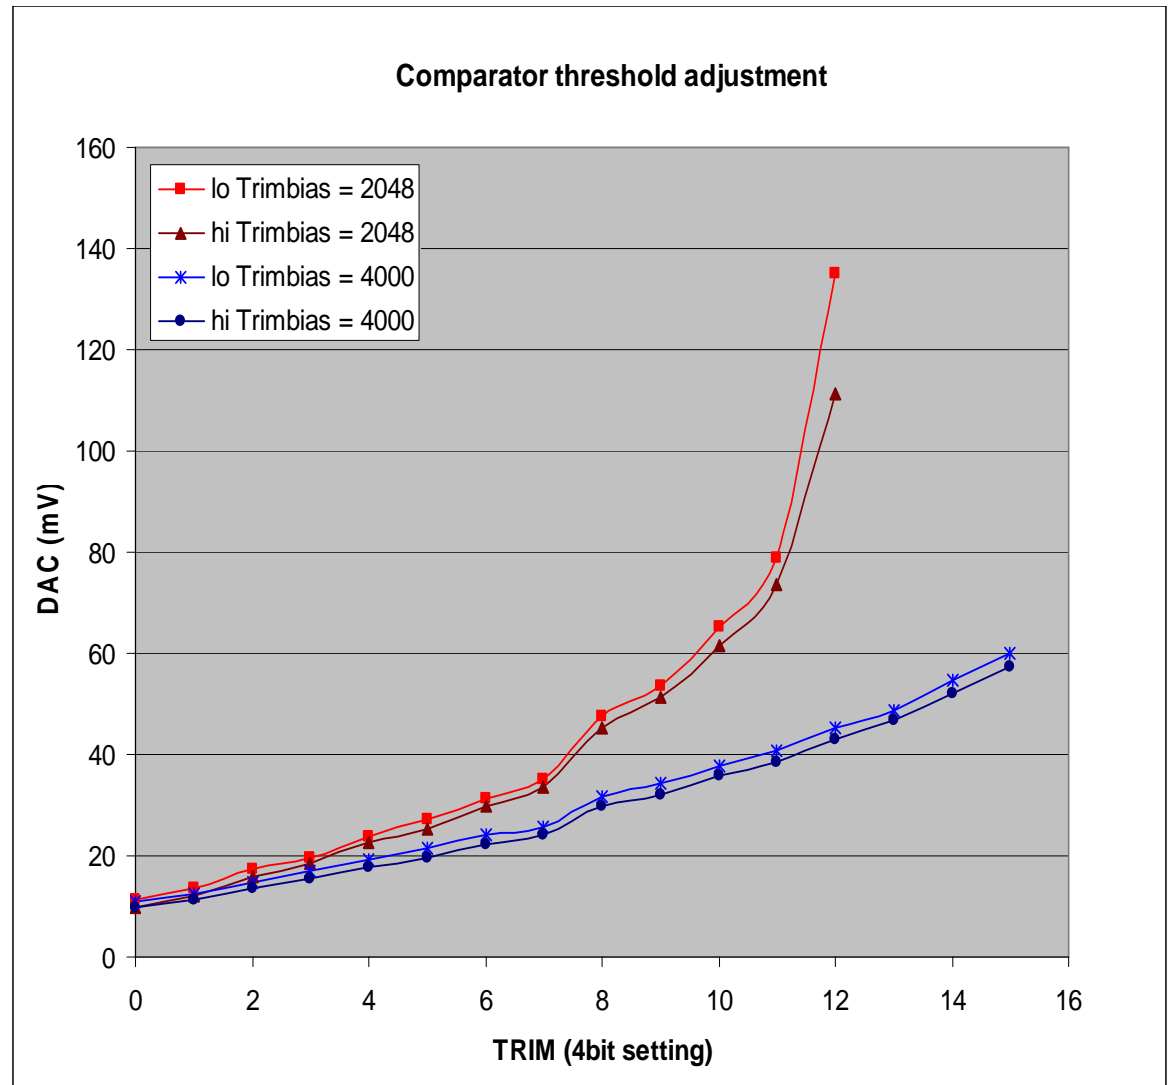
Comparator & Trim

- Comparator trim biases adjusted to give sensible step size
- Holding test pixel in reset (ie zero input), record switching threshold for each trim setting
- Upper and lower limit of switching point recorded:

NB: One DAC step $\sim 0.4mV$
